NASA CR-134656
BAC Report No. 8654-953005

NONDESTRUCTIVE TESTS OF REGENERATIVE CHAMBERS

NATIONAL AERONAUTICS AND SPACE ADMINISTRATION

CONTRACT NAS 3-16800

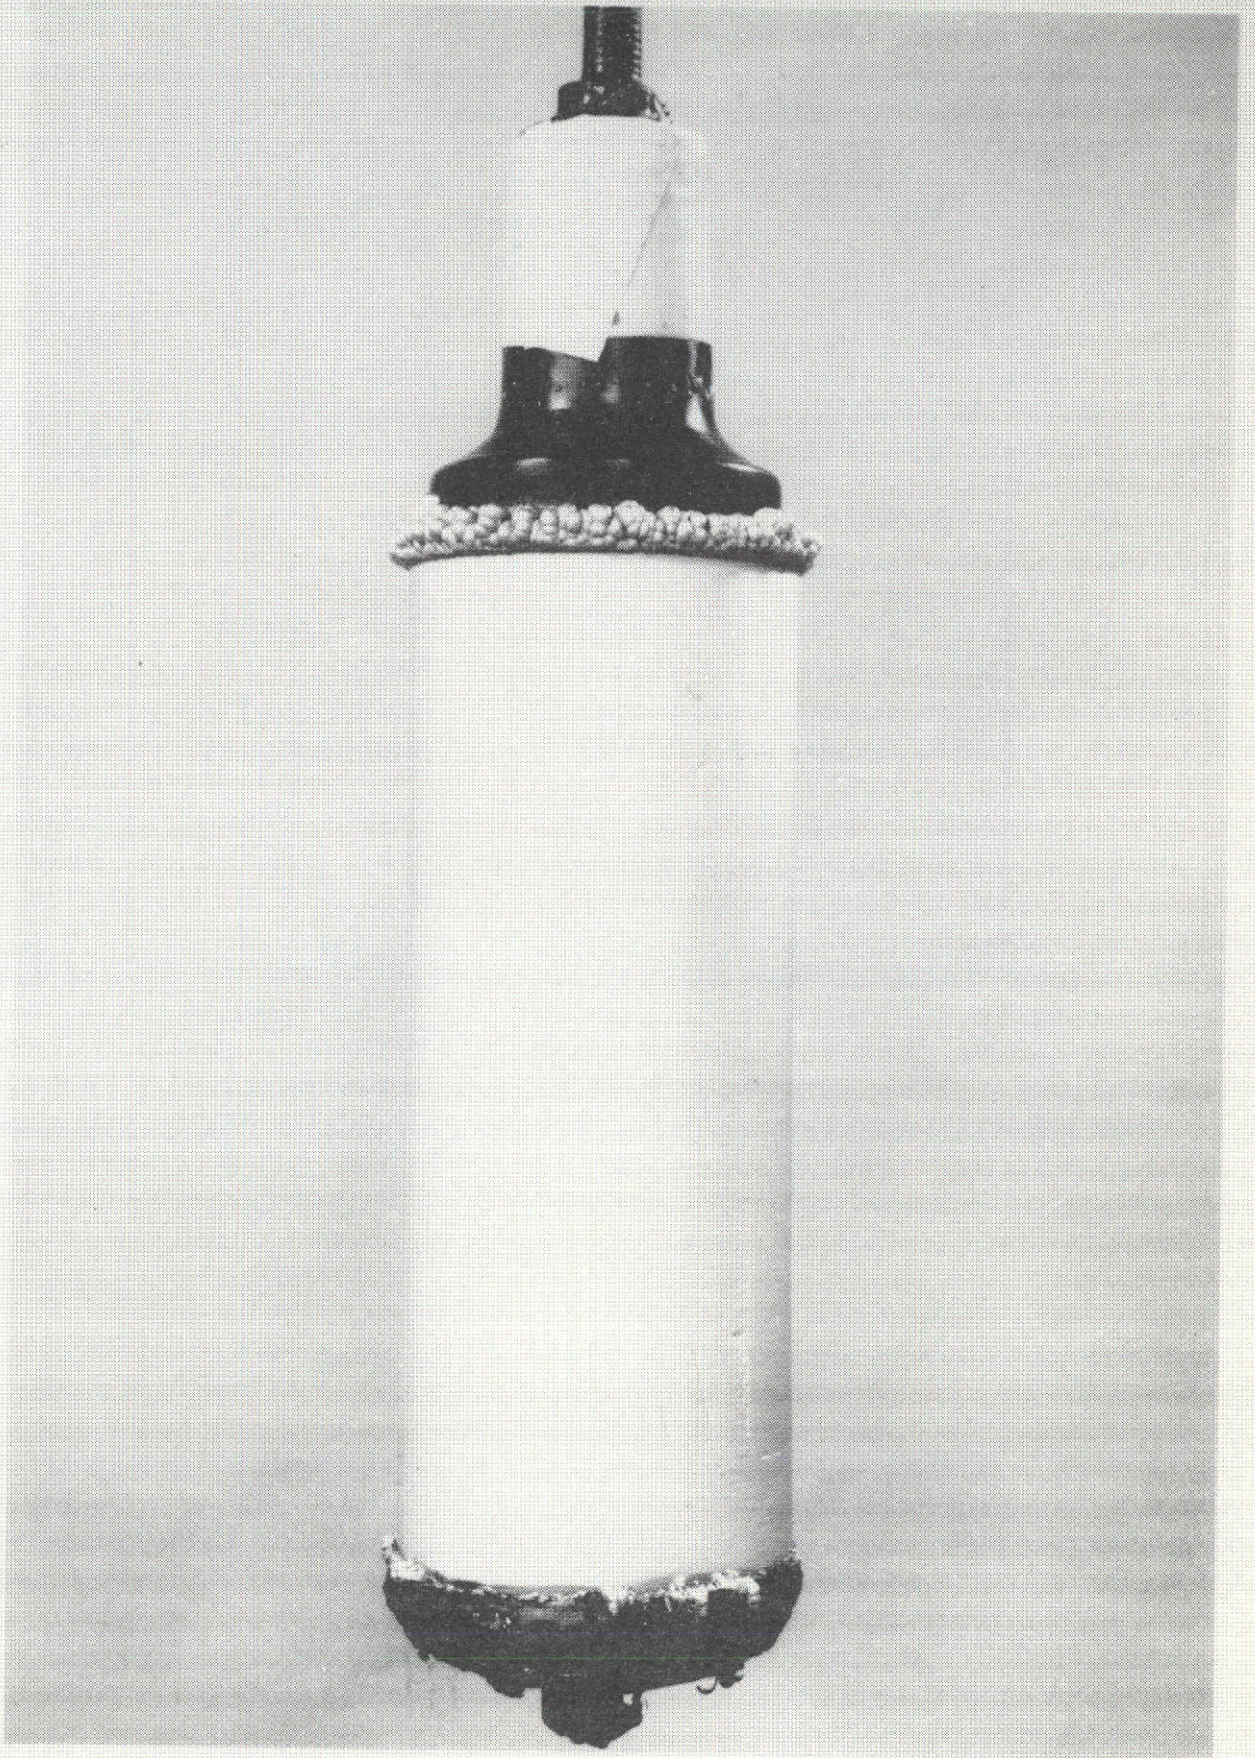
Figure 21. Fixtured Test Cylinder After Electroforming

An initial thin layer of fully bonded nickel was electrodeposited on all exposed OFHC copper surfaces, except for the two areas to receive planned defects shown in Figure 4. These areas were masked during the initial electroplating. The weak bond and nonbond flaws were produced by previously described means. The entire cylinder was then electroformed to a thickness exceeding the required outer shell thickness of 1.016 mm. (0.040 inch) to permit machining for uniformity. A current density of 279 amp/m.² (30 amp/m.²) was employed and the electrolyte operating conditions were those used to produce high strength electroformed nickel on flat panels. Figure 21 shows the cylinder after electroforming.
