NASA CR-132495

PROGRAM FOR ESTABLISHING LONG-TIME FLIGHT SERVICE PERFORMANCE
OF COMPOSITE MATERIALS IN THE
CENTER WING STRUCTURE OF C-130 AIRCRAFT

PHASE III - FABRICATION

Prepared under Contract No. NAS 1-11100 by
LOCKHEED-GEORGIA COMPANY
Marietta, Georgia

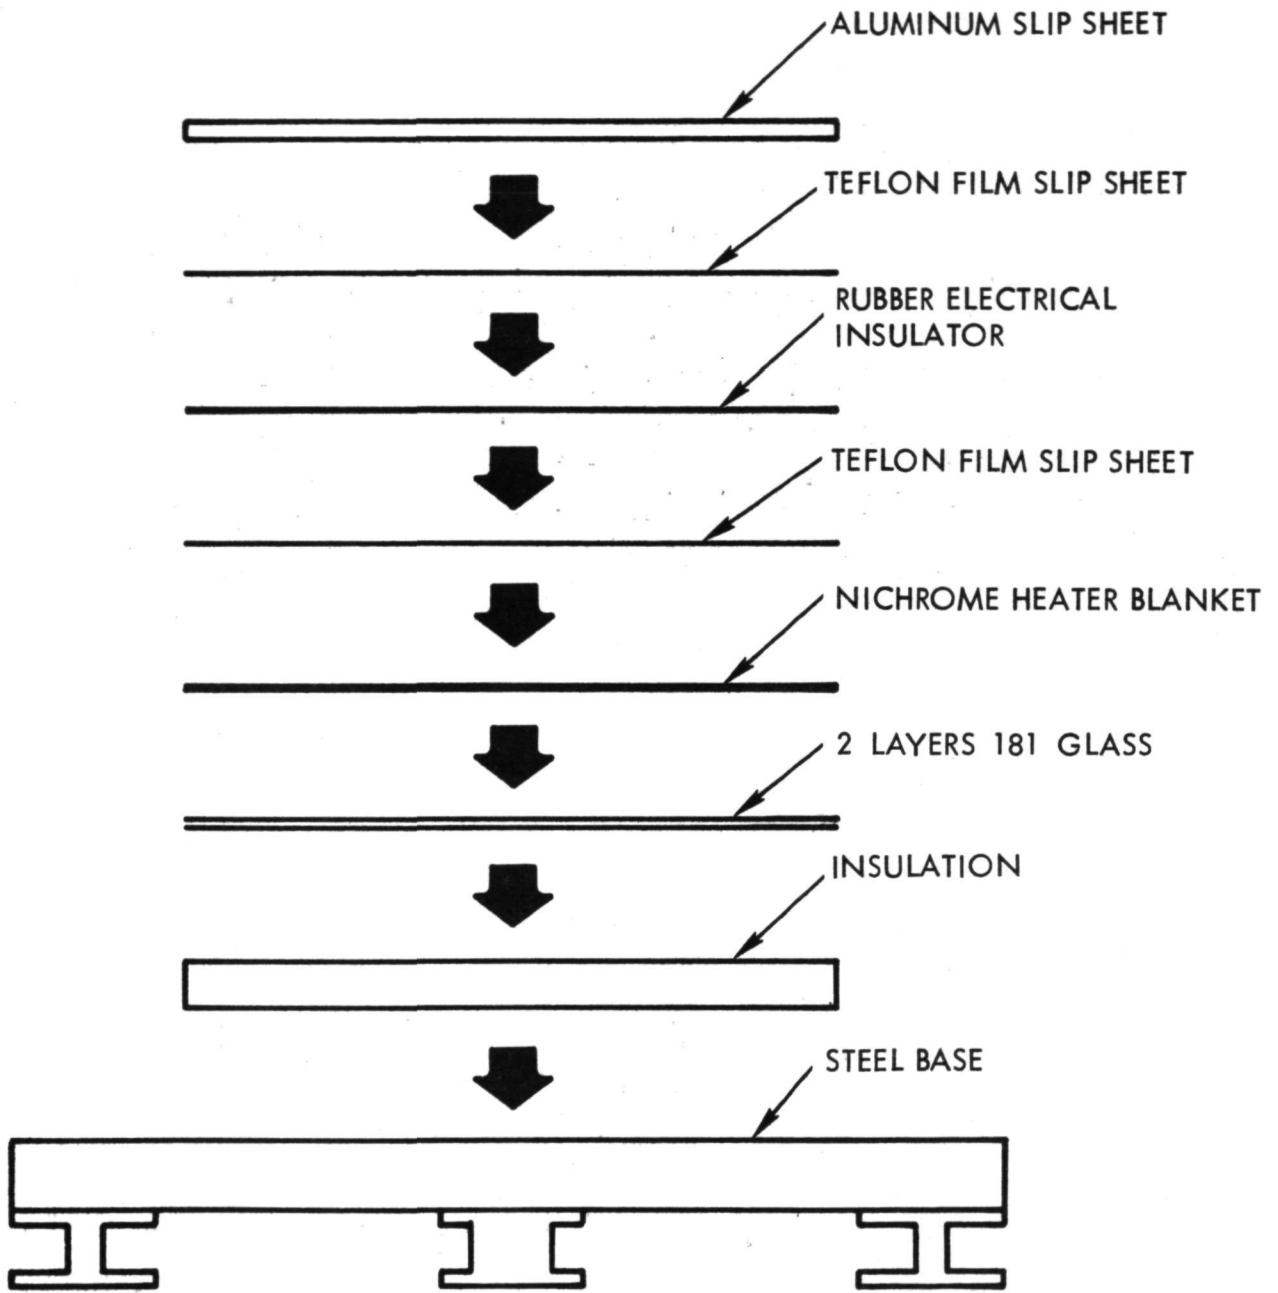
A cross section sketch of the "cool tool," used for restraining the metal parts during the bonding cycle, is shown in Figure 21. It consists of steel beams welded to a steel face sheet overlaid with insulation. Two layers of 181 fiberglass cloth were placed over the insulation to provide additional insulation for the fiberglass/nichrome heater blanket and for the steel tool. The zoned heater blanket is covered with a teflon film slip sheet, followed by a thin rubber electrical insulator. A second film slip sheet is added and the tool buildup is completed by a partitioned aluminum sheet. The aluminum sheet is not continuous over the tool length, but is sectioned, with gaps to allow for expansion when heat is applied. Figure 22 shows the basic steel tool.

FIGURE 21. - COOL TOOL (CROSS-SECTION SKETCH)
