Architectural heritage of the north eastern Portugal: History, construction and valorisation

ABSTRACT: This article is based on a study carried out in different small houses located along the margins of the Tua River, in the county of Alijó and Carrazeda de Ansiães, in order to perform a characterization of constructive techniques and materials. It is considered as a constant goal throughout this study the appreciation of natural stone, in this case granite and schist, as construction materials that were used in large scale in this region in the past and continue to be applied in the present, encouraging and valuing its use as a construction material.

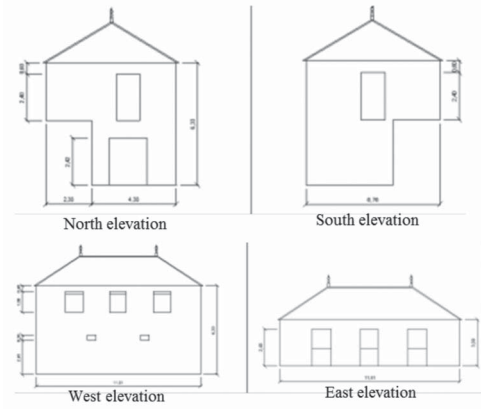
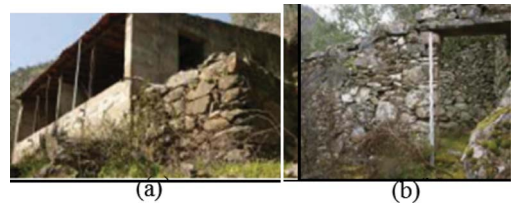
Figure 3. Dwelling houses: (a) house 6; (b) house 55. Credits: Authors.

Housing and/or shelters' constructive typology was also identified. The shelters have a lower layout area. The dwelling houses have a layout area of about 50 m² and a ceiling of approximately 3 m. In Figure 3a, a house of vernacular architecture with single floor and rectangular layout is presented. The house presents roof with marseille tile and lean-to roof east oriented and two entrances north oriented. The house has regular granite masonry with cement mortar. In Figure 3b it is represented one house of vernacular architecture of a single floor with "L" plan view. This house has no roof anymore, which should be a lean-to roof. Two entrances exist oriented at north and one entrance

oriented at south. The masonry walls are built with schist, without mortar in between the stones and with varied irregular stones to reasonably carved stones.

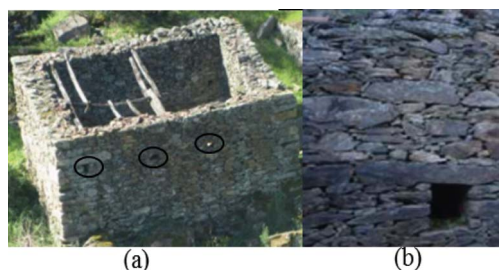
Figure 4. (a) Holes/openings: (a) house 14; (b) house 10. Credits: The authors.

At the corners and wedges of the walls it was observed the presence of carved elements with larger stones, for strengthening these spaces. At the windows and door lintels, as well as, on the side of doors and windows, big stones are applied. This technique aimed at promoting enough resistance to bending stresses at lintels, even if the openings of the windows and doors have reduced size and are made only in places critically needed, see Figure 4.

As the glass was an expensive material, the windows and doors were entirely in wood, allowing only illuminating the space when open. In other situations the openings in the walls are reduced to small holes, whose function was to ventilate and illuminate the space (see Figure 4).

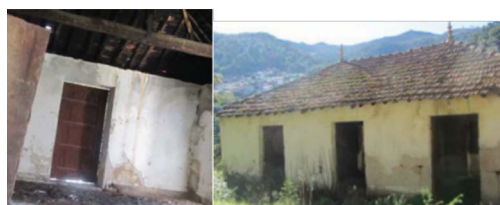
Figure 5. Construction 38 (house) – roof with tile. Credits: Authors.

these beams (wooden beams) and two triangular wooden trusses. It is under this structure that clay tiles are applied with or without bedding mortar (Figure 5). In some cases, simple timber trusses are also applied.

A fundamental element of the roof shown in Figure 5 is the eave, whose function is the routing of the water into a zone spaced from the walls. The roof shown in this figure is a hip roof, but the most common situation identified is a gable roof, which terminates in an eave sufficiently protruding from the outer walls. This technique proves to be effective as the coating below the eaves was found to be in relatively good state of preservation, which is a visible signal that the water does not focus directly on this site, nor runs down the wall.

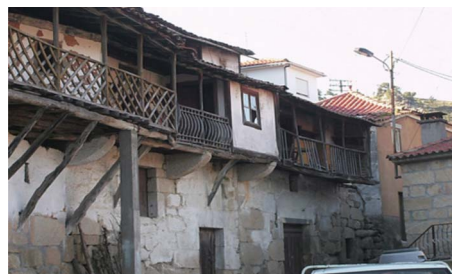
Figure 6. Traditional dwelling house in Amieiro—Alijó. Credits: Authors.

In relation of the material commonly identified in the village of Amieiro and Codeçais the stone (granite and schist) is of the same type of the construction identified along the railways line of the Tua river. The houses have carved stone masonry, with several sizes and mostly dry joints, have being identified some examples of carved masonry with mortar joint and plastered with lime, as seen Figure 6.

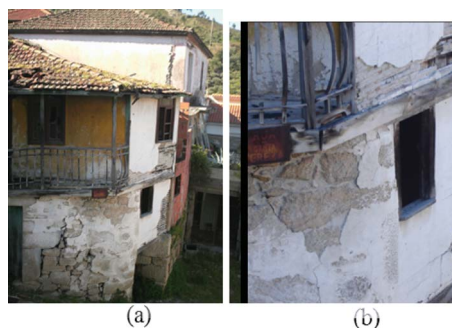
Figure 7. (a) Exterior wooden wall on the 1st and 2nd floor of the house, (b) detail of the wall (Amieiro-Alijó). Credits: Authors.

The structural system of the timber walls consists of a timber structure formed by a sequence of vertical boards aligned in the plane of the wall, and connected together on both sides by horizontal wooden slats. The connection between vertical and horizontal elements is materialized by metallic nails. The wooden structure is filled and coated on both sides by earthy material (simple earth or earthen bastard mortar and lime) (Pinto *et al.*, 2011). In Figure 7 the outer face of these walls were coated with lime mortar to provide additional protection to biological agents and water. These walls are very sensitive to water, reason by which this type of wall is not performed on ground floor. In addition, these walls are not thought for structural purposes and in this case only receive the loads of the roof. The number of floors in the village of Codeçais and Amieiro is commonly of three floors (ground floor and two upper floors). The ground floor was often used for placement of the cattle and the upper floors served as housing in order to take advantage of the heat generated by the animals.
