James Webb Space Telescope (JWST) **Integrated Science Instrument Module (ISIM)** Cryo-Vac #3 (CV3) Thermal Vacuum Test

AIAA Working Group on Space Simulation November, 2016

NASA Goddard Space Flight Center

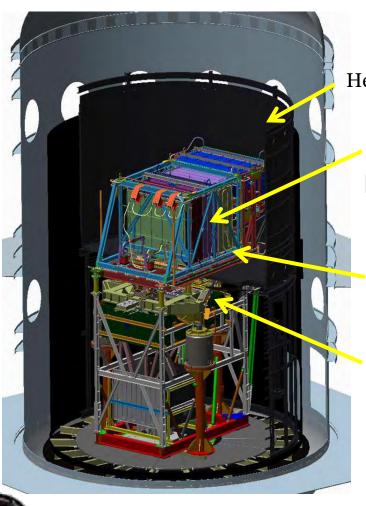
He Shroud

STMS [ISIM]

SIF

OSIM

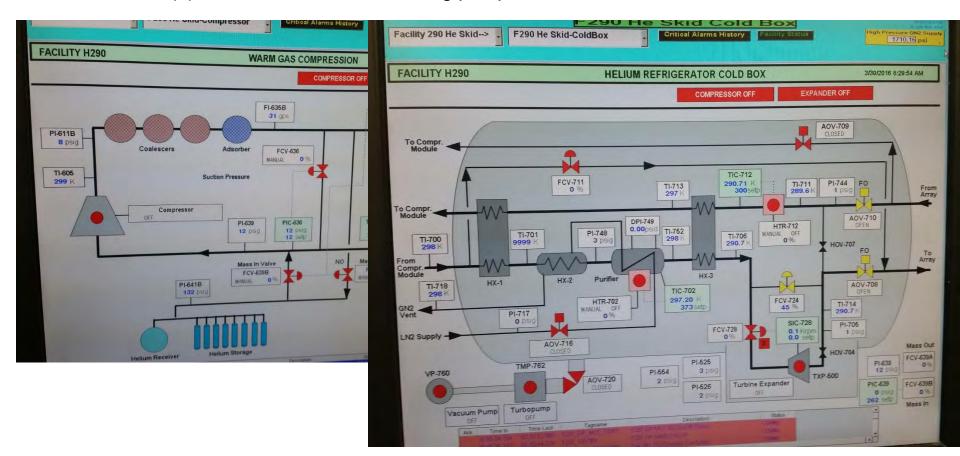
Helium Skid Shutdowns

- In an attempt to expedite cool-down helium skid compressor start-up early
- Over-temp shut-down skid
- During pumpdown on 11/7/2015 0:10; minimal effect on the test

Resolution: The helium skid did not lose power as stated in the PR. Instead, (only) the turbine was shut-down as a result the expander wheel hitting a inlet pressure alarm. The cross-over to turbine mode (from bypass mode) was accelerated because the differential pressure across the purifier was going up rabidly. The valve to the turbine was opened when the inlet temperature to the turbine was at 140K, instead of waiting for it to get to 100K. As a result, the higher inlet gas temperature corresponded to an inlet pressure that exceeded the limits of the expander wheel and consequently shut-down the turbine. In response, the turbine throttle valve immediately failed closed to 0%, and the bypass valve opened to almost 50%. The system (valve positioning) was restored to its configuration (prior to the turbine shutdown) well within 15 minutes. The result was a 10K spike in the expander outlet temperature (helium shroud inlet temperature), but the spike was back to its pre-shutdown temperature within 15 minutes. The effect on the helium shroud average temperatures was less than 0.5K.

Total of one (1) helium skid shutdown during pumpdown on 11/7/2015 0:10

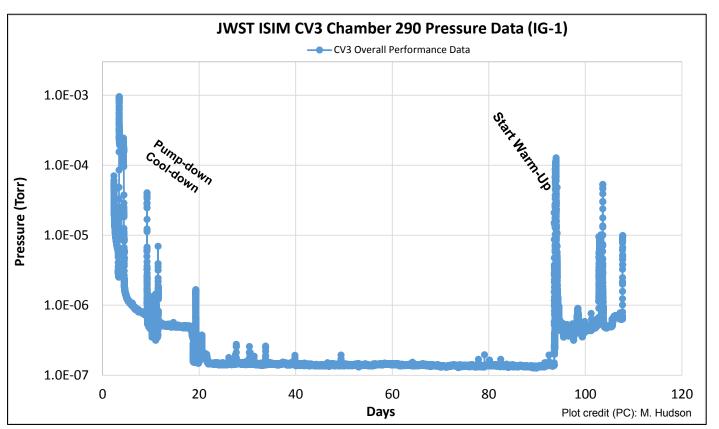
Chamber Vacuum Performance

Pressure (Torr)	Time from start
5.0 x 10 ⁻⁵	3.5 hrs (0.15 days)
1.0 x 10 ⁻⁵	11.1 hrs (0.46 days)
5.0 x 10 ⁻⁶	24.5 hrs (1.02 days)
1.0 x 10 ⁻⁶	88.2 hrs (3.7 days)
5.0 x 10 ⁻⁷	177.6 hrs (7.4 days)

Pump-down to 5 x 10⁻⁷ Torr took about 7.4 days from start of Pumpdown #2, after the initial leak was resolved

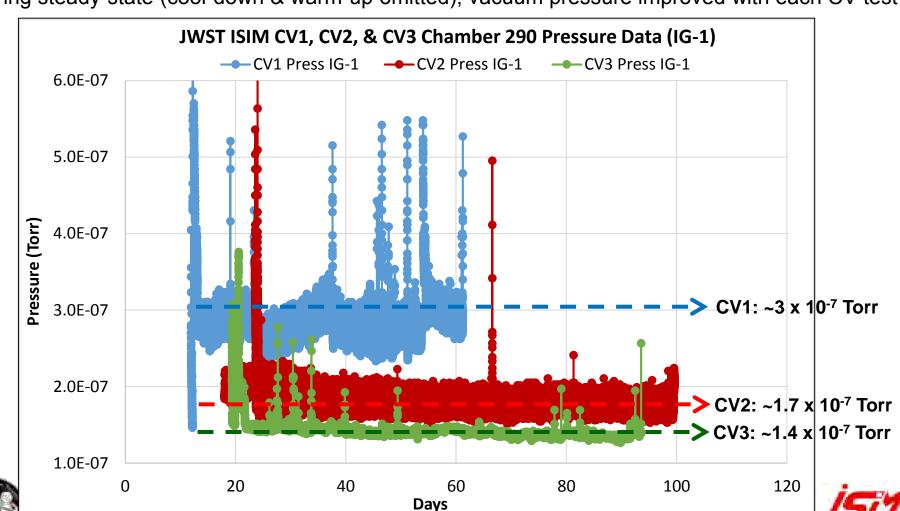
Chamber Vacuum Performance: CV1 vs. CV2 vs. CV3

During steady-state (cool-down & warm-up omitted), vacuum pressure improved with each CV test

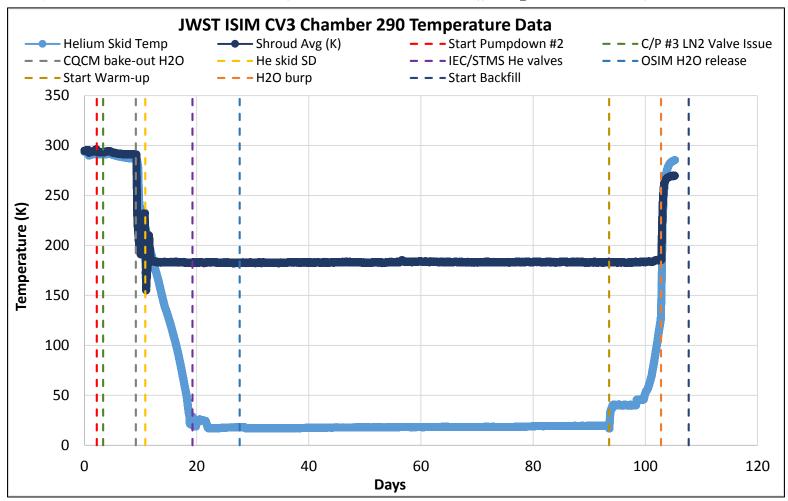
Shrouds Temperature Performance

At steady state: Helium shroud average achieved: 18K ±1K || LN₂ shroud average: 180K ±3K

= Switch $GN_2 \rightarrow LN_2$ (DAY 8 - 6/24/14 03:44) $LN_2 \rightarrow GN_2$ (DAY 15 - 6/30/14 22:40)

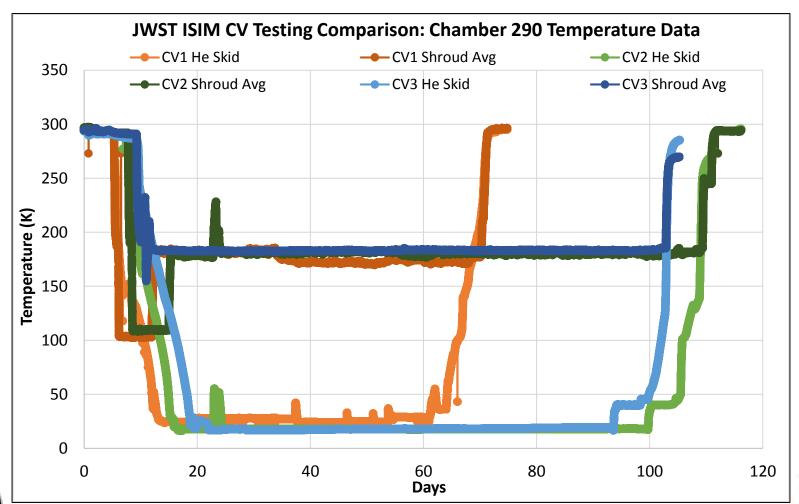
Shrouds Temp Performance CV1 vs. CV2 vs. CV3

At steady state: Helium shroud average achieved: 18K ±1K || LN₂ shroud average: 180K ±3K

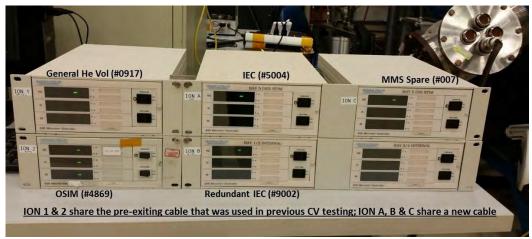
- Redundant micro ion gauge for IEC
- During check-out of the CV2 IGs, it was discovered that the extension used for the IEC IG was the root cause for the erratic and unreliable readings (per the spec sheet, maximum cable length allowable is 50')
- Cross-calibration of existing and new harnesses (+1 new redundant IEC micro IG) was performed in Facility 281

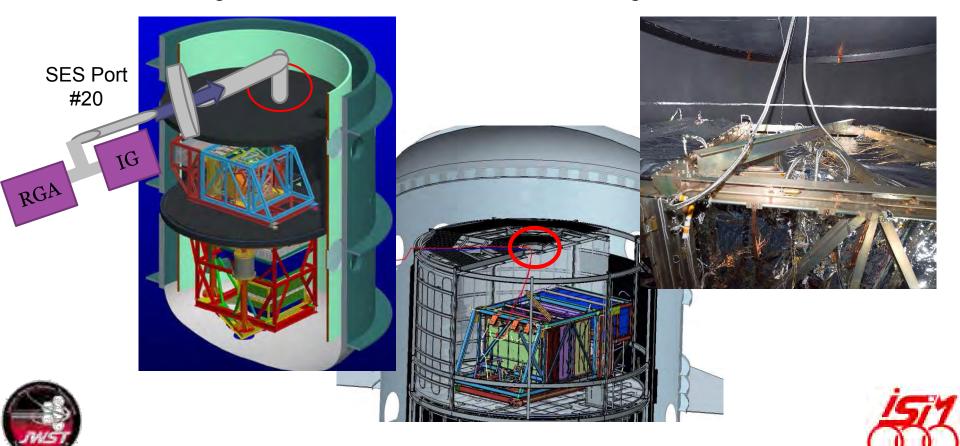
- Residual Gas Analyzer (RGA) to monitor STMS inside helium shroud
 - CV2: Added a RGA using flex lines into helium volume
 - CV3: Bought new calibrated RGA; used SS tubing instead of flex lines

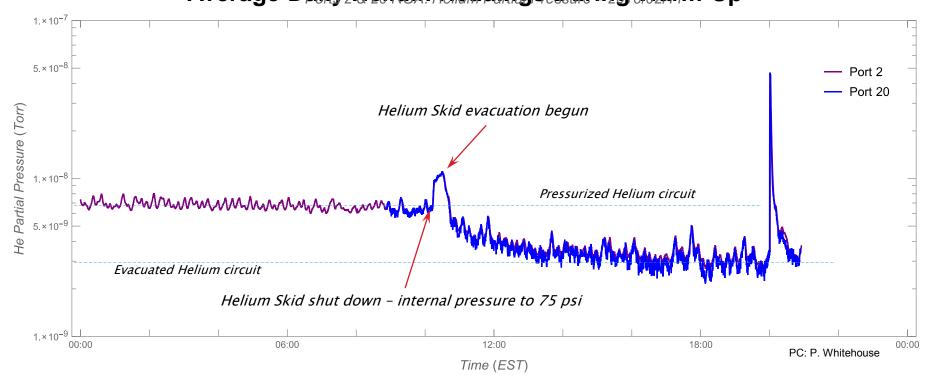
Readings between the two RGAs are consistent at warm temperatures

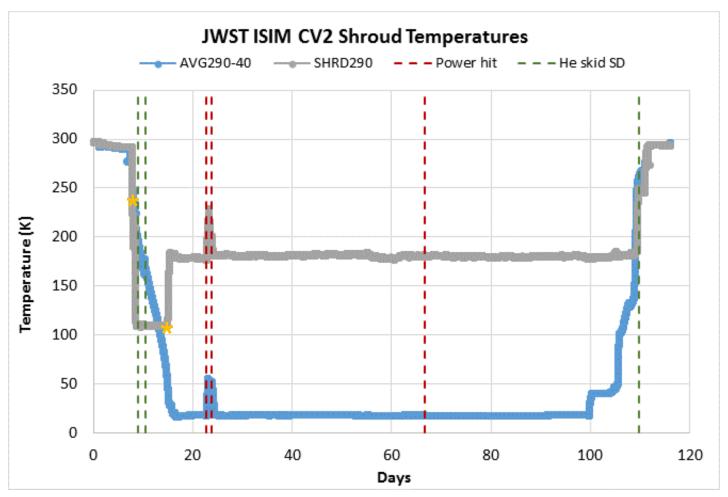
Shrouds Temperature Performance

At steady state: Helium shroud average achieved: 18K ±1K || LN₂ shroud average: 180K ±3K

⇒ Switch $GN_2 \rightarrow LN_2$ (DAY 8 – 6/24/14 03:44) $LN_2 \rightarrow GN_2$ (DAY 15 - 6/30/14 22:40)

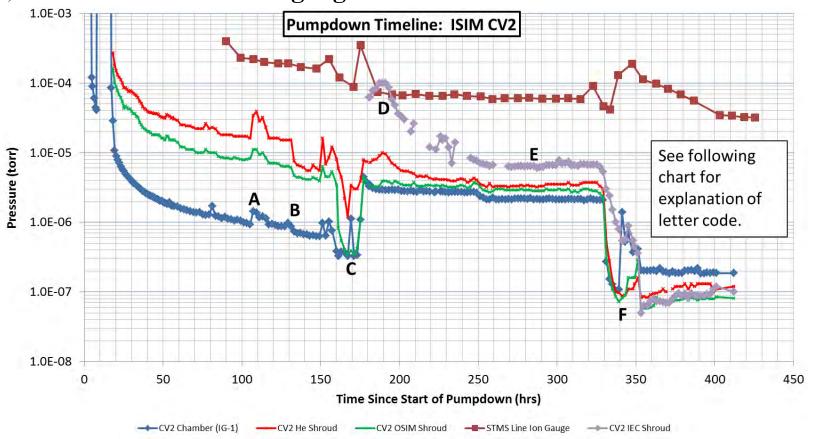
1) Redundant micro ion gauge for IEC

- A: Response to raising IEC N2 panel temp
- **B:** Response to cooling of CQCM lines
- C: Adjustments to facility N2 shroud
 - D: IEC temperature cycle from 273-308 K and back, after which pressure continues to drop as IEC He panels get cold enough to sink water
 - E: Pressure in IEC shroud stabilizes, though panels are $130K \rightarrow 100K$, with much lower water vapor pressure than P observed: suggests an N_2 leak inside IEC shroud; need to check/fix before CV3
 - **F:** He panels reach temperature for sinking N₂/O₂; pressures everywhere plummet

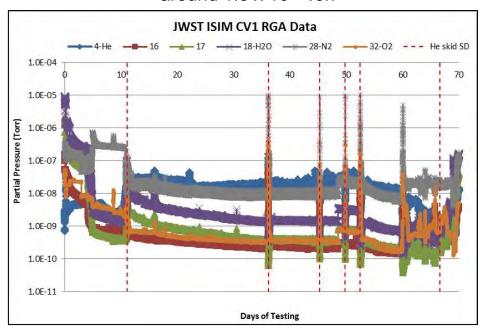
ISIM CV1: Chamber RGA detected helium levels around 1.5 x 10⁻⁷ Torr

Levels of detected helium using chamber RGA decreased by almost two orders of magnitude from CV1 to CV2

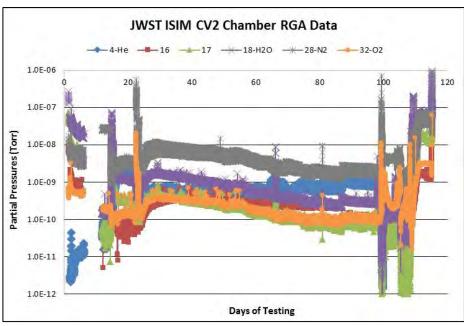
ISIM CV2: Chamber RGA detected helium levels around 1.0 x 10⁻⁹ Torr

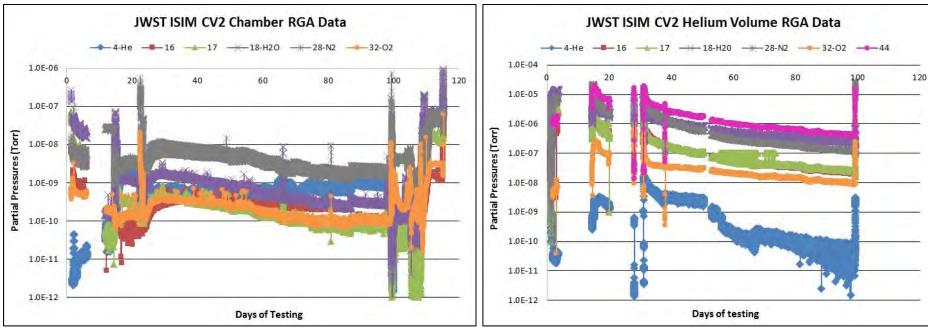
CV2 Chamber RGA vs. Helium Volume RGA Detection

ISIM CV2 ISIM/STMS volume RGA detected helium levels consistently <1.0 x 10⁻⁸ Torr

ISIM CV2 Chamber RGA detected helium levels were more consistent throughout the test, whereas the detectable helium levels using the ISIM/STMS RGA slowly decreased throughout the test

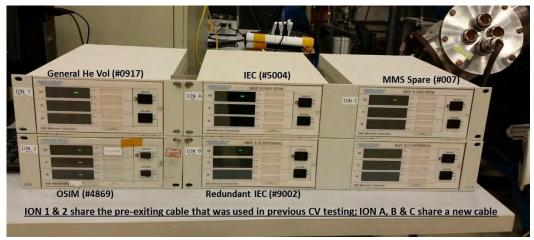
1) Redundant micro ion gauge for IEC

- During check-out of the CV2 IGs, it was discovered that the extension used for the IEC IG was the root cause for the erratic and unreliable readings (per the spec sheet, maximum cable length allowable is 50')
- Cross-calibration of existing and new harnesses (+1 new redundant IEC micro IG) was performed in Facility 281

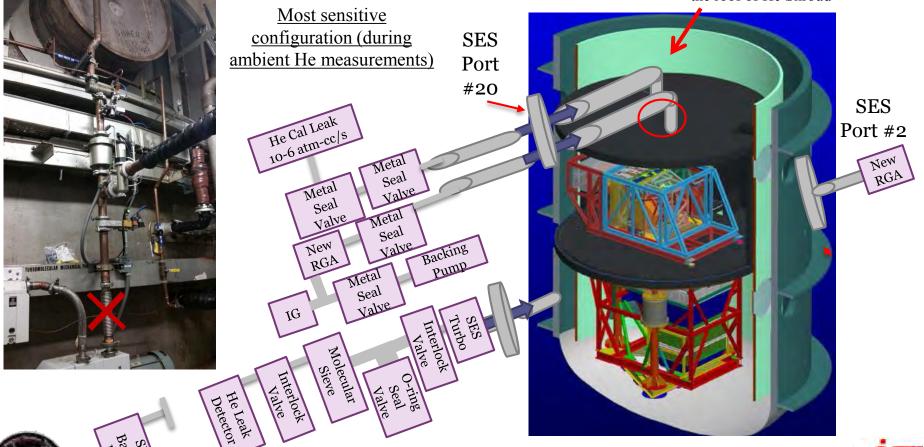
2) New, calibrated RGA for helium shroud volume

Entrance of two (1/2" SS line) tubing from chamber port thru the hole on the roof of He Shroud

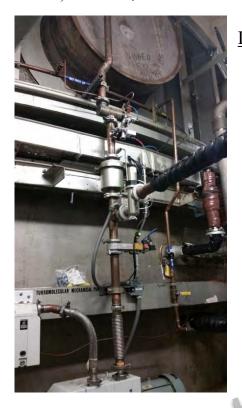
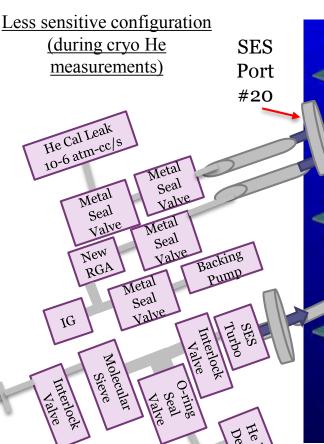
2) New, calibrated RGA for helium shroud volume

Entrance of two (1/2" SS line) tubing from chamber port thru the hole on the roof of He Shroud
