FRAC TOGRAPHY OF POLYMER COMPOSITES: CURRENT STATUS AND FUTURE ISSUES

E. S. Greenhalgh¹ and M. J. Hiley²

¹ The Composites Centre, Imperial College, London, UK, SW7 2AZ

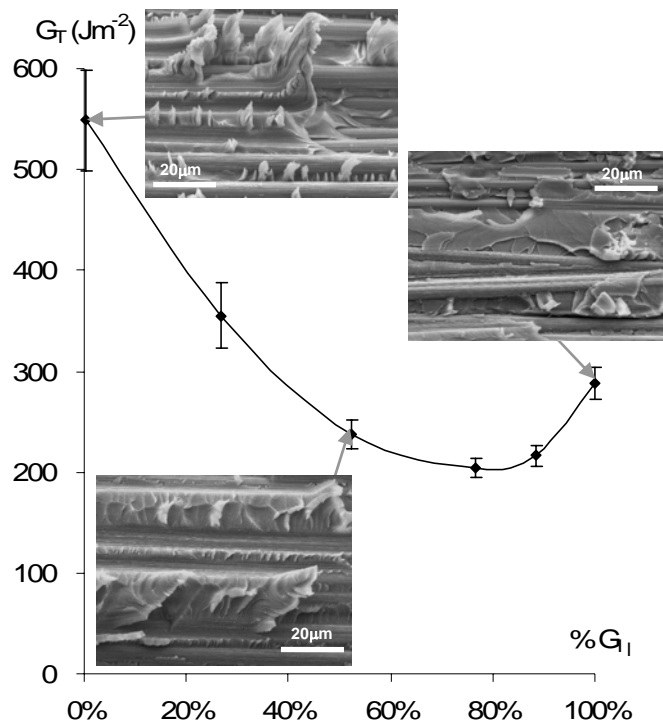
Fig. 1 Toughness versus mode mixity for T800/924 showing the change in fracture morphology

The application of fractography to composites research is now diverse. At a fundamental level, it provides an insight into damage and failure processes, and offers a route to material optimisation. It thus provides a means to validate physically based predictive models and failure criteria, linking the two disciplines of experimental and predictive research. A good demonstration of this are fractographic observations on delamination micromechanisms. Fig. 1 shows how the delamination toughness and associated fracture morphology of a unidirectional carbon fibre/epoxy composite varies with mode mixity¹⁹. Under pure mode I (opening) loading, toughness is controlled by processes such as cohesive fracture of the matrix and fibre bridging. Fracture initiates as cracks at the

fibre/matrix interface which then extend into the matrix between the fibres; the plane of these cracks is approximately coincident with the laminate plane. Therefore, relatively little fractured surface is generated and the corresponding toughness is low. However, as the mode II (shear) component increases, these cracks are reoriented, such that they develop at an angle to the laminate plane; under pure mode II they are inclined at 45° to this plane²⁰. These cracks consequently coalesce, leading to the formation of cusps (Fig. 2), a characteristic morphology associated with delamination¹⁷.

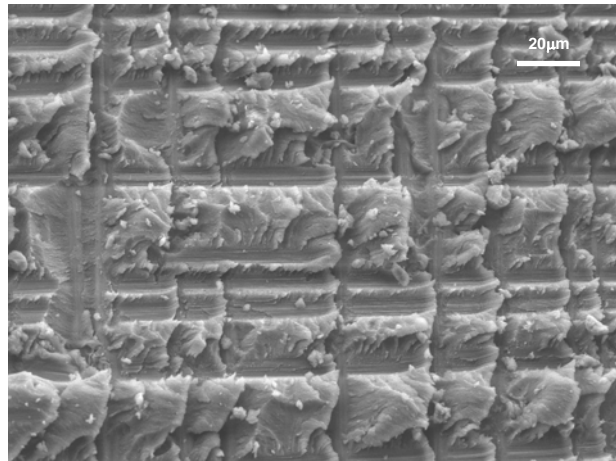
Fig. 2 Cusps in unidirectional T800/924 under mixed-mode loading

In summary, increasing the mode II component increases the degree of matrix deformation and total fractured area¹⁹. This consequently manifests as a toughness increase with rising mode II component. By understanding the cusp formation and deformation process through detailed fractographic analysis, predictive models can be developed which capture the key micromechanisms of delamination growth. These provide the basis for delamination failure criteria, and the development of improved delamination resistant materials. The influence of environmental factors can be included in such models, thus underpinning predictive tools for damage tolerance.

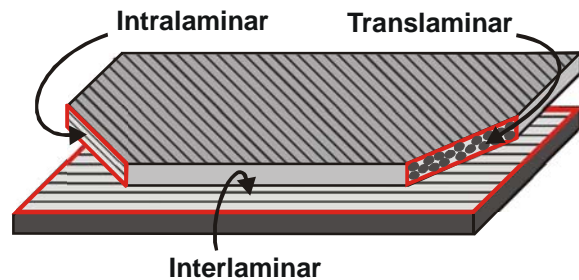
Fig. 3 Classes of failure mode in laminated polymer composites

To undertake a fractographic analysis it is important to understand the basic failure modes in the constituent materials. However, composites fail in numerous different modes, all of which interact, the degree to which depends on factors such as loading conditions, material architecture, component geometry, environment, etc. These failure modes can be grouped into one of three classes¹⁷; *translaminar*, *interlaminar* and *intralaminar*, as illustrated in Fig. 3. *Translaminar* failure entails fracture of the reinforcing fibres and includes modes such as fibre cleavage, buckling and shearing. The other two failure modes don't involve any significant fibre fracture; *interlaminar* (delamination) entails fracture between the layers whilst *intralaminar* fracture entails through-thickness fracture between the fibres. These two classes include modes such as fibre/matrix debonding, matrix cleavage or cohesive fracture and shearing of either the matrix or the fibre/matrix interface.

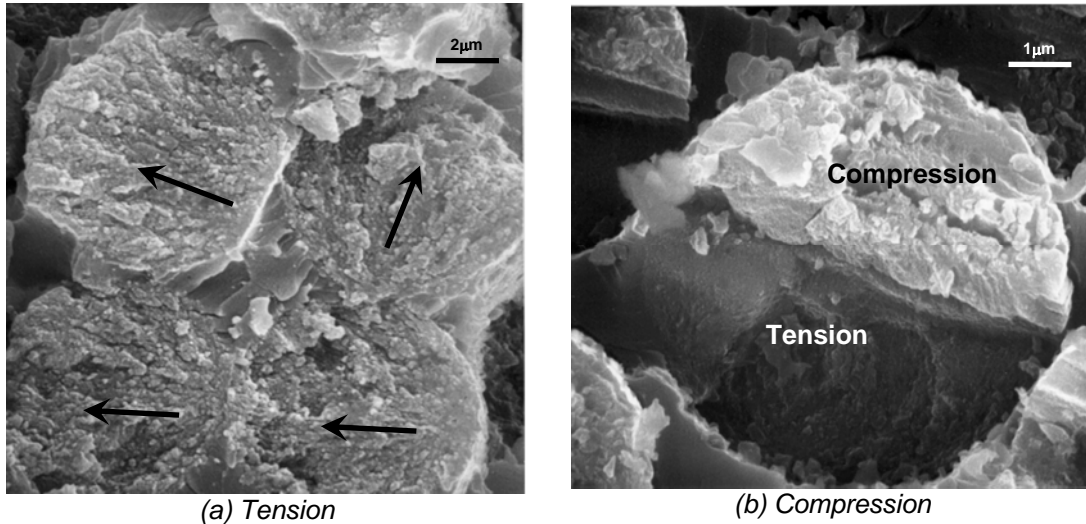
Fig. 4 Fibre end fracture morphology for tension and compression failures in CFRP

From a fractographic perspective, under translaminar fracture the fractured fibre ends provide evidence of the failure conditions, such as whether a fibre has failed in tension or compression. In the case of tensile failure (Fig. 4a), the individual fibre fractures frequently show radial patterns on the fibre ends and often exhibit a 'mirror, mist and hackle' morphology⁵; this provides a means to deduce the local and global direction of failure. Failure in compression (Fig. 4b) is usually via microbuckling, which leads to 'chop marks' on one side of the failed fibre ends and radial patterns on the other. Compression microbuckling strongly interacts with other failure modes, such as

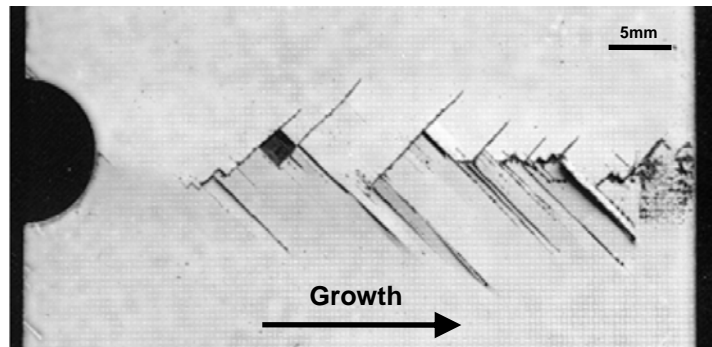
Fig. 5 Compression cracking in a notched laminate exhibiting ‘arrowheads’ which point to the failure source

delamination or ply splitting. The orientation of the chop marks can indicate whether in-plane (stable) or out-of-plane (unstable) failure has occurred², but does not provide direct evidence of crack growth direction. However, compression failure of multidirectional laminates does exhibit ‘compression cracking’ (Fig. 5)²¹; arrowheads which ‘point’ to the source of failure.

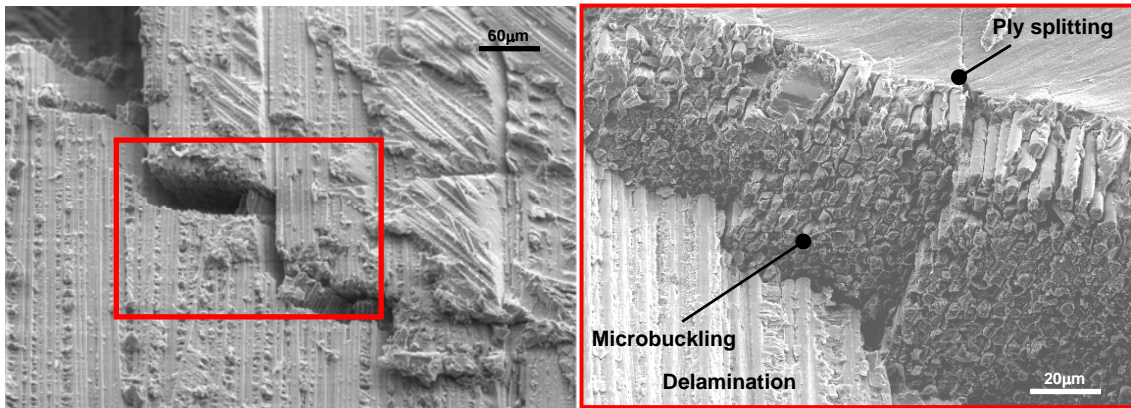
Fig. 6(a) Electron micrographs of in-plane shear fracture (b) detail of microbuckling fracture

One of the main difficulties with understanding composite failure are the strong interactions which develop between the different fracture modes. An example of such an interaction is apparent in in-plane shear failure of multidirectional laminates (Fig. 6), which is characterised by stepped translaminar fractures in the 0° plies¹⁷. Under in-plane shear loading, the first event is the development of ±45° ply splits adjacent to the 0°

layer due to the resolved tensile loading across the fibres. This leads to the initiation of delamination and longitudinal ply splits in the 0° layer, driven by the applied shear loading. As the loading increases, the number of 0° splits increases (and thus the spacing falls). When these splits reach a critical length, or spacing, the lateral support on the 0° fibres is no longer sufficient to inhibit microbuckling of these fibres and local failure occurs. Evidence of this in-plane microbuckling can be clearly seen in Fig. 6b. The site at which the microbuckling initiates is adjacent to the off-axis ply split, and spreads across the band of 0° fibres until it intercepts the next longitudinal ply split, leading to the characteristic step-like morphology.

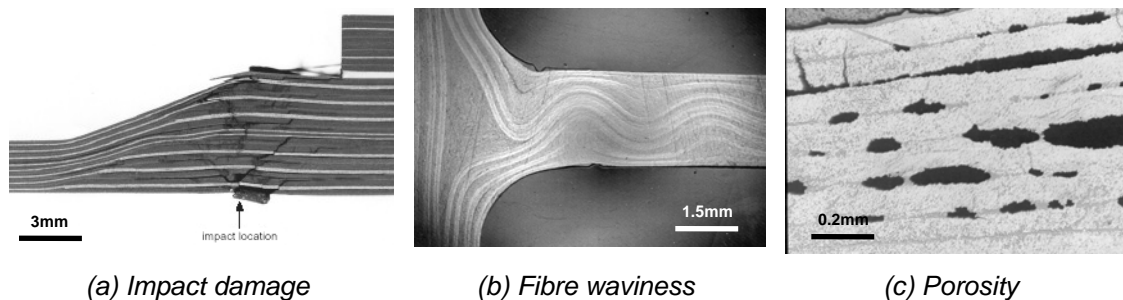
Fig. 7 Examples of defects and damage in polymer laminate composites

One of the key characteristics of composites has been their sensitivity to defects, such as the gross examples shown in Fig. 7. The influence of defects can be apparent on the fracture surfaces since failures often initiate from such sites²⁵; and thus fractography can provide material quality and manufacturing information. Strong interactions between defects and fracture modes are responsible for the inherent sensitivity of composites to defects. For instance, impact damage (Fig. 7a) is a combination of ply splitting,

to uniform stress states, so the fracture morphology tends to be fairly uniform. However, in structures, particularly at features such as notches, tapers and corner radii, high stress gradients exist and therefore the fracture morphology can rapidly change. This can lead to difficulties in interpreting the failures. Finally, there can be considerable manufacturing variations between coupons and structures. In particular, defects such as fibre waviness (Fig. 7b) and porosity (Fig. 7c) are more prevalent in structures, and often act as initiation sites for failure.

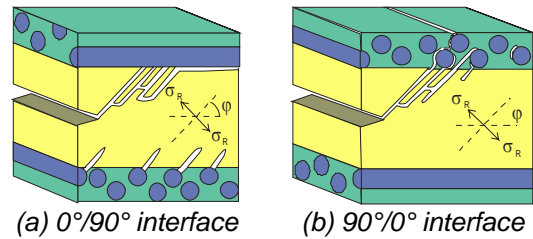
Fig. 8 Delamination mechanisms at a ply interface under mixed-mode loading (growth direction left to right)

An important instance of the interaction between fracture mechanisms and defects is delamination growth in multidirectional laminates. Delaminations growth from embedded defects does not remain within the original defect plane, but migrates through the laminate until it reaches a ‘preferential’ ply interface¹⁹. This migration can be explained by considering the resolved tensile stress, σ_R ,

due to the combination of shear and peel stresses at this site. Under mixed-mode (I and II) or mode II conditions, the resolved stress (and thus the crack front) is orientated out of the laminate plane. This means there is a natural tendency for the delamination to propagate out of the defect plane and migrate¹⁹. If this migration is towards a ply in which the fibres are aligned with the normal to the delamination front (i.e. parallel to the driving force), the delamination will remain within the original defect plane (Fig. 8a). However, if the ply orientation is not aligned with this direction (Fig. 8b), ply splitting will develop, and the delamination will migrate into the next ply interface. Ultimately, the delamination will migrate through the laminate until it reaches an interface in which the ply is orientated approximately parallel to the driving force.

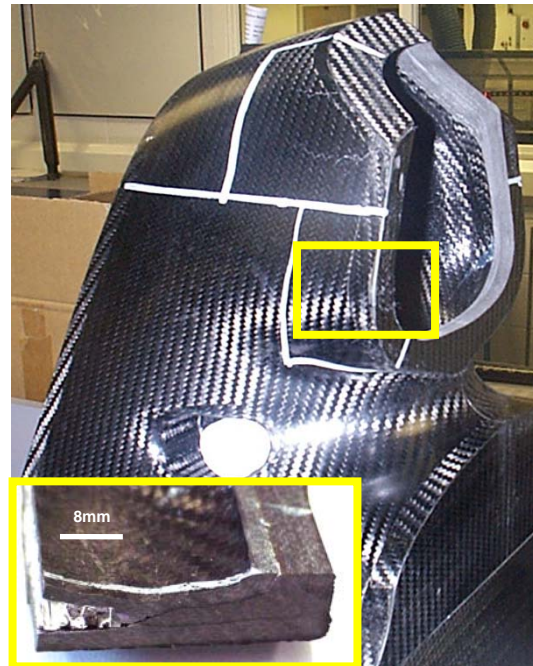
Fig. 10 Roll hoop failure and section through the failed skin (boxed)

Fractographic analysis offers a means to solve in-service failures, such as aircraft accidents or general component failures. Such an example¹⁷ is shown in Fig. 10, which is a CFRP roll hoop from a Formula One racing car; this component had failed well below its expected strength under loading applied to the top of the hoop. The component was a sandwich construction with CFRP skins and an aluminium honeycomb core which were bonded using a film adhesive. The skins were approximately 60 plies thick, with a quasi-isotropic stacking sequence. About 40 mm from the edge of the component, the honeycomb was ramped, leaving a monolithic construction to the edge.

Visual examination indicated that a free edge compression failure had occurred at the point of tightest curvature near the lowermost part of the hoop. As can be seen in the section shown in the box in Fig. 10 there were also two delaminations both extending from the fractured free edge up to and beyond the honeycomb core. Detailed examination of the delamination closest to the inner face of hoop indicated that it was continuous through out; i.e. there was no evidence to suggest that the delamination had occurred as a result of the compression fracture on the free edge surface. Inspection of the delamination indicated it had been generated under interlaminar shear stress parallel to the free edge of the specimen; i.e. extending circumferentially around the hoop. The source of the delamination was at the tip of the honeycomb ramp at the point of tightest curvature which exhibited regions of smooth featureless fracture surface and evidence of porosity (Fig. 11); this morphology was consistent with poor bonding or consolidation of the honeycomb ramp. The second delamination at the interface between the skin and honeycomb (closest to the outer face of the hoop) appeared to have initiated at the tip of the honeycomb and

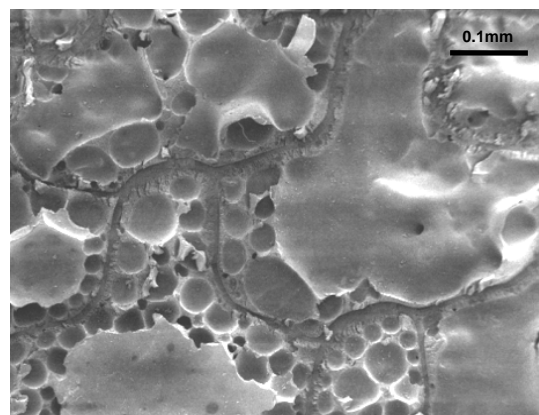
Fig. 11 Porosity at the tip of honeycomb ramp in Fig. 10

grown out from this point. Again the crack growth direction was parallel to the free edge (and tip of the honeycomb ramp), extending towards the loading point. However, unlike the innermost delamination, this delamination was not as extensive.

To summarise, the first event was caused by delamination growth initiating at the tip of the honeycomb ramp, coincident with the point of tightest curvature due to poor bonding or consolidation. This subsequent delamination growth was driven by interlaminar shear, and extended parallel to the tip of the honeycomb ramp (circumferential about the hoop). The presence of delamination led to a reduction in the load-bearing material in the roll-hoop. Consequently, compression failure at the free edge in the remaining load-bearing material occurred.

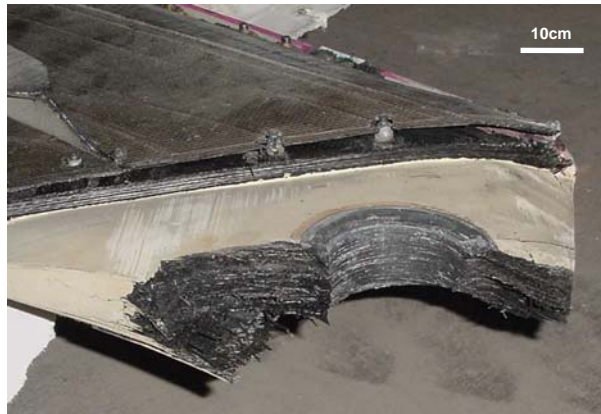
Fig. 12 Lug failure from the A300 Airbus tail from Flight AA589

There are numerous instances of how composites fractography has been key to solving in-service failure events¹⁷; one of the best examples is the Flight AA589 accident in 2001. The tail of the Airbus A300 detached during flight, unfortunately leading to loss of the aircraft and all the passengers. A detailed fractographic analysis of the vertical tail³⁰, in particular the failure of the lugs (Fig. 12), was used to deduce the sequence of events which had led to the accident. Consequently, it was identified that no material defects, design deficiencies or in-service damage had provoked the structural failure and the accident was attributed to other factors.

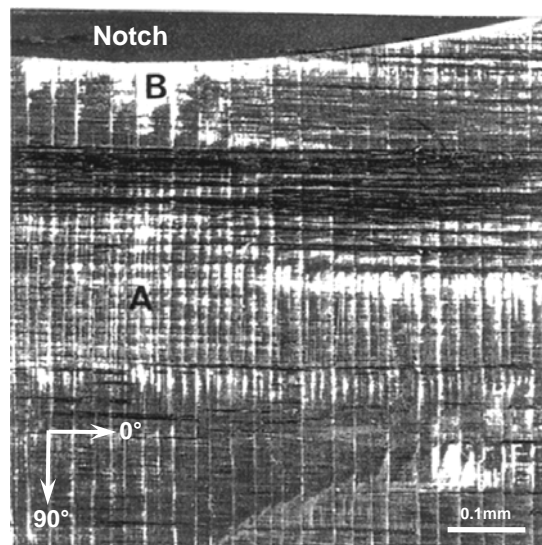
Fig. 13 Transverse cracking/delamination providing evidence for failure from a notch

For the fractographic analysis of metal components, factors such as service temperature, severity of loading and cycles to failure can be quantified from the surface morphology^{4,7,18}. Unfortunately, composite fractography is not as mature and currently such measurements cannot be made. However, there is scope to develop techniques to allow such quantities to be deduced. For instance, crack velocity in rate sensitive materials such as thermoplastic composites¹², the stress at failure of corroded laminates³¹ or delamination development in laminates exhibiting ply splitting are all quantities which could potentially be determined directly from the fracture morphology. With respect to the latter¹⁰, Fig. 13 shows the delaminated surface of a 0°/90° interface (0° ply visible) in a multidirectional laminate. The laminate contains a notch (top of Fig. 13) and was loaded in tension (horizontal in this image). The vertical imprints on the

fracture surface correspond to 90° ply splits which had developed prior to delamination formation. It is apparent that the split spacing at site B (close to the notch) is greater than that at site A (away from the notch). Given that split density is proportional to the applied stress³², and the formation of these vertical imprints would have stopped when the delamination had occurred (i.e. when the 90° ply had delaminated from the 0° ply in Fig 13.), this morphology has provided a record of the delamination extent as the applied loading increased. That is, by identifying the exact relationship between split spacing and applied stress, perhaps via finite element modelling, the stress levels at which delamination had grown at sites A and B could be deduced.

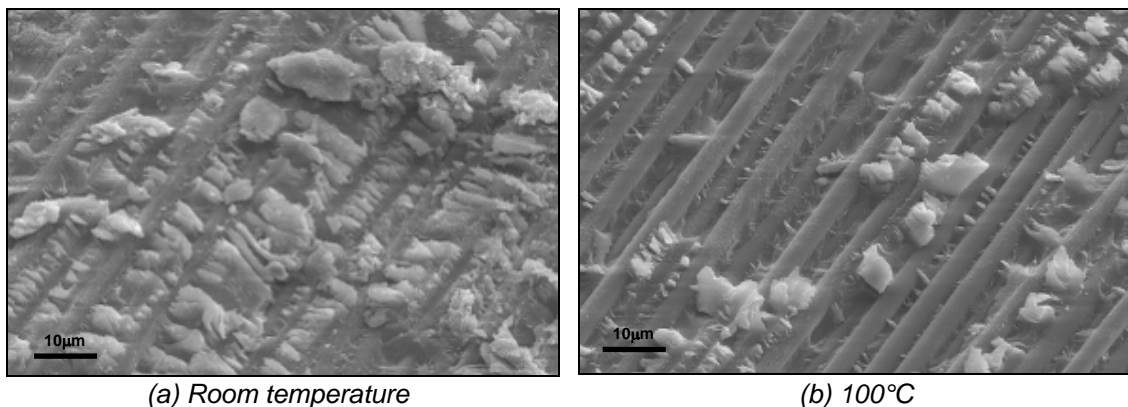
Fig. 14 Effect of temperature on static mode II toughness of HTA/6376³³

To improve the value of fractographic techniques to composites engineers, there are a number aspects which still need to be addressed. Firstly, in-service environmental effects such as moisture and temperature have an effect on composite performance, particularly as the temperature approaches the glass transition temperature of the matrix³³. The fibre/matrix interface is sensitive to these factors and will thus influence the fracture morphology. Therefore, components which have been exposed to temperatures or moisture excursions beyond their normal service conditions will exhibit ‘cleaner’ fibres, increased matrix ductility and increased fibre bridging between the crack faces (Fig. 14)¹⁷. However, although such morphology is indicative of exposure to extreme conditions, it is difficult to relate the extent of these morphologies to the conditions to which the component has been exposed. Furthermore, evidence of exposure can only be deduced by comparing with fracture morphologies generated under ambient conditions (Fig. 14).

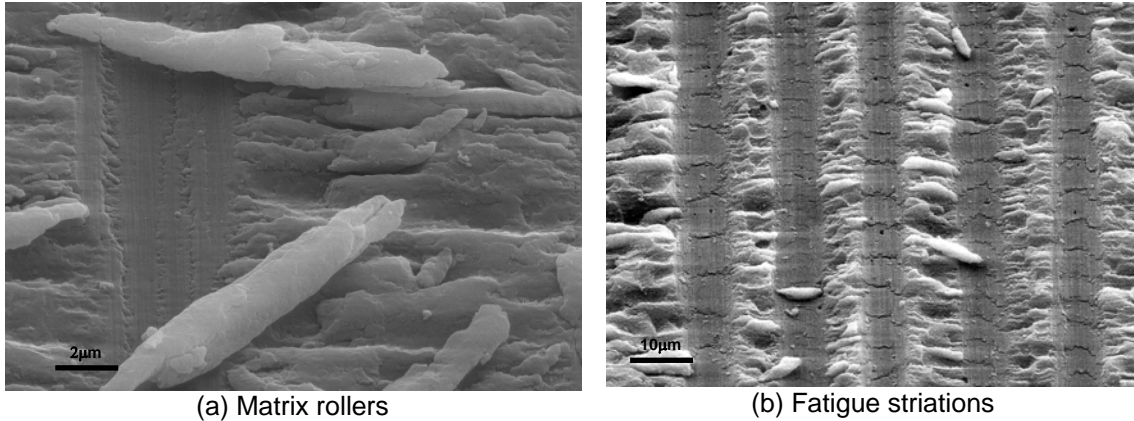
Fig. 15 Fracture morphology particular to fatigue (mode II fracture of HTA/6376)³³

There is limited knowledge of the fracture morphologies associated with fatigue loading. Surface features particular to fatigue failures include matrix rollers (Fig. 15a) and striations (Fig. 15b)³³, both of which tend to be observed on mode II dominated fracture surfaces. Matrix rollers are formed by a similar mechanism to that by which cusps develop³⁴, however, striations in polymer composites are not formed in the same manner to those in isotropic materials¹⁸. In some instances the number and spacing of the striations correlate well with the loading history and intensity to which the component has been exposed. However, in many instances these ‘striations’, which appear to actually be discontinuous growth bands³⁵, vary considerably in spacing due to the highly localised stress state within the composite; thus the fracture features cannot easily be correlated with the loading history¹⁴. Furthermore, fatigue failures are often subject to fretting damage which can hide or obliterate vital information. Finally, the morphology of striations and matrix rollers may vary considerably, depending on the mode, R-ratio and frequency of loading and fibre/matrix architecture; further research still needs to be done in this field.

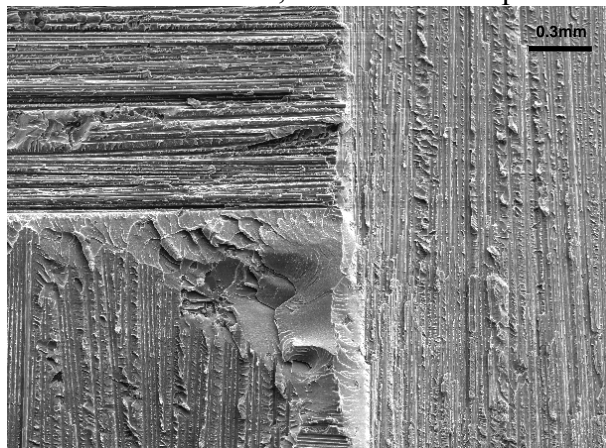
Fig. 16 Fracture at a warp/weft boundary in a woven CFRP laminate

A wide range of different fibres, matrices and architectures are now being used in composites²⁵. In particular, in an effort to improve processability, drape and damage tolerance, unidirectional tape is being replaced by textile configurations such as woven fabrics. However, from a fractographic perspective, these materials are complex and hence more difficult to analyse. In unidirectional tape laminates, the crack plane is relatively continuous and the crack front fairly localised. However, because of this discrete architecture, in textile composites the fracture processes are much more complicated, the damage fronts less clearly defined and the crack plane more convoluted. The failure progression tends to occur as an amalgamation of localised fracture events. For example, delamination in a plain woven laminate (Fig. 16) locally initiates at the resin-rich sites at the cross-over points between the warp and weft tows. Consequently, failure of the individual cells of the weave are isolated events, and the local crack paths may differ from the global fracture directions.

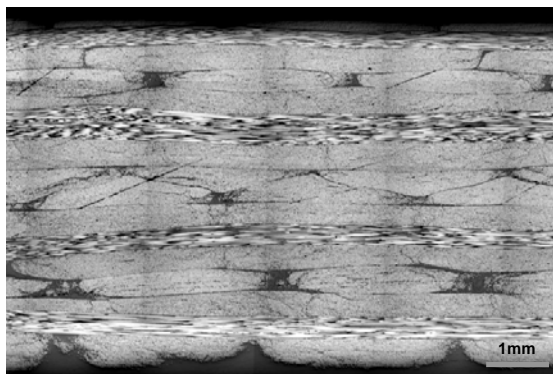
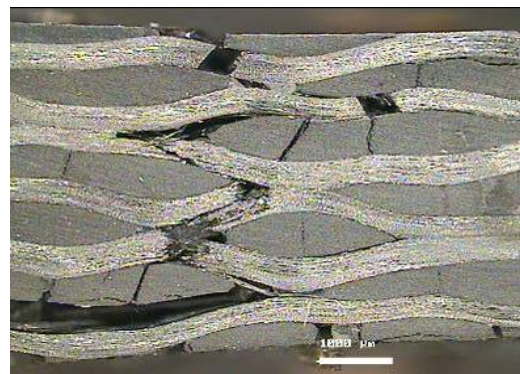
(a) Non-crimp fabric laminate

(b) 3D braided laminate

Fig. 17 Cross-sections through textile and through-thickness reinforced laminates

Moreover, through-thickness reinforced materials (Fig. 17), such as non-crimp fabrics (NCFs), stitched, Z-pinned and braided components are now becoming more prevalent.

Rather than two scales of microstructure (fibre and lamina), the through-thickness reinforcement leads to three scales; fibre, tow/bundle and lamina. This further complicates the fracture morphology and encourages interaction between the different fracture mechanisms such as delamination, splitting and fibre fracture. Furthermore, the through-thickness reinforcement introduces crimp into the fibre tows, which promotes mechanisms such as localised delamination and fibre microbuckling. Finally, in these materials the through-thickness reinforcement does not appear to fracture cleanly, and consequently the fracture planes are not well defined. Thus from a practical perspective, it becomes very difficult to separate and expose the fracture surfaces for inspection without damaging them. As the use of these materials increases, further fractographic studies to understand the complex interaction between different fracture mechanisms will be needed.
