Bagley, Frank and Atlar, Mehmet and Charles, Alasdair and Anderson, Colin (2015) The use of copper-based antifoulings on aluminium ship hulls. Ocean Engineering, 109. 595–602. ISSN 0029-8018 , <http://dx.doi.org/10.1016/j.oceaneng.2015.09.044>

The Use of Copper-based Antifoulings on Aluminium Ship Hulls

Frank William Bagley, Mehmet Atlar, Alasdair Charles
(Newcastle University, UK)

Colin Anderson
(American Chemet, USA)

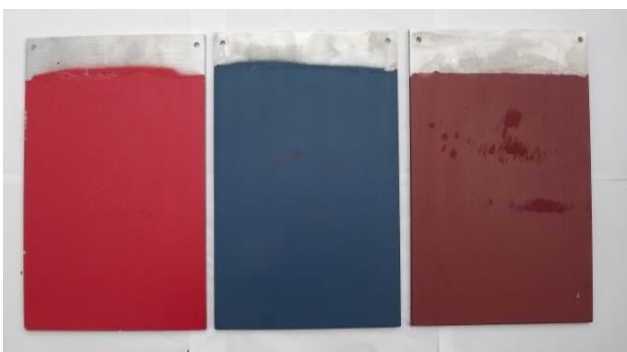
The seawater immersion tests were carried out on the three plates cut to a size of 300mm x 205mm. These plates were coated with the three different antifouling paints using air less spray under ambient conditions, to the thickness recommended by the paint manufacturer (International Paint). A strip of aluminium was left uncoated at the top of the panel, 20mm high and 205mm wide, as shown in Figure 2. This was intended to show if any copper leaching from the antifouling deposited on the bare aluminium substrate. In addition one completely bare and uncoated control plate was also used for comparison. The plates were immersed in the North Sea (Blyth harbour, North East of England) for a total of 88 days during December 2013 - March 2014).

Figure 2 Sea Plates before immersion
(Left AF, Middle SPC and Right CDP)

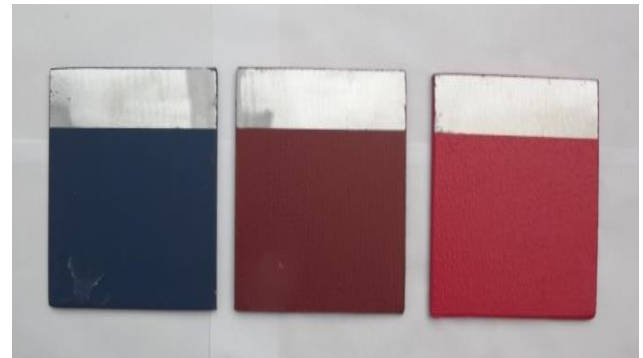
A controlled laboratory experiment was also set up identical to the sea water immersion experiment but with 100mm x 100mm size plates, and a 20mm x 100mm strip of bare aluminium, as shown in Figure 3. This test was undertaken to see if similar results could be achieved in a controlled laboratory experiment. The specimens were placed in a plastic rack 100mm apart and placed in a bath 350mm x 700mm, the bath is shown in Figure 4. This was filled with 25 litres of distilled water and sea salt (35g per litre) with the temperature set at 34°C this was to

Figure 3 Laboratory plates before immersion
(Left SPC, Middle CDP and Right AF)

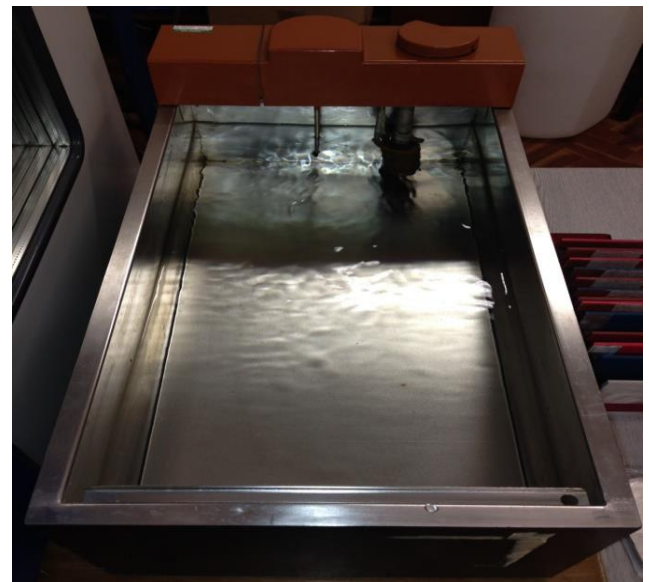
increase the reaction time of the corrosion. A layer of polystyrene foam pieces were used to cover the solution surface in order to reduce heat loss and to limit evaporation. The laboratory specimens were placed fully immersed in the bath for 8 days.

Figure 4 Solution Bath

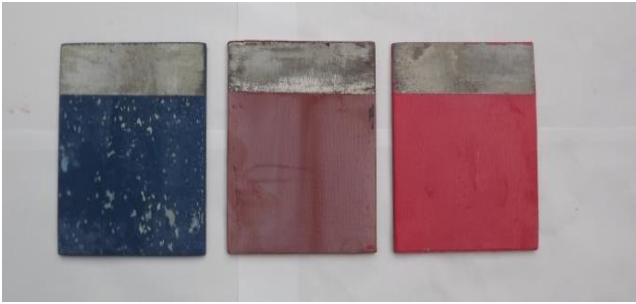
The visual examination of the specimens after 8 days in the artificial seawater solution revealed a dulling of the surfaces of the aluminium and the antifouling, as seen in Figure 5. Also evident is the breakdown of the SPC.

Figure 5 Laboratory plates after artificial immersion (Left SPC, Middle CDP and Right AF)

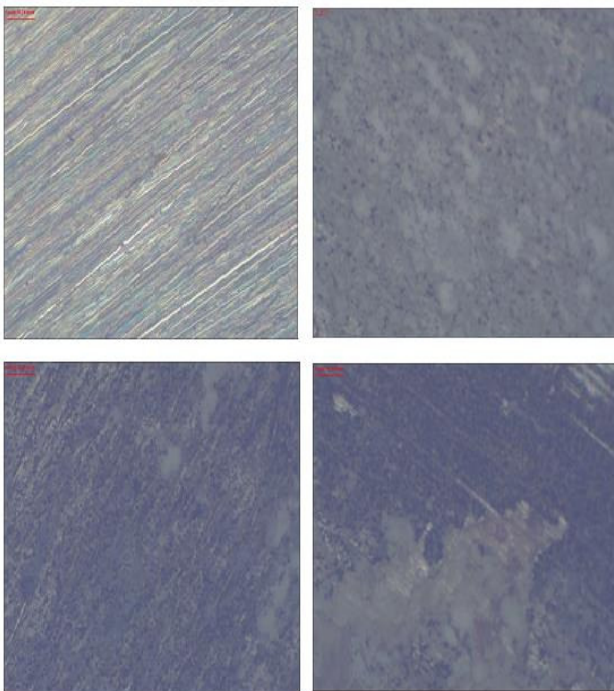
The bare aluminium strips of each test plate plus a aluminium strip before immersion, were examined with the low powered microscope, as shown in Fig 6. The top left picture in Fig 6 show an aluminium strip before it was put in the solution. The top right picture is the view above the SPC coated strip after 8 days in the solution; the bottom left picture is the view above the Aluminium antifouling, after 8 days in solution and the bottom right is the view above the CDP coated antifouling, also after 8 days in solution. All the specimens from the solution had dark brown spots which followed the lines of the surface preparation grooves. Also pockets of aluminium oxide can be seen at random points all over the aluminium substrate.

Figure 6 Laboratory specimens (aluminium strip) (x10) (Top left test plate before immersion, top right SPC after immersion, Bottom left AF after immersion and bottom right CDP after immersion)

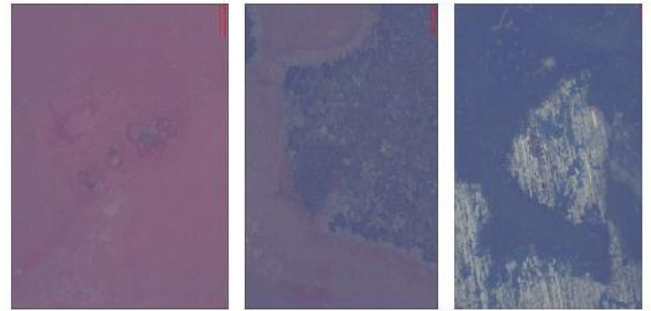
The visual examination of the antifouling surface using the low powered microscope revealed the aluminium antifouling showed some defects, with a darkening in the centre of each defect as shown in left hand side picture in Fig 7. The CDP coating also had a minor defect at a point in the coating under the microscope it was evident some corrosion had taken place this can be seen in the middle

picture of Fig 7. The SPC coating had a complete coating breakdown, as seen in the right hand side picture of Fig 7, the exposed aluminium on all the plates showed dark brown spots in the crevices that followed the lines of the surface preparation grooves.

Figure 7 Laboratory samples (x10) (Left AF, Middle CDP and Right SPC)

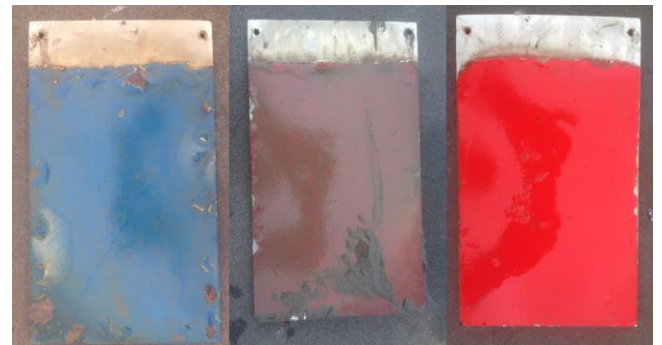
When the three coated test plates were taken out of the sea, after 88 days of immersion it was noticed that all of the plates were free of any visible biofouling. However, all of them had blisters and obvious deposits of corrosion product, mainly where the antifouling and the bare aluminium alloy met, as shown in Fig 8.

Figure 8 Plates after immersion (Left SPC, Middle CDP and Right AF)

An area of each specimen where the corrosion was at its worst was selected. The worst area was where the antifouling and the bare aluminium alloy met, and it is this area where copper deposits on the aluminium substrate, resulting from leaching, might be expected. Also the joint between the substrate and the antifouling created a crevice, hence the possibility of corrosion. Each area was examined under the microscope (x10) magnification, as seen in Figs 9 to 11. This shows ruptured corrosion blisters of various sizes on each sample. The bare aluminium strip above each antifouling showed the same dark spots in the crevices as also seen in the lab experiment, which were formed by the breakdown of the aluminium oxide film (Davis, 1999).

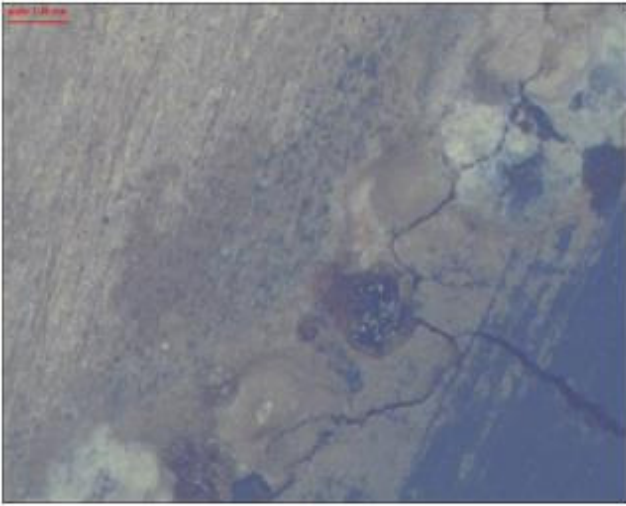
Figure 9 Self Polishing Copolymer (x10)

Initial inspection of the panels showed that the areas where the bare aluminium and the coated aluminium meet had suffered from corrosion. White and brown corrosion

is clearly visible in this region of the plates as seen, in Fig 9 to 11.

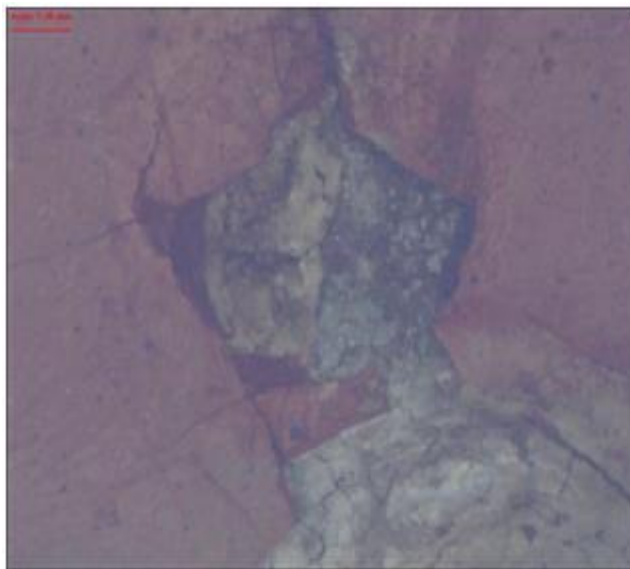
Figure 10 Controlled Depletion Polymer (x10)

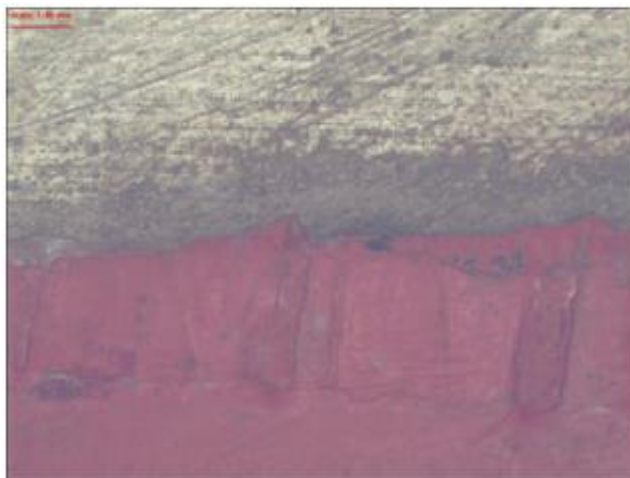
Figure 11 Aluminium Antifouling (x10)

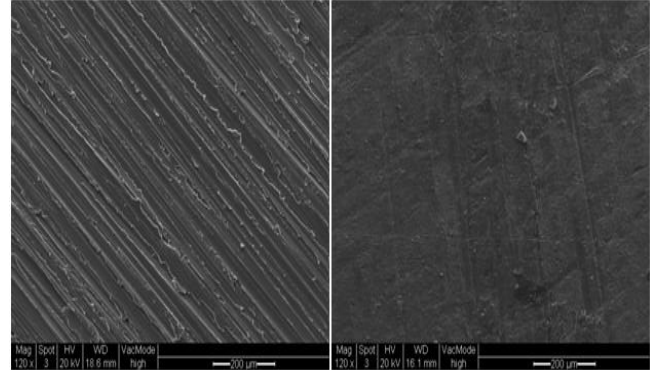
Figure 12 bare Aluminium test plate before (left) and after (right) immersion (x120)

Table 2 Aluminium before immersion (x120)
(As seen EDX results of aluminium before immersion)

Element	Atom. C [at.-%]
Aluminium	94
Magnesium	6

Table 3 Aluminium after immersion (x120)
(As seen EDX results of aluminium after immersion)

Element	Atom. C [at.-%]
Aluminium	56
Magnesium	4
Oxygen	40

The specimens were examined using the Scanning Electron Microscope (SEM), and the Energy-Dispersive X-ray (EDX) as presented in Tables 2 to 9, as well as Figs 12 to 18.

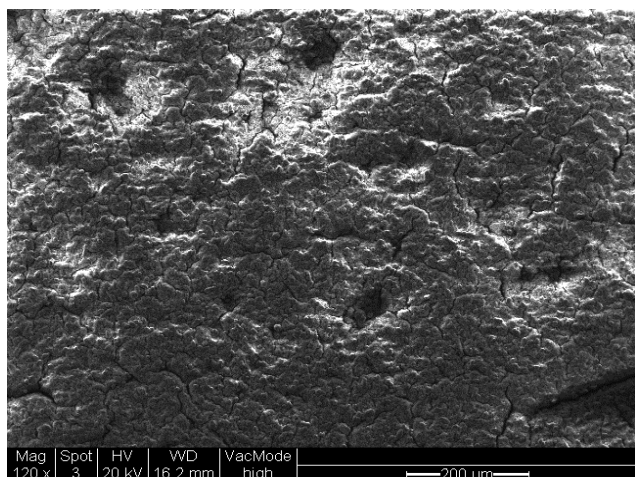
Figure 13 Aluminium Antifouling (x120)
(Surface of the AF after immersion)

Table 4 Aluminium Antifouling (x120)
(As seen EDX results of AF surface after immersion)

Element	Atom. C [at.-%]
Aluminium	1
Chlorine	5
Copper	7
Magnesium	1
Oxygen	74
Phosphorus	2
Silicon	3
Sulfur	7

Typical views from the SEM for the three different coated surfaces are also presented in Figures 13 to 15, while the analysis results from the EDX for the same surfaces are tabulated in Tables 4 to 6.

As can be seen in Figs 13 to 15, the structure of the each coated surface is very different. The aluminium antifouling has very few cracks and holes, it is also relatively smooth, whereas the CDP coated surface has many small holes and it can also be seen that the surface is very rough. It is well-known that CDP type antifouling generate a thick leached layer through which the biocide must travel to prevent fouling effectively (Anderson, 2007). This layer has affected the EDX results given in Table 5, which show a low copper content on the surface. The SPC coated surface has many holes and cracks but a fairly smooth surface. The EDX results showed all three antifouling had high oxygen contents after immersion, as seen in Tables 4 to 6.

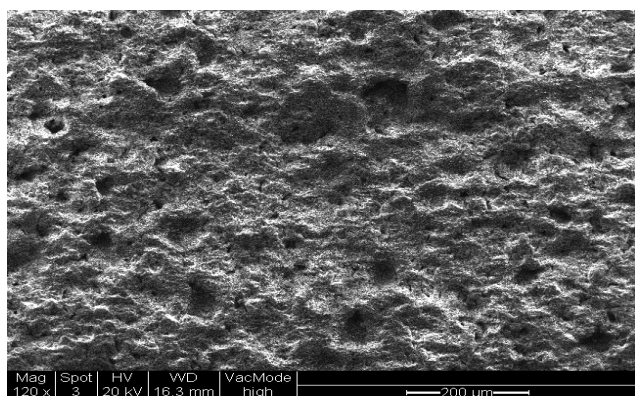
Figure 14 Controlled Depletion Polymer (x120)
(Surface of the CDP after immersion)

Table 5 Controlled Depletion Polymer (x120)
(As seen EDX results of CDP surface after immersion)

Element	Atom. C [at.-%]
Aluminium	2
Chlorine	2
Copper	4
Iron	1
Oxygen	70
Phosphorus	1
Silicon	5
Sulfur	7
Zinc	8

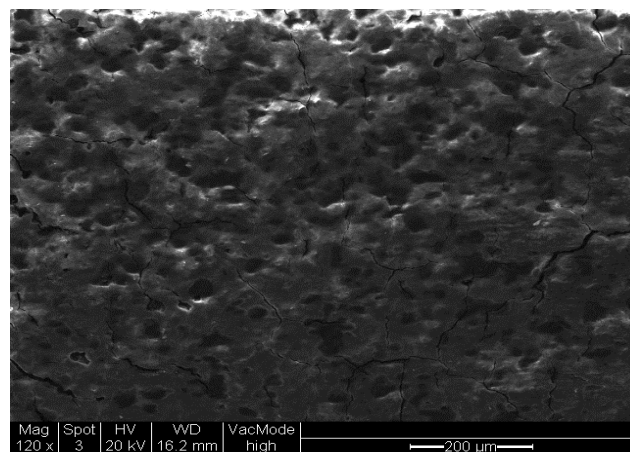
Figure 15 Self Polishing Copolymer (x120)
(Surface of the SPC after immersion)

Table 6 Self Polishing Copolymer (x120)
(As seen EDX results of SPC surface after immersion)

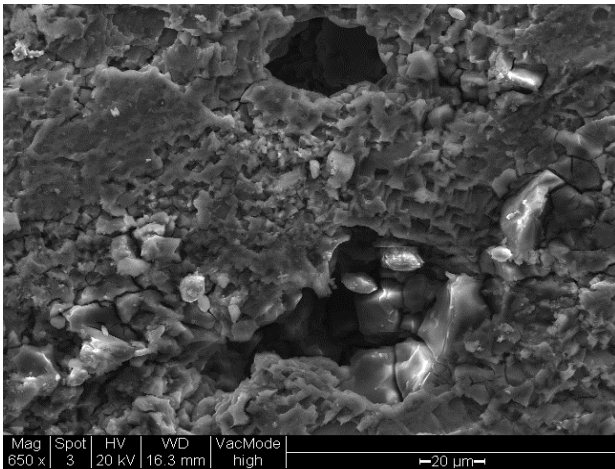
Figure 16 Aluminium Antifouling pits (x650)
(aluminium surface under blister after immersion)

Table 7 Aluminium Antifouling pits (x650)
(As seen EDX results of AF surface after immersion)

Element	Atom. C [at.-%]
Aluminium	49
Copper	1
Chloride	1
Magnesium	3
Oxygen	45
Sulfur	1

After first investigations and analyses, the three test plates were washed in deionised water and placed in a sonic bath to remove the loose material (blisters) and examined under the electron microscope. The typical views of the three substrate surfaces from the SEM are presented in Figs 16, 17 and 18 while the analysis results from the EDX are given in Tables 7, 8 and 9 for the same surfaces. Corrosion pits were found where the loose material was removed from the Aluminium antifouling coated plate as shown in Fig 16 and the CDP coated plate in Fig 17. These areas were examined by the EDX and traces of the antifouling elements were present on the surface as seen in Tables 7 to 9. The results of the analysis for the SPC coating show a brown layer of

corrosion product covering the metal surface, as shown in Figures 18. The pits seen in Fig 16 with the Aluminium antifouling coated plate could also suggest some intergranular attack, again high amounts of oxygen were also present on all three samples as seen in Table's 7 to 9.

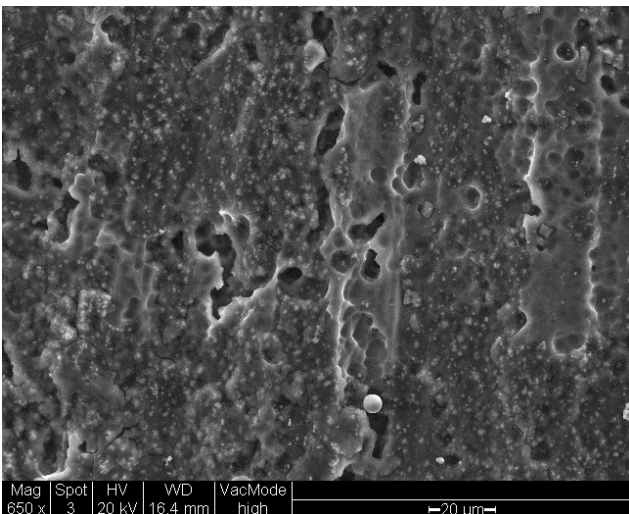
Figure 17 Controlled Depletion Polymer pits (x650)
(aluminium surface under blister after immersion)

Table 8 Controlled Depletion Polymer (x650)
(As seen EDX results of CDP surface after immersion)

Element	Atom. C [at.-%]
Aluminium	53
Copper	2
Magnesium	6
Oxygen	38
Sulfur	1

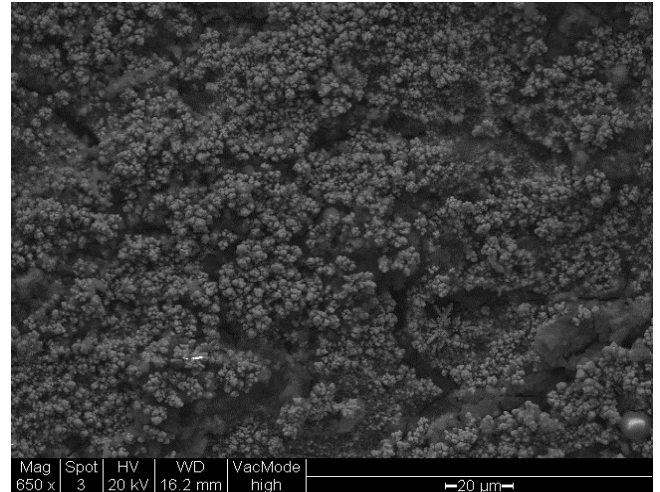
Figure 18 Self Polishing Copolymer (x650) (aluminium surface under blister after immersion)

Table 9 Self Polishing Copolymer (x650)
(As seen EDX results of SPC surface after immersion)
