Biofouling of leisure boats as a source of metal pollution

Maria Alexandra Bighiu¹ · Ann-Kristin Eriksson-Wiklund¹ · Britta Eklund¹Received: 22 December 2015 / Accepted: 10 October 2016 / Published online: 20 October 2016
© The Author(s) 2016. This article is published with open access at Springerlink.com

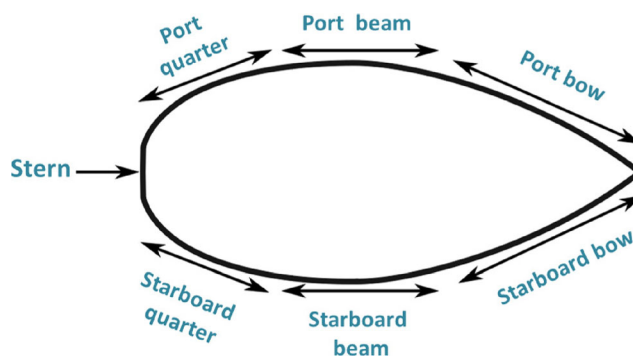
Fig. 1 Areas of each boat from which biofouling was sampled

To obtain a representative estimation of the biofouling coverage, seven samples were taken per boat from different areas of the hull, which included the starboard (bow, beam, quarter), port (bow, beam, quarter) and stern (Fig. 1). Biofouling covering areas between 2 and 8 dm² was removed a few centimetres below the waterline using rubber scrapers. The scraped material was then placed into preweighted bags, transported in coolers and frozen at -20 °C once it reached the laboratory. The biofouling material was then dried in the oven at 60 °C for 2–3 days, after which the dry weight was measured. No species identification was performed for the field study.

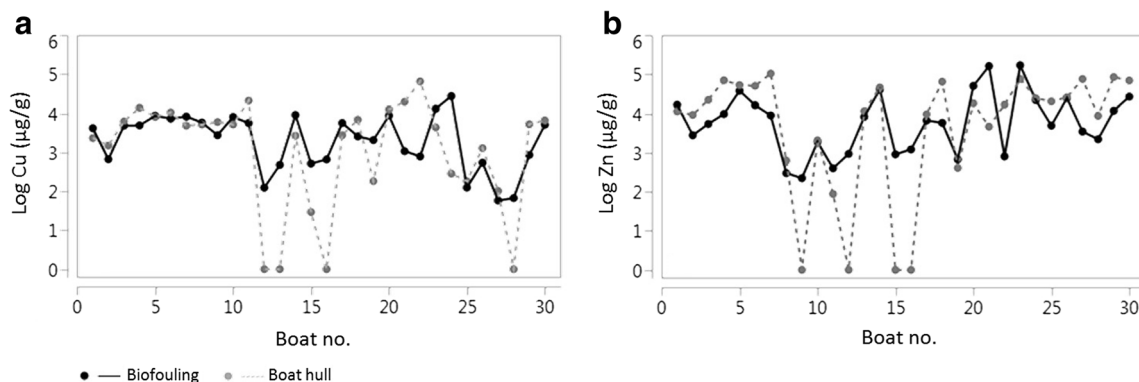
Fig. 2 a, b Relationship between the concentrations of metals in the biofouling material and on the boat hulls

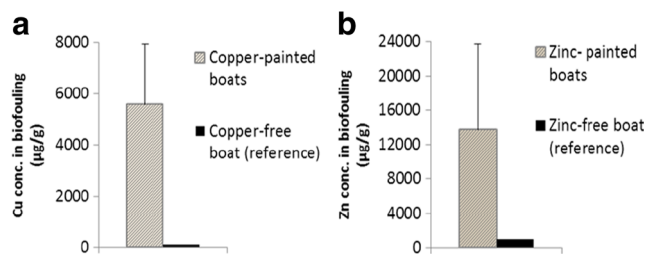
Fig. 3 a, b Average concentrations of copper and zinc in biofouling sampled from coated vs non-coated boats; error bars show standard deviations

Secondly, the uptake of metals from water can be evaluated by comparing the concentrations in biofouling sampled from a reference boat (i.e. a 10-year-old boat which has never been painted) to those sampled from boats coated with copper or zinc-containing paints. Figure 3 shows the high difference in uptake of metals from water vs antifouling paints, implying that the boat hulls are the main source of metals for the fouling organisms. Moreover, the levels of metals in the biofouling material show a positive (though not statistically significant) correlation with the volumes of antifouling paint used on the respective boats (data not shown).

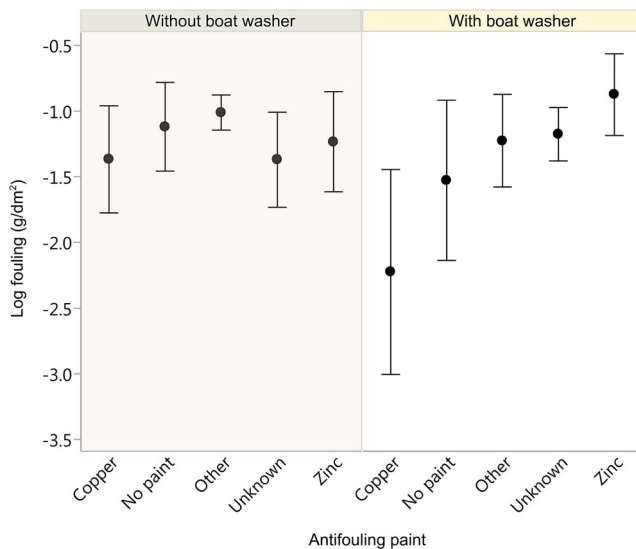
Fig. 4 Dry fouling (log scale) in relation to different AF paints, without and with the use of boat washers; means ± sd

Approximately 22 % of the boats in this study were cleaned on boat washers (the rate of response to this question was 100 %). These boats had slightly lower biofouling (e.g. on average 7 % less biofouling) than those not cleaned mechanically, though the difference is not statistically significant (Fig. 4). Half of these mechanically washed boats were also coated with AF paints; consequently, in some cases, it is difficult to conclude which treatment was responsible for the observed amount of biofouling. It is also important to note the limitation of not knowing when the boats were cleaned mechanically during the season. Nevertheless, in the case of those boats that were not painted at all during the season, those washed mechanically had, on average, half of the amount of biofouling of those that were not cleaned on boat washers (i.e. average biofouling was 0.06 vs 0.11 g/dm², not significant).

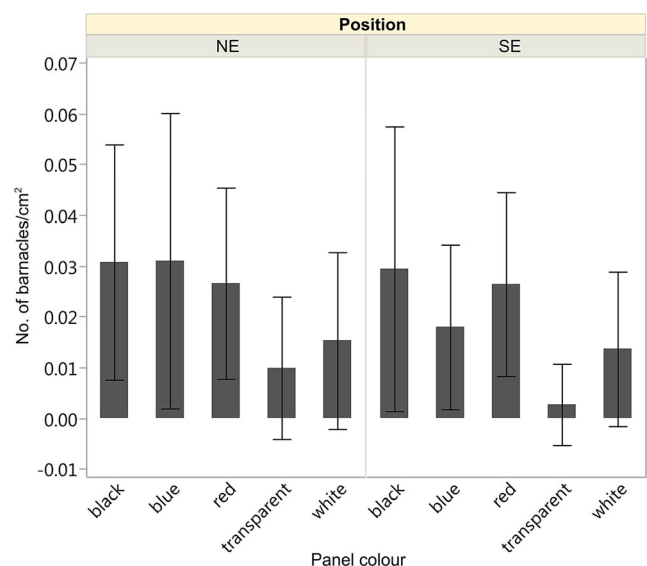
Fig. 5 Density of barnacles (*Balanus improvisus*) settled on panels of different colours, facing NE and SE; means ± sd

There was a strong effect of the substratum colour on the settlement of barnacles ($p < 0.0001$, $df = 4$, chi sq. = 26.95), which preferred darker panels (i.e. black, blue and red), while white and transparent panels had the least barnacles (Fig. 5). These results are in accordance with previous studies (Hurley 1973; Satheesh and Wesley 2010; Dobretsov et al. 2013) in which barnacles settled most abundantly on dark surfaces (blue, red, black). Significantly lower densities of *Balanus improvisus* were found on panels on which the algae *Ulva*

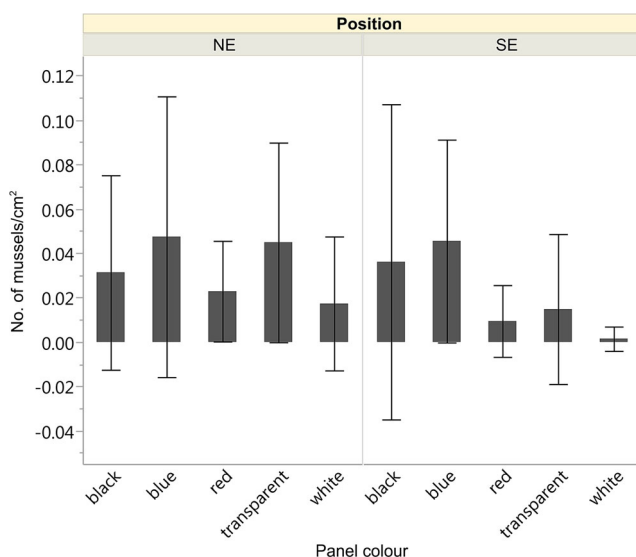
Fig. 6 Density of mussels (*Cerastoderma glaucum*) settled on panels of different colours, facing NE and SE; means \pm sd

The attachment of the mussel *Cerastoderma glaucum* was also different among colours ($p = 0.0023$, $df = 4$, chi sq. = 16.58, Fig. 6), with white panels having significantly less mussels than do blue or black ones (the comparisons between all pairs are found in Table 3 in the Annex). The mussels were also more abundant on the panels facing NE ($p = 0.024$, $df = 1$, chi sq. = 5.12). The settlement of ostracods was significantly higher on panels oriented towards SE, regardless of colour ($p = 0.012$, $df = 1$, chi sq. = 6.28). For both positions, control (transparent) panels had significantly higher densities of ostracods than black, blue or white panels (Table 2 in the Annex).
