2<sup>nd</sup> CIRP Conference on Surface Integrity (CSI)

## Biodegradation control of magnesium-calcium biomaterial via adjusting surface integrity by synergistic cutting-burnishing

M. Salahshoor, Y.B. Guo\*

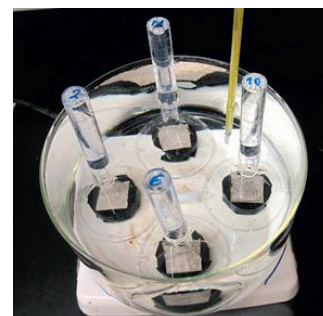
Cylindrical-shaped samples of MgCa0.8 of 38 mm (dia.) × 12 mm (length) were dry face milled using PCD inserts (ADKW 1505-75RW PDR) at feed 0.2 mm/rev, DoC 0.2 mm and velocity 2000 m/min. A square-shaped area of 24 mm × 24 mm was burnished (SiN ball 12.7 mm dia) after face milling. All the samples were ultrasonically cleaned in ethanol and then dried in a stream of air. Unburnished surfaces of each sample were covered to avoid the exposure to simulated body fluid (SBF) in immersion corrosion tests. Table 1 shows the chemical composition of the applied SBF. Fig. 1 shows the experimental set up. The volume of the SBF in the corrosion cell was 2200 ml and its temperature was maintained at 37 ± 1 °C. The solution was also stirred to keep the temperature and chemical concentration uniform all over the cell. Two sets of immersion tests were performed to study the effects of burnishing feed and pressure on degradation kinetics of MgCa0.8. In the pressure-effect set, there was one reference sample which was only face-milled in addition to three more samples burnished at pressure of 2, 6, and 10 MPa. Likewise, there were four samples in the feed-effect set, a face-milled reference and three burnished samples at the feed of 60, 100, and 200 μm. Each test was run for 300 hours and 500 ml of the solution was replaced with fresh SBF for every 12 hours to account for the fluid exchange of an adult human by urination.

Fig. 1 Immersion corrosion testing setup.

The other factor against complete stabilization of the hydroxide layer is the body fluid flow in actual physiological case. The fluid flow caused by stirring action in the corrosion cell (Fig. 1) accelerates the mass diffusion around implants, prevents the precipitation of corrosion products to some extent, and results in acceleration of Mg<sup>2+</sup> dissolution. The mechanism of the corrosion is complex and is affected by metallurgical factors, alloying additions, and impurities. Mg<sub>2</sub>Ca phase, formed on the grain boundaries, is more active than α-Mg [3] in the bulk of grains and it assumes the role of anode contradicting other intermetallics which are cathode in relation to Mg. Hence, the corrosion concentrates in the grain boundaries followed by undercutting and falling-out of grains. Evidences of such selective attack in grain boundaries are visible in the micrographs of Figs. 8 and 9. This might be a reason for powder-like structure of the white substance mentioned in section 5.

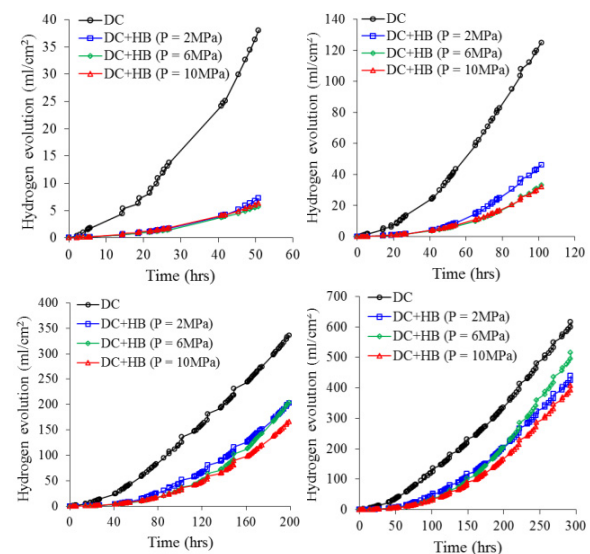
Fig. 2 shows the amount of evolved hydrogen collected during 300 hrs. immersion tests on burnished samples processed under different burnishing pressures. It is clear that there is significant improvement in corrosion resistance, particularly in first 100 hrs after implantation, by adding burnishing to the surface layers. The capability to adjust the degradation kinetics of MgCa0.8 alloy, particularly for several days after the surgery, is critical in the sense that absorption rate of the corrosion products could match the production rate in order to avoid accumulation of them in the operation site, disrupting the metabolic reactions, and ultimately delaying healing process. Undisturbed healing will provide bone cells with sufficient time to grow at fractured sites and hence the bone will gain increasingly higher strength for carrying daily life loads as the implant gets weaker due to corrosion.

unveiled as the corrosion progresses and at some point for all the samples, the bulk material with uniform mechanical and biodegradation properties would be attacked by corrosion reaction and that is when the slopes of the plots in Fig. 2 become identical. Higher burnishing pressures show more gain on corrosion resistance which is due to larger and deeper compressive residual stresses in the subsurface [1]. It is worth mentioning that for this set of tests a plastic tape was used to cover the unprocessed surfaces of the samples. It was observed that corrosion had happened on those surfaces as well when the tape was removed at the end of the test. This might have been caused due to crevice corrosion. As the corrosion progresses on target areas of the implants, a narrow gap grows gradually between the surface and the tape which is a potential site for crevice corrosion and it spreads to the rest of the unprocessed surface from there as the time passes on. Therefore, some amount of hydrogen in Fig. 2 is produced by unwanted surfaces; however, since all the samples were in same cell, under same condition, and covered identically the comparative study in Fig. 2 would still be valid. Crevice corrosion is a probable reason that degradation curve corresponding to 6MPa pressure gets ahead of the 2MPa curve after 200 hrs immersion.

Fig. 2 Effect of burnishing pressure on cumulative hydrogen evolution in 50, 100, 200, and 300 hrs immersion in SBF (DC: dry cutting; HB: hydrostatic burnishing).

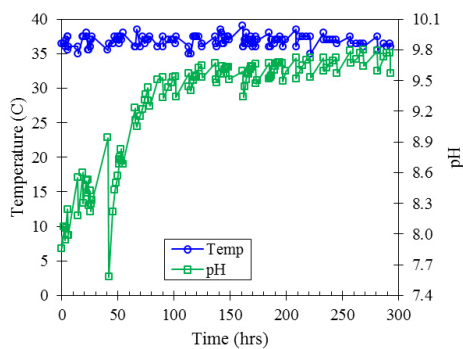
The solution temperature and pH were monitored, as are shown in Fig. 3, throughout the immersion test. The temperature was kept around physiological temperature of 37 °C, however, the pH was constantly above the physiological pH of 7.4 even though the solution volume to corroding surface area ratio was

big and almost one quarter of the solution replaced every 12 hrs with fresh solution. The whole solution was replaced by fresh solution at 40<sup>th</sup> hour, seen as a sharp ditch in Fig. 3, to investigate whether there were other unforeseen factors affecting the pH or it was just the fast corrosion reaction producing large amount of hydroxide and rising pH. The pH read-out intervals were selected very short right after the solution replacement and it was noticed that the pH increased fairly quickly and stabilized around 9.65 for the rest of the test. It is expected for degradation to progress faster at physiological pH of 7.4. Higher pH values reflect the presence of larger amount of hydroxide in the solution which will in turn decrease the driving force of the reaction (1) to progress towards the right side and produce more corrosion products. This unconformity in the pH still does not affect the goal of this comparative study to investigate the effect of mechanical surface treatment by synergistic process on degradation kinetics, since all the samples are at same environmental conditions.

Fig. 3 Time history of solution temp. and pH in pressure-effect test.

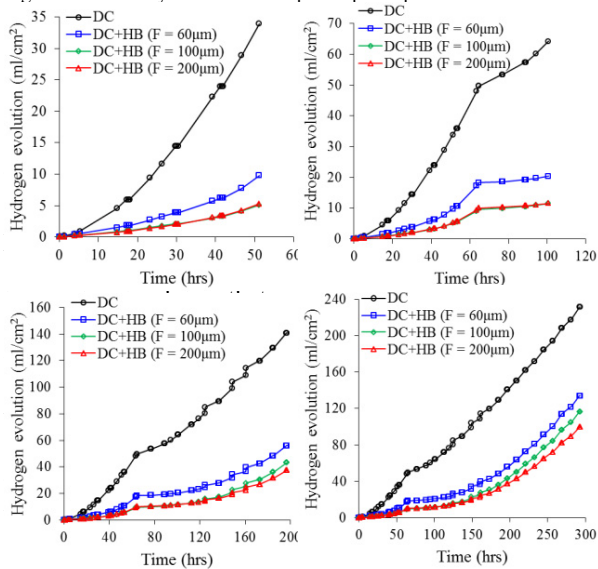
Fig. 4 Effect of feed on cumulative hydrogen evolution in 50, 100, 200, and 300 hrs. immersion in SBF.

To avoid the occurrence of crevice corrosion in this set of samples, the non-processed surface of the samples were covered using nail polisher. However, after about 60 hrs. immersion small particles of nail polish were spotted flowing around in the solution. That was an indication of potential break down in the protective layer in case the test was to run for longer periods. Therefore, the test was stopped and the samples were pulled out of the solution to try cold epoxy mount as the last resort to protect the non-processed surfaces from crevice corrosion. The samples had to be sized smaller in order to fit the epoxy mount molds. That was done by grinding using SiO<sub>2</sub> abrasive papers and the final exposed area was 1.8 mm × 1.8 mm rather than original 2.4 mm × 2.4 mm. The little kink in degradation curves around 60 hr immersion is due to this change in the size of the exposed area. In order to plot the data collected before the cold epoxy mount and afterwards in the same diagram, the measured volume of the collected hydrogen was normalized by the exposed area.

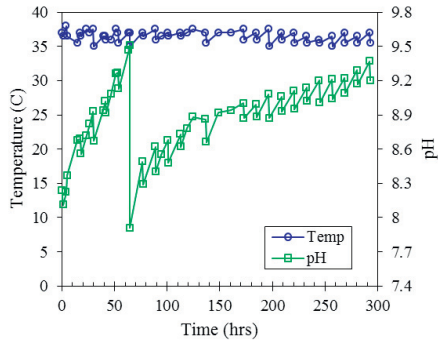
The temperature and pH of the solution were monitored in this test as well (Fig. 5). The temperature was kept around the physiological value; however, the pH showed pretty much the same pattern as in pressure-effect case. The big pH drop in Fig. 5 around 60 hr immersion is caused by replacing the whole solution with fresh one after epoxy mounting of the samples. A longer-term (> 300 hrs.) corrosion test would be helpful to evaluate the limit the process effect.

Fig. 5 Time history of solution temp. and pH in feed-effect test.

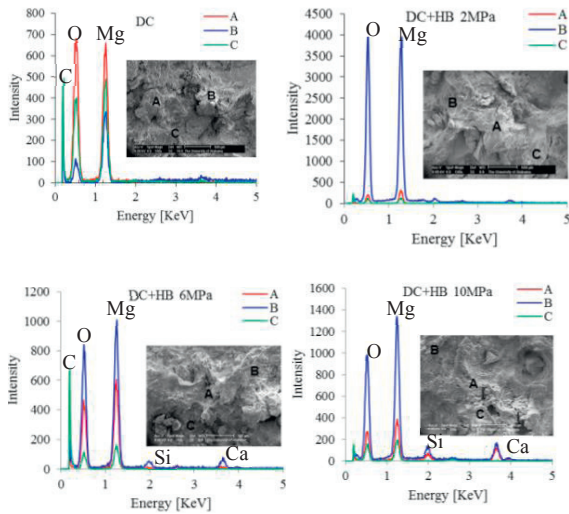
The morphology of the corroded surfaces after immersion tests is shown in Fig. 6. All the samples processed at different burnishing pressures and feeds showed similar morphology with heavily localized corrosion due to the fact that after nearly two weeks of immersion the mechanically affected zone (MAZ) would be dissolved entirely in the solution and underlying substrate would be exposed to corrosive medium. This substrate is the as-cast MgCa0.8 with same mechanical and biodegradation characteristics on all samples. Therefore, degradation will have pretty much the same dynamics on all the samples resulting in similar looking morphology as in Fig. 6.

Fig. 6 Surface morphology and EDS spectrum of MgCa0.8 implants processed under different pressure and feed (DC: dry cutting; HB: hydrostatic burnishing).

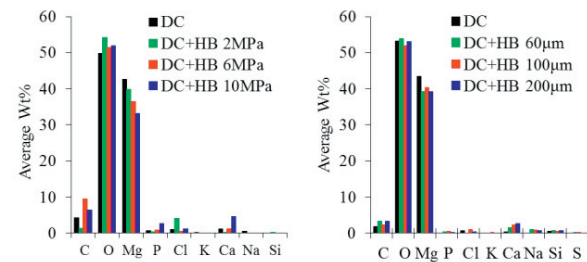
amount of each element is computed and shown in Fig. 7 for all the samples. Degradation depletes surface layer from Mg, more than 50%, while makes it richer in Ca content. It is also noticeable that more than 50% of the corroded surface layer is composed of oxygen. This could be due to diffusion of phosphate (PO<sub>4</sub>)<sup>3-</sup> and carbonate (CO<sub>3</sub>)<sup>2-</sup> ions from the solution into the surface or hydroxide (OH<sup>-</sup>) formation on the surface. It is worth mentioning here that all sample surfaces were covered with a thick layer of powder-like, white-color substance which was removed mechanically to expose the surfaces shown in Fig. 6. There is a very high chance for this substance to be magnesium hydroxide Mg(OH)<sub>2</sub> particularly due to high pH value of the solution in Figs. 3 and 5 which stabilizes the hydroxide. The other possibility is the formation of hydroxyapatite Ca<sub>10</sub>(PO<sub>4</sub>)<sub>6</sub>(OH)<sub>2</sub> which is the naturally occurring form of calcium and has strong resemblance to the bone structure. This similarity is favored from the medical viewpoint since it stimulates bone cells to grow into the implant surface and make proper bonding which is vital for keeping bone fragments in their original anatomical alignment during recovery.

Characterizing the mentioned substance needs further investigation. Moreover, Si was detected on feed-effect samples as is shown in Fig. 7. This element was neither in the MgCa0.8 alloy nor in the solution (Table 1). A possible source for this element is SiO<sub>2</sub> abrasive papers used in the grinding stage to resize the samples before cold epoxy mounting.

Fig. 7 Quantitative EDS and elemental composition of the corroded MgCa0.8 surfaces (DC: dry cutting; HB: hydrostatic burnishing).

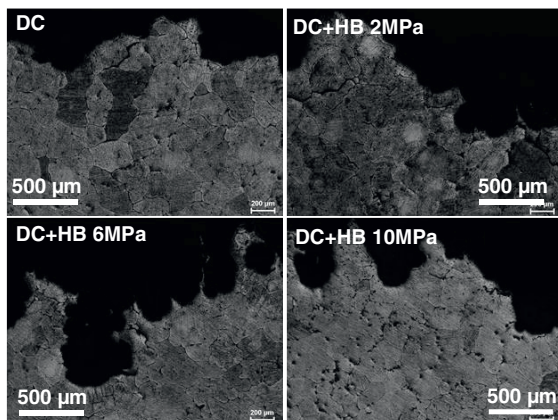
Fig. 8 shows subsurface (cross section) grain sizes of the corroded samples. The localized nature of corrosion after two weeks immersion and irregular shaped pits are clearly visible in the subsurface. The overall reaction (1) consumes H<sup>+</sup> and produces OH<sup>-</sup> which causes the pH value to increase and favors the formation of Mg(OH)<sub>2</sub>. Therefore, it seems the corrosion should stop at some point due to protective function of the formed hydroxide layer. However, in

Fig. 8 Subsurface micrographs of the corroded MgCa0.8 surfaces processed under different burnishing pressures (DC: dry cutting; HB: hydrostatic burnishing).

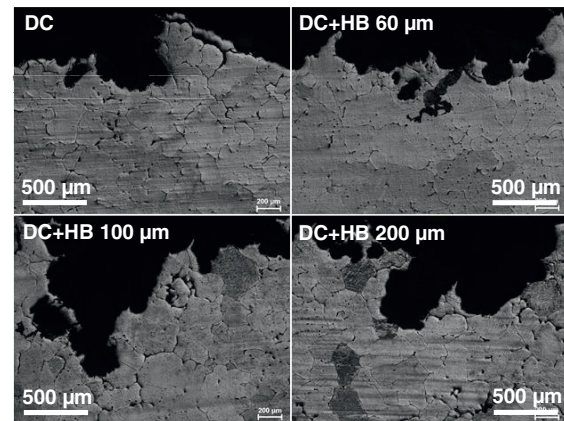
Fig. 9 Subsurface micrographs of the corroded MgCa0.8 surfaces processed under different burnishing feeds (DC: dry cutting; HB: hydrostatic burnishing).
