Procedia Economics and Finance 18 (2014) 483 – 488

4th International Conference on Building Resilience, Building Resilience 2014, 8-10 September
2014, Salford Quays, United kingdom

The Role of Buildings in Disaster Risk Reduction: Focusing on the Great East Japan Earthquake

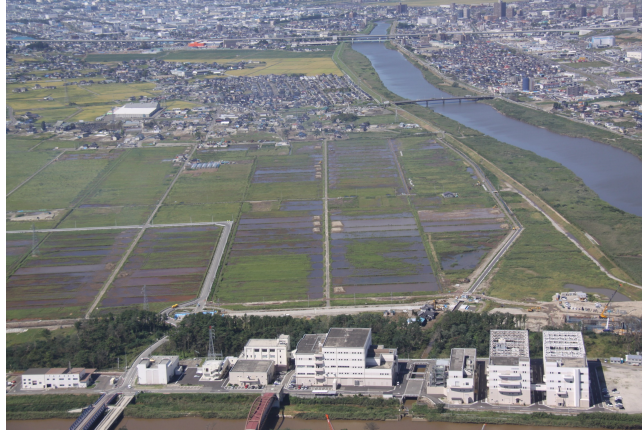
Figure 1(b). An aerial view of purification center used for photogrammetry surveys

Due to the space limitations this paper reports only the set of survived buildings in Sendai sewage purification centre in Miyagi Prefecture. However, the authors acknowledge that the buildings washed-away should also be reported, in order to understand the boundary condition of washed-away and survived. Hence, this paper refers to boundary parameters given by Matsutomi et al. (2012) and Ogata (2014). Figure 1(a) and (b) show aerial views of Sendai sewage purification centre, and Figure 1(c) is a view of purification centre on 11 March, 2011.

- The heights of objective buildings were obtained through photogrammetry survey methods using aerial photos taken by the authors, pictures of Google earth, and aerial photos provided by Geospatial Information Survey Authority of Japan.
- Inundated vertical sectional area is the product of inundation height (P) multiplied by the depth of the building (D) which is parallel to the tsunami direction (see Figure 2(a)).
- Inundated sectional area is an area of a building which faces the tsunami. It is the product of inundation height (P) multiplied by width (W) of the building right-angled to the tsunami direction (see Figure 2(b)).
- The opening ratio was obtained by dividing the area of openings in the inundated sectional area by inundated sectional area.
- Opening ratio difference was obtained by subtracting landward opening ratio from seaward opening ratio of the building.

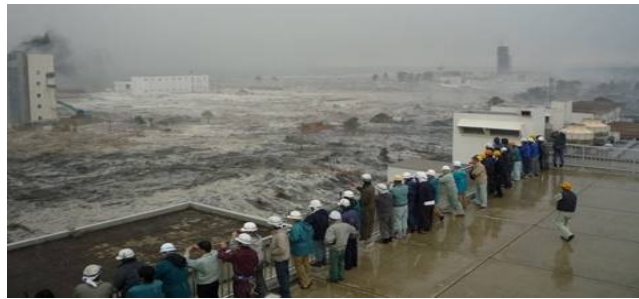
Figure 1(c). A view of purification centre on March 11, 2011 (source: Sendai City)
