Procedia Engineering 11 (2011) 100–106

The 5th Conference on Performance-based Fire and Fire Protection Engineering

Microscopic Investigation of a Copper Molten Mark by Optical Microscopy (OM) and Atomic Force Microscopy (AFM)

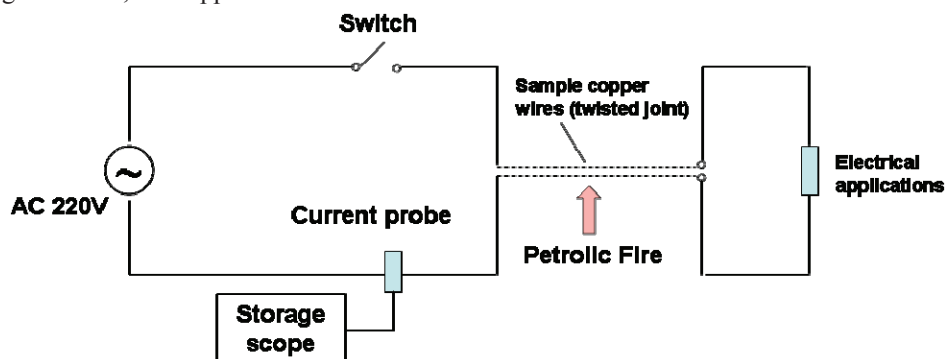
Fig. 1 Experimental circuit

In this study, in order to form a typical copper molten mark, new flexible PVC-coated copper cord (single-strand, allowable current: 20 A at 25 °C, diameter is 1 mm² [4]) was used. An experimental station to form typical short-circuit copper molten marks was constructed. Figure 1 is the schematic illustration of the experimental circuit. A single electrical circuit, composed of power source (AC 220 V), a switch, sample copper wire, electrical applications and current probe, was wired in the experimental station. The electrical molten marks that were formed between two PVC-wounded copper cords in a container, when brought in contact (twisted) with each other. The wrapping insulated polyvinylchloride of the wires was burnt out by the petrolic burner flames, and then the copper wires in the two cords were contact with each other, short circuit happened.

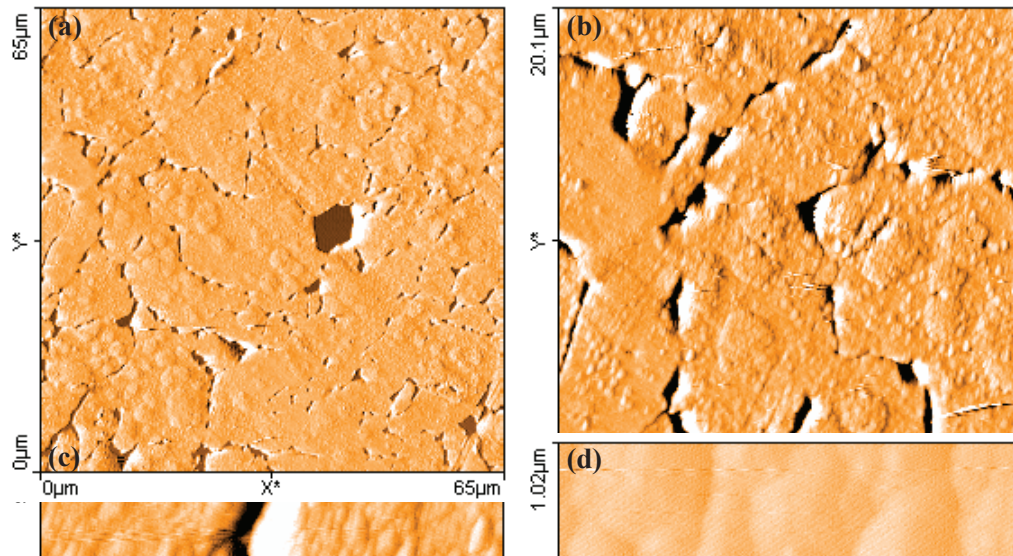
Fig. 3 Typical microstructures of copper molten mark under atomic force microscopy (AFM) with etching, (a) $65 \times 65 \mu\text{m}$, (b) $20.1 \times 20.1 \mu\text{m}$, (c) $5.01 \times 5.01 \mu\text{m}$, $1.02 \times 1.02 \mu\text{m}$.

This large dynamic range was illustrated in Fig. 3 with four pictures, where the microstructures of the copper molten mark were visualized clearly with the AFM. The microstructures consisted of three parts: grains, surrounded by grain boundaries, grain boundaries and voids. By monitoring the copper molten mark in a series of AFM images, including 65 μm , 20.1 μm , 5.01 μm and 1.02 μm scans, the details of the grains, grain boundaries and voids could be seen. It could also be seen that there were deeper worn traces on the rubbing surface of copper wire molten mark (as shown in Fig.3 (a)), the wear scar is similar to “ploughing” and there were some adhesion traces (grain boundary) of grains (black places shown in Fig.3 (a)). The grain boundaries were easily identified in all of the images since the height differences on the boundaries were much larger than the average surface roughness. In Fig. 3 (b), it could be seen that there were many independent particles in the grains. In the magnified micrographs (Fig. 3 (c) and (d)), the small sesame-like particles of about several hundred nanometer dispersed uniformly in the grains could be seen clearly.
