Physics Procedia 12 (2011) 345–352

Laser Cladding of Vanadium-Carbide Tool Steels for Die Repair

J. Leunda, C. Soriano*, C. Sanz, V. García Navas

Tekniker-IK4, Advance Manufacturing Technologies Unit, Avda. Otaola 20, 20600 - Eibar (Gipuzkoa), Spain

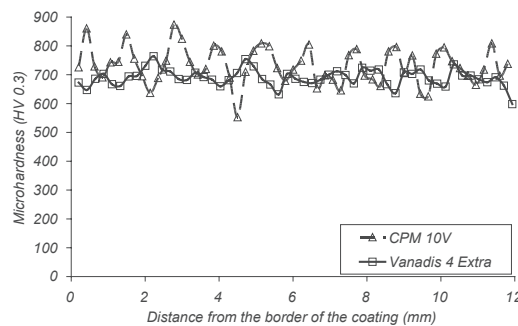
Figure 8. Horizontal microhardness profiles of CPM 10V and Vanadis 4 coatings measured at 0.2 mm above the original surface

Figure 8 shows the horizontal microhardness profiles measured in the CZ of both coatings at 0.2 mm above the original surface. The CPM 10V coating presents higher overall hardness, but a more heterogeneous profile due to the microstructure differences between the area of the tracks, unaffected by the subsequent depositions, and the RHZ. In the unaffected track centers tiny multi-shape carbides are scattered all over the metal matrix, leaving little space between them, while in the RHZ larger globular carbides are distributed with major carbide free regions, so the probability of the indentations to hit a carbide is much lower in the RHZ than in the track center, resulting in a lower hardness values in that region. With regard to the Vanadis 4 coating, the only difference between those two areas is related to the tempering of the matrix being the carbide shape and distribution similar in both zones. The hardness profile is therefore smoother, as is the microstructure variation.
