Nuclear Materials and Energy

Plasma etching to enhance the surface insulating stability of alumina for fusion applications

M. Malo*, A. Moroño, E.R. Hodgson

National Fusion Laboratory, CIEMAT, Madrid, Spain

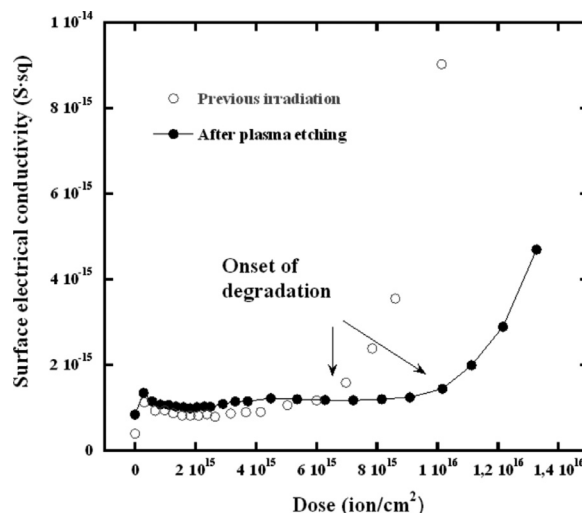
In contrast, a complete surface recovery was achieved when the sample was subjected to low energy oxygen ions (<1.3 keV) produced with a sputter coater. The system, operated at 1.3 kV and 30 mA, does not permit one to register conductivity data as a function of oxygen exposure, hence surface electrical current is given as a function of helium irradiation before and after a 25 minute plasma etching treatment (Fig. 2).

For the first irradiation with helium (open circles), performed at $6 \cdot 10^{12}$ ions/cm²s at room temperature, conductivity degradation initiates above about $5 \cdot 10^{15}$ ions/cm². For the second irradiation (solid circles) after etching, performed under the same conditions, the initial conductivity not only has been fully recovered but also

Fig. 2. Surface electrical conductivity as a function of He ion dose.

the sample shows improved performance under irradiation, with approximately double the dose needed for the onset of degradation.

Oxygen implantation at 22.5 and 45 keV causes additional damage in the sample surface with no recovery, the conductivity increase being even more severe than during helium irradiation (Fig. 1). These results may be directly related to the higher sputtering yield, according to SRIM [4] simulations given in Table 1. However, the use of low energy oxygen plasma etching seems to completely recover and even improve surface initial properties (Fig. 2).

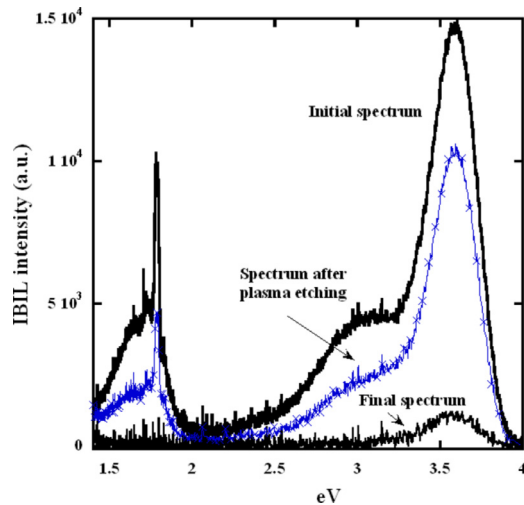
Fig. 3. Luminescence spectra induced by He irradiation before plasma etching (initial and final spectra after 10¹⁶ ion/cm²), and after oxygen plasma etching treatment.

No indication of luminescence recovery has been observed for oxygen implantation. On the contrary, continuous reduction of IBIL takes place with oxygen dose, in agreement with the further material degradation revealed by the conductivity increase (Fig. 1). However, following plasma etching the spectrum recovers the initial structure (F, F⁺, and Cr bands) lost during He irradiation and practically the same intensity ($\sim 70\%$ F⁺ band), as shown in Fig. 3.

Although initial surface electrical conductivity is fully recovered in all cases, it must be taken into account that although surface electrical conductivity is measured in a very shallow region, luminescence is collected from a volume of about ~160 nm in depth corresponding to the 45 keV He ion penetration in alumina given by SRIM simulation (damaged volume), and is therefore a good indicator of the real state of the material. In fact, the material stability under further irradiation presents important differences depending on the luminescence recovery, being improved for annealing during exposure to ionizing radiation [6] and more notably for plasma etching (Fig. 3).

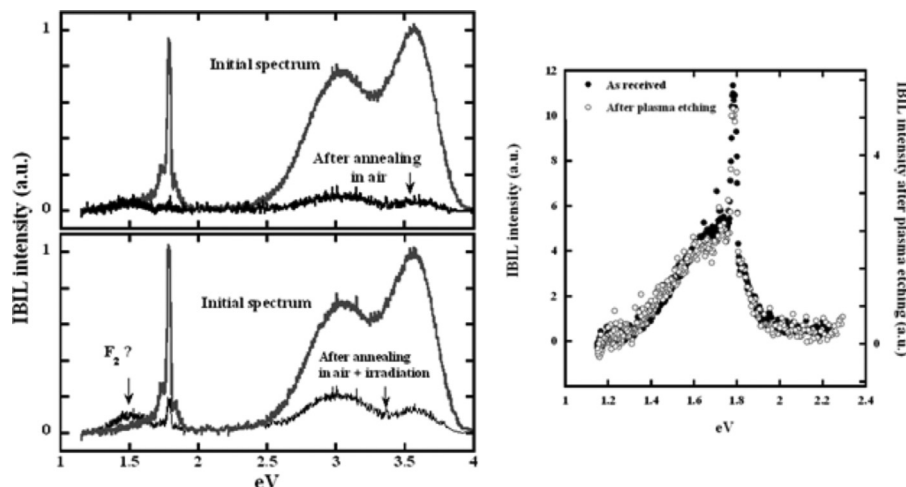
Fig. 4(a, b) shows initial luminescence spectra taken at room temperature for Deranox alumina before and after the annealing treatments discussed above [6]. An additional band for annealed samples (more intense when annealing during irradiation) is observed at 1.5 eV, which might be related to F₂ centres [7], or impurity segregation. This is indicative of active processes that are taking place as a consequence of heating, enhanced by ionization. No indication of this new band is observed in this region for Wesgo, as is clearly seen in Fig. 4c despite the difficulties introduced by the additional band overlapping the Cr³⁺ emission (associated with Fe [8–9]). The identical luminescence structure suggests a physical removal of the damaged layer (surface cleaning).

Fig. 4. IBIL spectra for an “as received” Deranox sample and after 10¹⁶ ion/cm² He irradiation plus posterior annealing in air (a), and posterior annealing in air during electron irradiation (b). IBIL spectra (detail) for Wesgo “as received”, and after 10¹⁶ ion/cm² He irradiation plus posterior plasma etching treatment (c).

Examination of the whole IBIL spectrum from 1 to 4 eV reveals that there are important differences between the heating methods and the plasma etching technique.
