Energy Procedia 96 (2016) 170 – 179

SBE16 Tallinn and Helsinki Conference; Build Green and Renovate Deep, 5-7 October 2016,
Tallinn and Helsinki

Pending for renovations: Understanding the conditions of the multi-family housing stock from before 1945

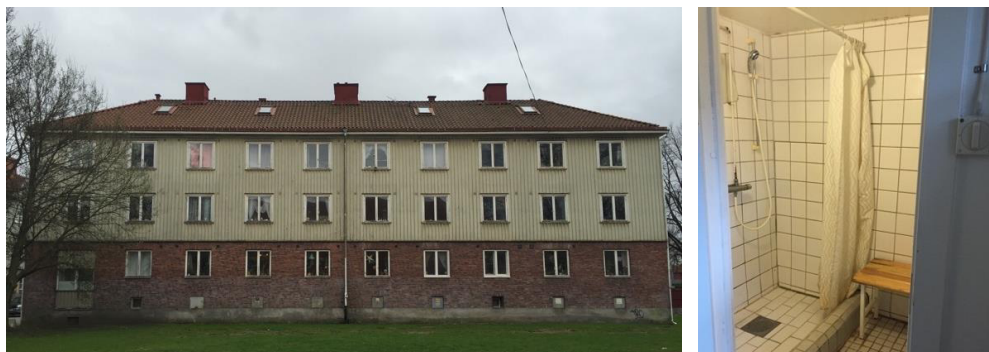
Fig. 4. Case study building 1 is a Landshövdingehus on Banérsgatan 6. Left: façade with brick on ground floor and wooden weather board on the upper two floors. Right: common shower in basement.

Case 1, Fig. 4, is built in 1929 and has not been renovated apart from smaller repair. The building is not categorized as housing but rented by the city as such. The standard is very low. Only four larger apartments out of approximately 20 have bathrooms, the rest have common showers in basement and shared WC on each level. The tenants profit from very low rents but they have pay high electricity bills as the building is only equipped with electric heating. It was supposed to be demolished to make way for a new plan for the area. The plan is now to renovate the building for continued function as housing. Workshops have been carried out in order to understand the tenants' expectation for an up-coming renovation. Tenants complain about draught, high electricity bills but are otherwise satisfied with the low standard and the high level of social interaction between tenants.

There is no energy performance certificate for the building but after an ocular inspection it was concluded that the building is poorly insulated. Some of the tenants' electricity bills have been retrieved which point to a possible energy use of over 200 kWh/m². A number of windows have been exchanged, mainly to units of two panes. However, both newer and old windows are in poor condition and our view is that all windows are in need of renovation. The façade consists of brick and wood, see Fig. 4. The brick is in good condition in most places but the wooden part needs painting. On the interior, some water leakage into the attic was detected. Further investigations need to be performed to determine whether the leakages are old or ongoing. On the first floor, some of the internal brick walls have been severely damaged by water. There seem to be water suction through the basement floor, which also has resulted in biological growth. The common bathroom is in bad condition, with for example cracked tiles. Interior surfaces need to be painted, plastered or replaced.

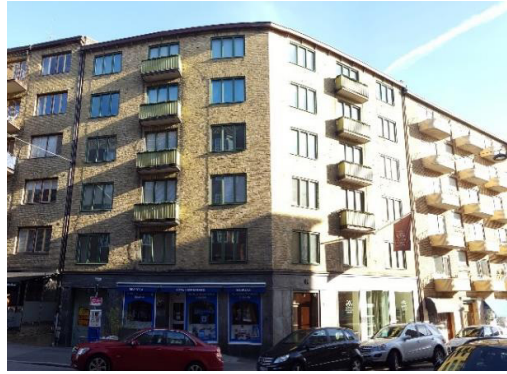
Fig. 5. Case study building 2 is a brick building located on Geijersgatan 14.

The building built in 1932, see Fig. 5, is located on Geijersgatan in the centre of Gothenburg. The area as a whole is protected and 'represents an excellent example of the late 19th century upper-class urban areas and is one of the country's most well-preserved environments of this kind' [13]. The building was and is consisting of dwellings on the upper floors and shops on the ground floor. It is situated in a bend of the block with the façade facing the street pointing at south and south-east. The inner courtyard is facing north, north-west. The façade is a yellow brick, most likely the same brick type is used consistently in the construction. The inspection of the façade indicates large exposure to weather and wind, since exterior damages can be seen on the façade facing the street. The condition of the bricks was better on the façade towards the courtyard than on the other one.

The façade facing the street has an extra window pane added on the inside of the existing windows. The original window frame was kept and with an external cover layer so that the wooden frame is no longer visible, but the original shape of the window remains. The walls are unchanged with the original brick wall with different thickness dependent on the floor level. The façade facing the inner courtyard is not so different from the façade towards the street. There is no added insulation, the window construction is the same as for the other façade. The entrance doors of the building are original from 1932. The foundation is a crawl space underneath the bottom slab due to uneven excavations underneath the building. The roof of the building was replaced due to water leakage. The original structure of the roof was kept and slightly improved with a double layered roofing felt. The roofing tiles are made of slate [11].

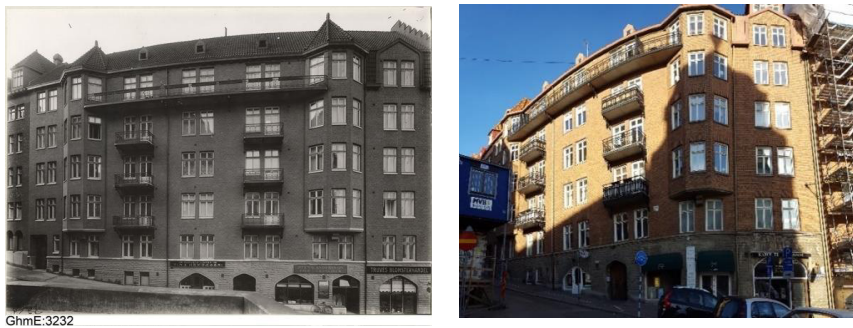
GhmE:3232

Fig. 6. Case study building 3 is a brick building of National Romantic style located on Föreningsgatan 34. Left: Photos show before (left) and after (right) renovation.

The more renovated building, see Fig. 6, is situated in the inner city of Gothenburg and was built in 1929. The building contains rental apartments. Today the bottom floor consists of two shops and one restaurant. The façade facing the street is original with red bricks and the entrance doors are original. The attic has partly been re-constructed to create additional apartments. The only apparent exterior change is new dorm windows in the new attic seen in the far left in the picture, a change that has been approved by the Museum of Gothenburg. There is still a small unheated attic on top of the apartments, close to the ridge.

The original windows were changed around 1980, but the original windows were kept in the stairwell. The newer windows are chosen with the same design as the original in order to respect the architecture. On the façade facing the courtyard, 100 mm mineral wool was added on the exterior which was plastered. This added insulation unfortunately covers detailing on the eaves. The windows were kept in the same depth in the wall construction after the insulation was added. Many of these kind of houses had stucco on the façades heading to the yard in original. Therefore it is hard to say how far the façade is from its original appearance after the insulation was added. The only interior changes are re-painting and new wall papers [11].
