DEVELOPMENT AND TESTING OF A BALLISTIC
IMPACT LOADING DEVICE

A thesis submitted to the faculty of the University
of Utah in partial fulfillment of the requirements
for the degree of

Division of Materials Science and Engineering
Department of Mechanical Engineering
University of Utah

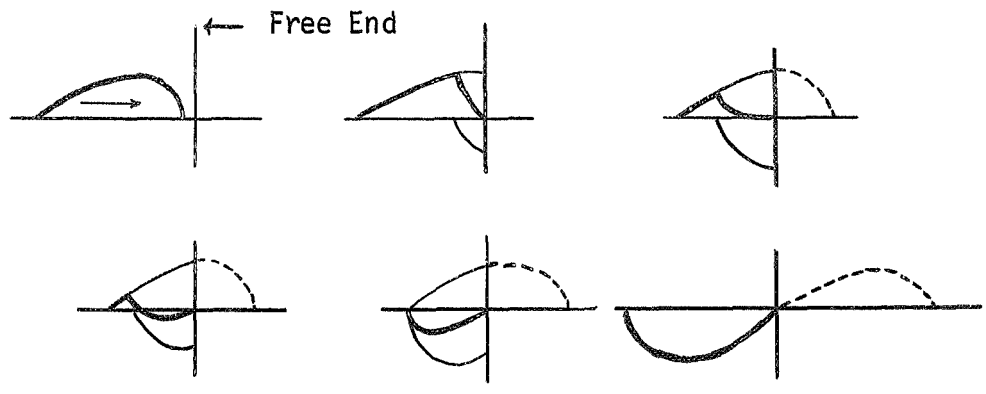
Figure 1. Reflection of irregular compression pulse at free end.

Now consider the stages when a plane compression pulse of arbitrary shape is reflected at a free surface, as shown in Figure 1. The resultant stress at any point in the media during reflection is obtained by adding the incident stress to the reflected pulses, designated by the thin line in Figure 1. The resultant stress is shown by the thickness line while the broken line refers to the reflected portion. This sequence of reflection covers the start, where only compression is present, to the finish where tension remains.

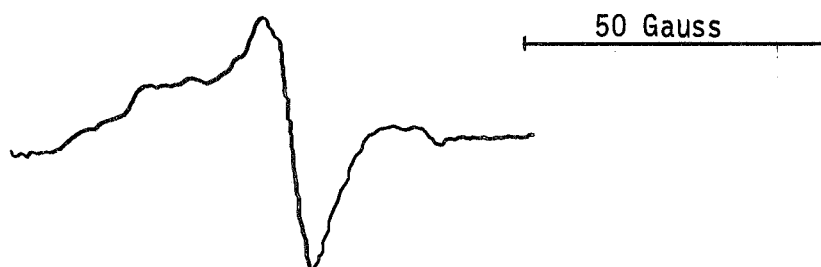
Figure 13. Free radical spectra of 0.250 in. diameter PMMA rod ballistically impact loaded: recorded at -150°C and a gain of 3×10^6 .

Attempts were made to obtain some measure of internal damage produced during ballistic impact loading of PMMA rods. EPR spectroscopy is a suitable technique for monitoring covalent bond rupture in polymers. A 1/4" drawn PMMA rod, commercial grade purchased at Plastic Products Company of Utah, Salt Lake City, was examined for a residual EPR signal. Figure 12 shows a typical residual spectra for the rod at - 150°C. Low temperatures are used to enhance any signal⁽³¹⁾ which might be present. To see the effect, if any, from ballistic impact loading, two rods were immediately examined after impact. The rods were quenched in a liquid nitrogen bath to preserve any damage introduced during impact. Neither of the specimens were fractured during impact. Figure 13 shows a representative spectra of the loaded rods. There was not a noticeable difference between the residual spectra and the test spectra. From this undefineable spectra, it was apparent that not enough damage was produced under this condition to be detected by the EPR spectrometer.

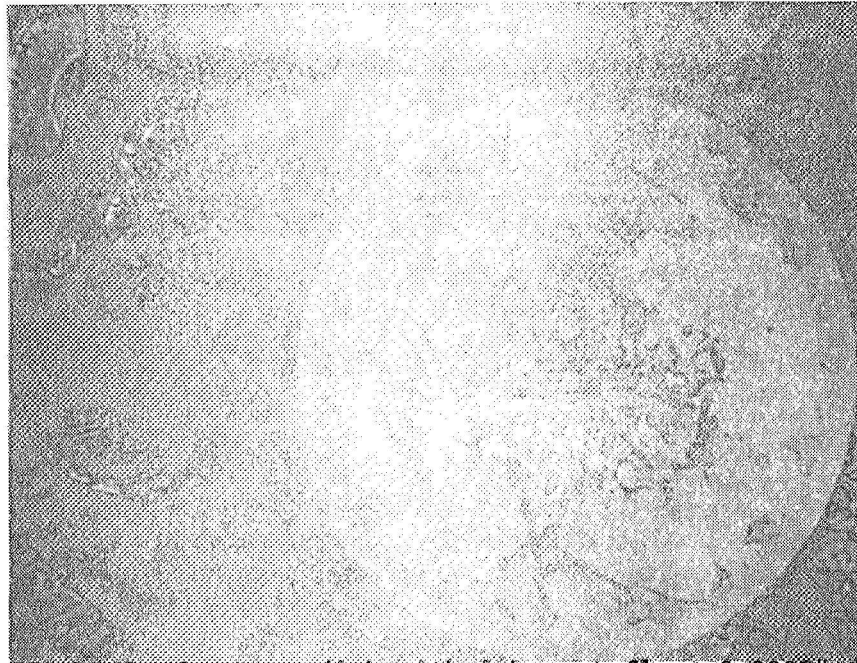
Figure 14. Solo fracture disk with inherent flaw, 0.0008" in diameter: 100X (Optical Microscope).

Approximately 30% of the fracture surfaces examined resembled the flaw region shown in Figure 14. The clear, flat, shiny, semi-circular area will be referred to as fracture disks. These fracture disks resemble "craze matter" observed by Kambour^(29,30) at incident angles between 44° and 55° in PMMA sheets. Careful examination of the rod, between loadings and before fracture revealed these "crazes" normal to the longitudinal axis. With each additional load, the number of these crazes increased. By recording their location with respect to the impact end, fracture did occur in a plane containing these sites or site.

In Figure 14 the fracture disk represents the fracture origin with the center acting as an inherent flaw, mentioned earlier.^(24,25) Optical measurements of these observed inherent flaws vary from 0.0008" to 0.002" in diameter depending upon individual fracture disks. The outer diameter of the fracture disk varies from 0.003" to 0.03".

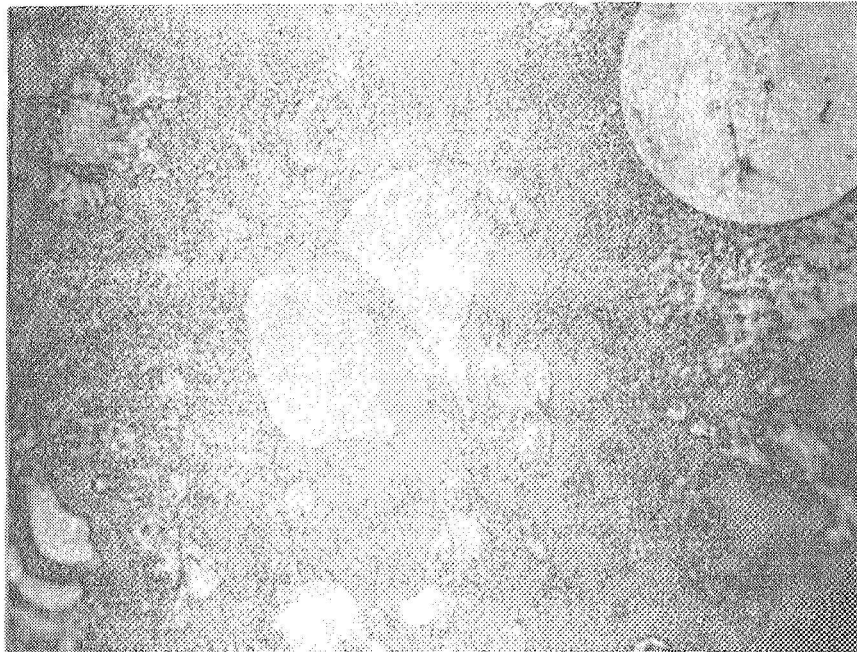
Figure 15. Solo fracture disk obscured by overlay and chipping out during fracture: 50X (Optical Microscope).

Figure 15 is a lower magnification optical photograph of the area surrounding and including Figure 14. Here, segments of fracture disks appear to overlap one another, while in fact, these segments are on different levels with portions chipped out. The small pieces that chipped out were recoverable, but extremely crumbly, making microscopic examination impossible.

The degree of surface roughness, with respect to mirror, mist, and hackle, as shown in Figure 4, includes the mirror only, in this fracture mode. Kies, et al.⁽²⁴⁾ observed PMMA fracture resembling a brittle fracture at high rates of loading due to many flaws becoming active. The area shown in Figure 15 includes several fracture disks suggesting a similar fracture mechanism.

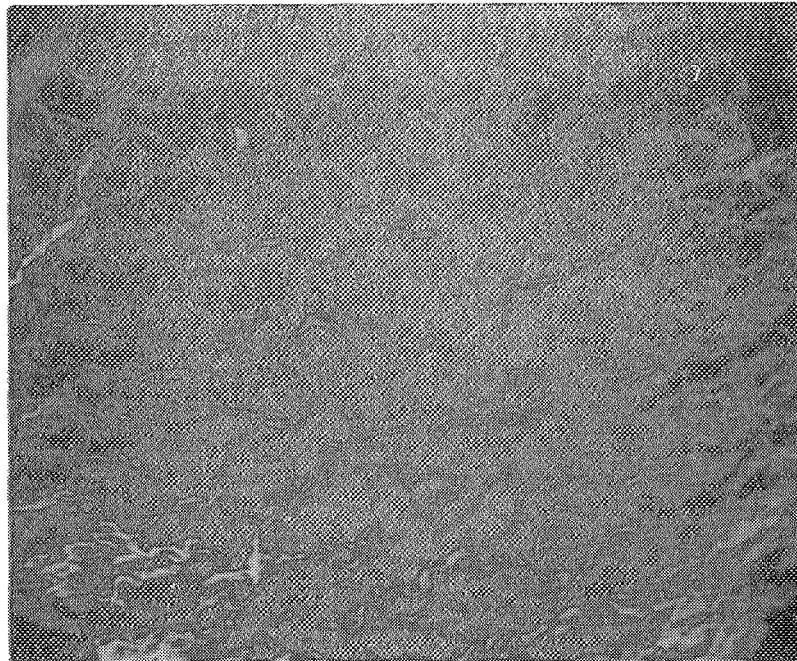
Figure 18. Representative low magnification scanning electron micrograph of Figure 17: 26X.

A scanning electron micrograph, Figure 17, shows the various levels of the flaw area. Figure 18 is a low magnification scanning electron micrograph to illustrate the drastic difference between the matrix and the fracture disk area.

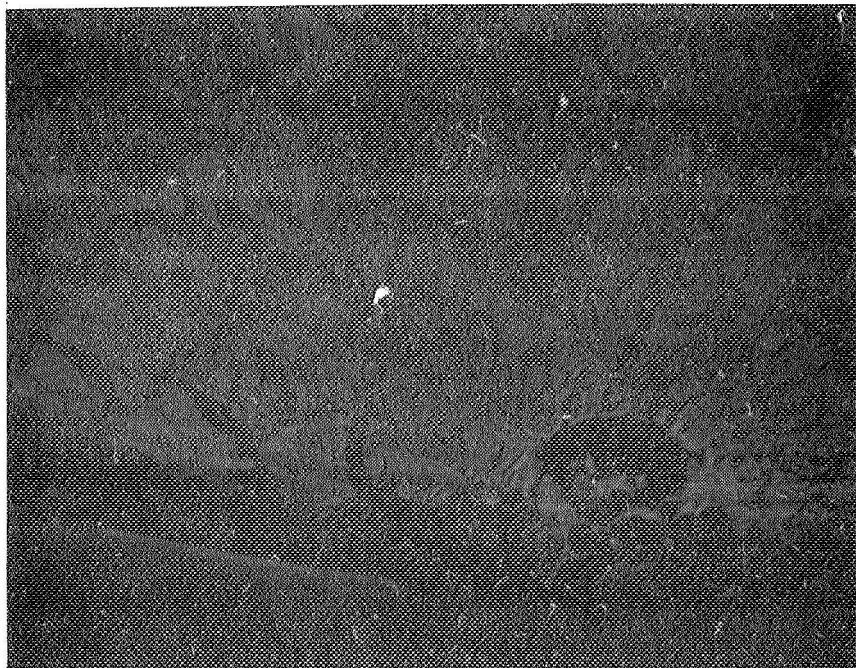
Figure 19(b). Surface flaw fracture disk initiation from inclusions approximately 0.006" in diameter: 100X (optical microscope).

disk pattern as in Figure 19-b. Here, large (approximately 0.006" in diameter) inclusions in 0.01" deep alter the fracture disk cyclic rings and obscure the origin. Even though both surface flaws have cyclic rings, the rings associated with the small inclusions are more regular and distinct than those surrounding the large inclusions. In general, there exists not more than two such patterns per fracture surface. This particular fracture initiation demonstrated the significance of surface conditions in studying fracture. The individual regions shown here, as described by Zandman, are identical to those described in failure mode 2.

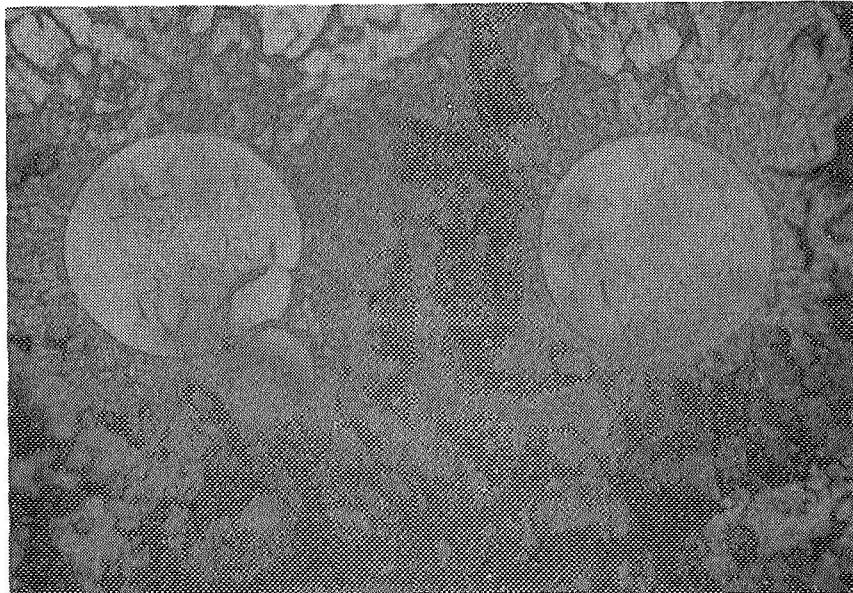
Figure 22. Solo fracture disks as found on rod photographed with a 16 mm camera: 50X (Optical Microscope).
