The construction of Kangerlussuaq Airport - A case story from West Greenland

Ingeman-Nielsen, Thomas; Foged, Niels Nielsen

Proceedings of the XI. International Conference on Permafrost

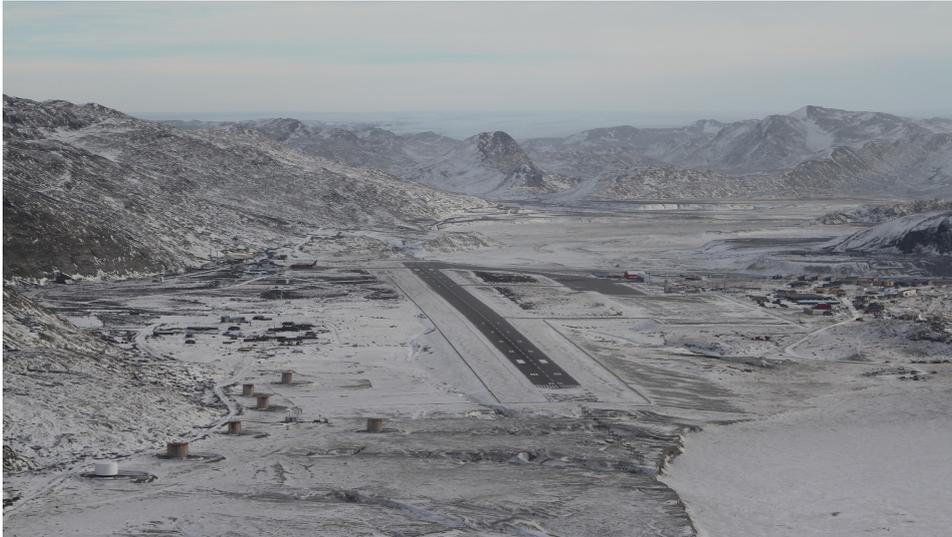
Figure 1: Aerial view of the Kangerlussuaq airport and surrounding settlement situated on a river terrace in a marine delta at the head of the Kangerlussuaq fjord.

The airport and supporting settlement (see figure 1) is situated in the rather complex geological setting of a marine delta in the valley system east of the head of the Kangerlussuaq fjord. The delta deposits formed during ice marginal retreat from the area approx. 7-8 ka BP, in a period of rapid sea level fall, and range from fine grained marine silt and clay deposits to coarse grained (sand, gravel and stones) river deposits. The combination of a relatively narrow valley confinement and rapid sea level fall, resulted in successive periods of fast depositional infill and subsequent erosion, leaving a system of distinct river terraces [Storms et al., 2012]. The major part of the Kangerlussuaq village, airport structures and runway are located on one such river terrace at an elevation of approximately +50 m.a.s.l., however, the western part of the runway extends onto a slightly sloping plateau of fine grained sediments (clays and silts) of marine origin at an elevation of +30 to +20 m.a.s.l. and dated around 6000 yr BP. Younger eolian deposits in the silt and fine sand fraction are wide spread in the area.
