# A gradient surface produced by combined electroplating and incremental frictional sliding

Published in: I O P Conference Series: Materials Science and Engineering

Publication date: 2017

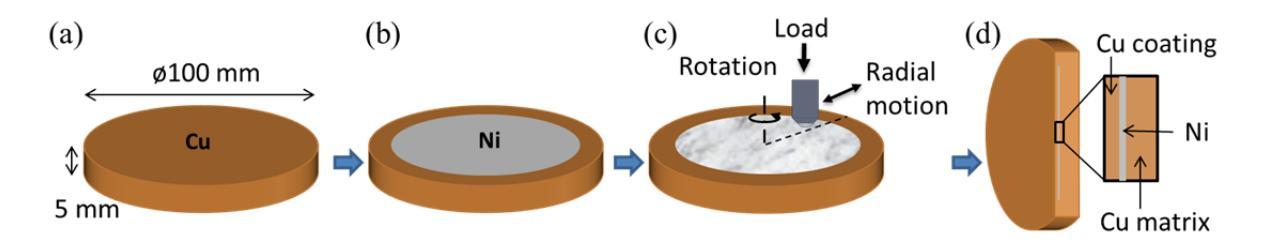
**Figure 1.** Schematic of the experimental procedure. (a) Geometry of the Cu plate, (b) electroplating of Ni, (c) deformation by IFS, and (d) coating of protective Cu on the processed surface. The marked and magnified area in (d) indicates the area for microstructural and hardness tests.

A phosphorus-deoxidized Cu plate (figure 1), 100 mm in diameter and 5 mm in thickness, was ground on one surface and then annealed at 600 °C for 2 h to obtain a fully recrystallized state (Vickers hardness 46 ± 3). The main impurities are 0.007Zn-0.024P-0.002Fe-0.002Ni (wt%) as measured by spark optical emission spectroscopy (OES). The central part (80 mm in diameter) of the ground surface was etched for 20 s in a solution containing H<sub>2</sub>SO<sub>4</sub>, HNO<sub>3</sub> and HCl to remove the oxide layer and to enhance bonding, during which the edge and the other side of the surface were protected by a Lacomit varnish. Ni was then electrodeposited on the etched surface of the Cu plate. A duration of 6 minutes with a current of 0.5 A at 55 °C (cathode current density 1 A/dm<sup>2</sup>) led to a thickness between 1 and 2  $\mu$ m (slightly thinner in the center and thicker in the periphery). The water-based solution (pH = 4.5) contained NiSO<sub>4</sub>·6H<sub>2</sub>O (310 g/L), NiCl<sub>2</sub>·6H<sub>2</sub>O (45 g/L) and H<sub>3</sub>BO<sub>3</sub> (37 g/L).

The electrodeposited surface of the Cu plate was then deformed by IFS close to liquid nitrogen temperature for 50 minutes at 200 rpm (figure 1c). To maintain a low temperature, the processing was carried out in 25 interrupted sessions. For each session, the plate was first submerged in liquid nitrogen and then processed for a relatively short duration of 2 minutes without further cooling. During each session, the load (about 100 N) along the normal direction (ND) was moved manually back and forth in the radial direction for about 100 times while the plate was rotating [5]. After deformation a bulging of the entire disk was visible, due to the extension of the processed surface along the radial direction, resulting in a bending of the disk.

Microstructural observations and hardness tests of the processed plate were carried out on the tangential section (perpendicular to the radial direction) containing the sliding direction (SD) and the ND, at locations between 20 and 35 mm from the center of the plate (figure 1d). For preparation of the tangential section samples, the processed surface was protected by electroplating of Cu, which was done at room temperature for 25 hours (cathode current density 3 A/dm<sup>2</sup>) using a solution containing CuSO<sub>4</sub>·5H<sub>2</sub>O (72.7 g/L), H<sub>2</sub>SO<sub>4</sub> (225 g/L) and NaCl (98.7 mg/L). Tangential section samples were prepared by mechanical polishing, with a colloidal silica suspension (0.04  $\mu$ m) used for the final polishing step. The microstructure was investigated using both electron channeling contrast (ECC) and electron backscatter diffraction (EBSD) in a Zeiss Supra 35 scanning electron microscope equipped with a field emission gun. For EBSD analysis, a step size of 50 nm and a cutoff misorientation angle of 2° were used. Vickers hardness tests were carried out on a Struers DuraScan-70, using a load of 245 mN. The Vickers hardness has a high reliability but as the indent diagonal was between 16 and 26  $\mu$ m in the current case, nanoindentation tests were therefore also carried out in a Hysitron TI 950 TriboIndenter with a maximum load of 2 mN in order to probe the hardness gradient at the top surface.

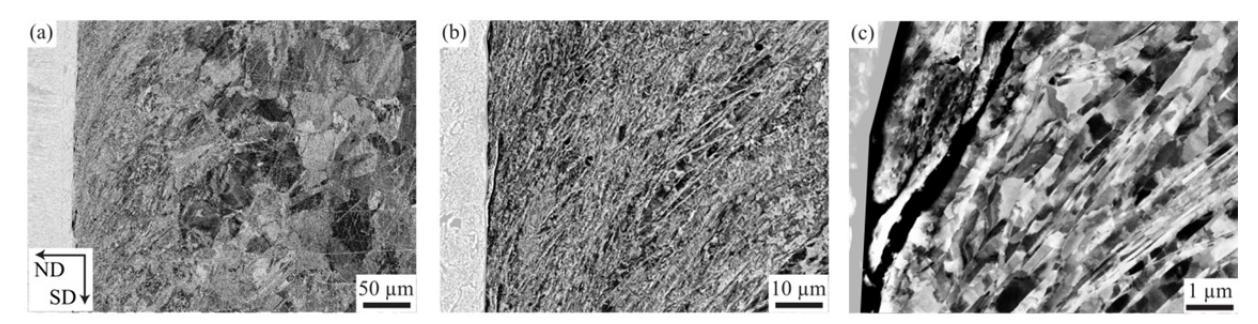
Figure 2. ECC observations at the tangential section of the processed sample at different magnifications. The light shaded area in the left part of each micrograph corresponds to the Cu protective coating.

The combination of electroplating and IFS led to a structural refinement of the processed surface layer. Figure 2 shows examples of ECC observations at the tangential section at different magnifications. The deformation is highly heterogeneous, and the thickness of the heavily deformed zone varies between 5 and 80  $\mu$ m, below which the initial grain boundaries are discernible. Typically, the top layer of about 40  $\mu$ m is heavily deformed (figure 2a). This top layer shows a finely spaced lamellar structure, and the extended lamellar boundaries are inclined on average at 30° to the surface, with boundary spacings varying from a few tens of nanometers to a couple of hundred nanometers.

The strain at the topmost layer of 5  $\mu$ m is highest. It can be seen from figure 2 that the surface has been ploughed and folded. The ploughed volume has a thickness of 3-5  $\mu$ m, and this ploughing and folding occurred approximately every 30-40  $\mu$ m along the SD. The ploughing and folding can be best observed from the distribution of the coated Ni layer by energy dispersive X-ray spectroscopy (EDS). Figure 4 shows the morphology of the Ni layer before and after surface deformation. Before deformation, there is a uniform Ni layer on the top of the Cu plate (figure 4a,b); after deformation, the Ni layer is extended and thus overlapped (as a result of the folding) in some places (figure 4c,d).

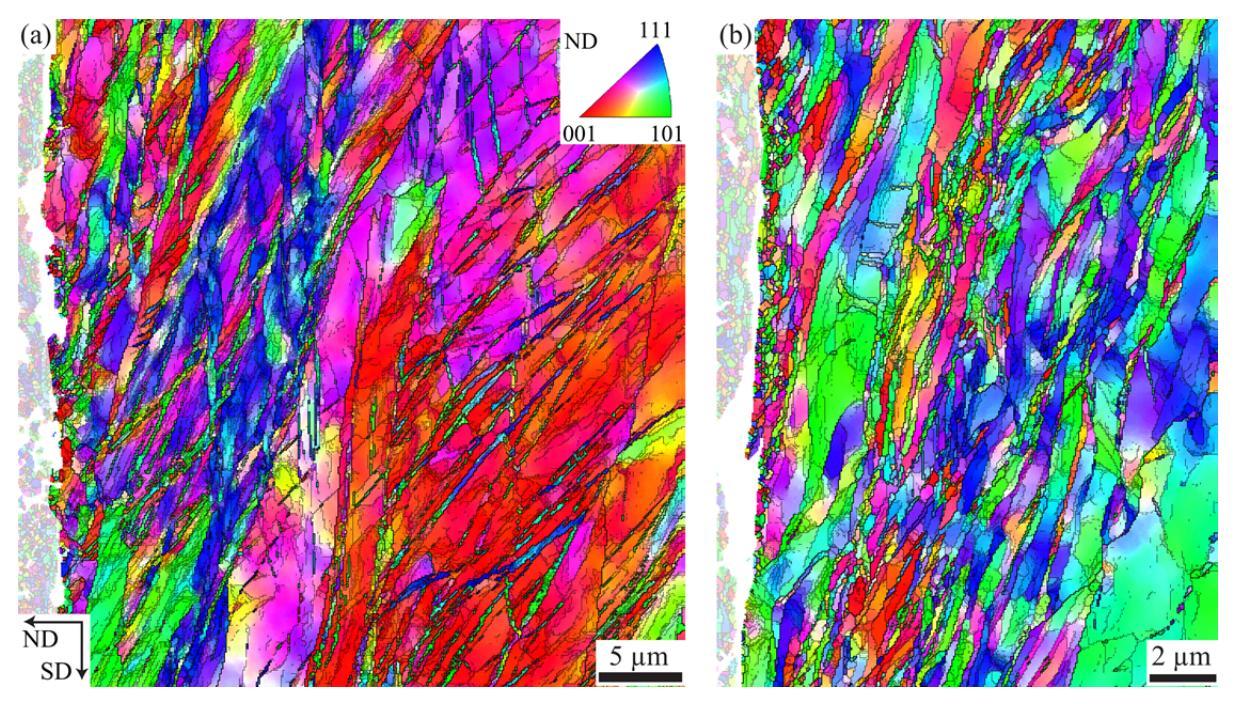
**Figure 3.** EBSD observations at two different locations at the tangential section of the processed surface layer. The colour is coded according to the orientation of the ND, and the Cu protective layer at the surface is shadowed. High angle boundaries (>15°) are shown by thick lines and low angle boundaries (2-15°) are shown by thin lines.

EBSD investigations were carried out in order to study the details of the nanostructured top surface layer, and two examples are shown in figure 3. The fraction of high angle boundaries (>15°) was found to be around 50%, and their distribution was highly heterogeneous. The deformation structure

depended strongly on the initial grain orientation. For some grains, well-defined lamellar structures are developed with a high fraction of high angle boundaries, whereas for others, the structure is relatively coarse and contains nanoscale twins. For the top layer of 40  $\mu$ m, the average boundary spacing measured along the ND in regions of well-defined lamellar structure is about 180 nm. However, the real lamellar boundary spacing is smaller since they are not perpendicular to the ND and many boundaries may be undetected due to the limited spatial and angular resolution of the EBSD technique.

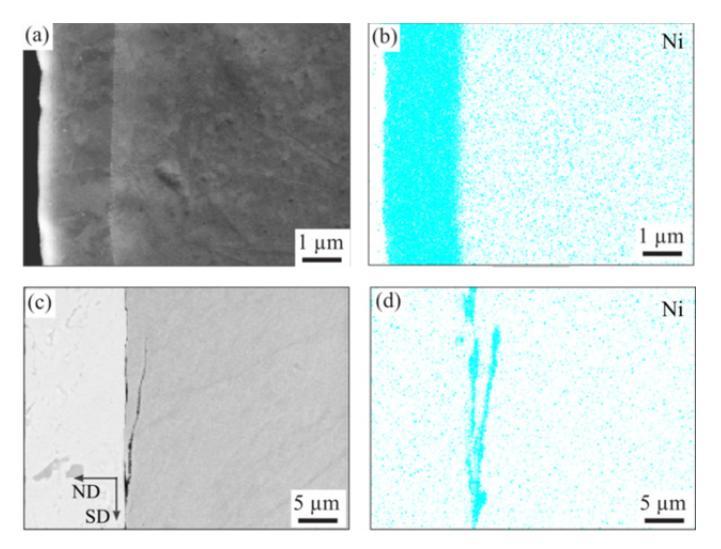
**Figure 4.** Morphology and Ni distribution observed in the tangential section of the surface layer before IFS (a,b) and after IFS (c,d). Note that there is no Cu protective coating in (a), whereas the Cu protective coating in the left part of (c) is seen in light grey. Note the scale bars are different between (a,b) and (c,d).

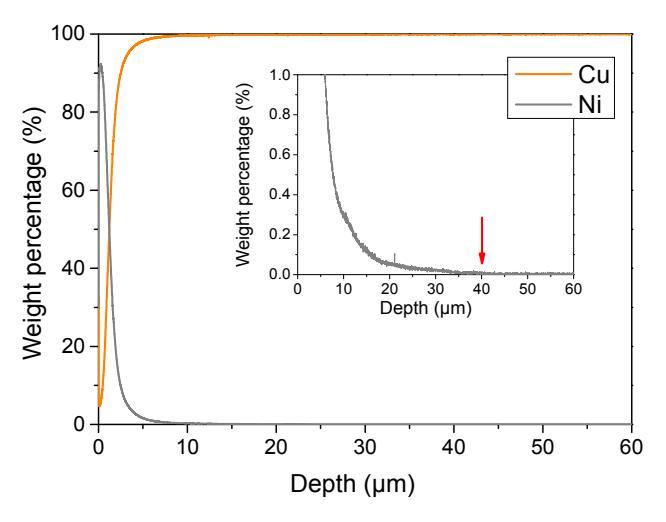
Figure 5. Depth profile revealing diffusion of Ni into the heavily deformed Cu matrix.

EDS is able to differentiate the Ni layer from the Cu matrix, but it cannot accurately detect the amount of Ni diffused into the Cu matrix. The diffusion of Ni was characterized instead by glow-discharge OES, as shown in figure 5. The result shows that on average Ni has diffused to a depth of  $40 \,\mu\text{m}$  through mechanical alloying, in agreement with the thickness of the heavily deformed surface layer.

Ni has diffused into the heavily deformed Cu layer to a depth of about 40  $\mu$ m (see figure 5). The diffusion is assumed to have occurred during deformation, i.e. through mechanical alloying. During deformation at liquid nitrogen temperature, a high concentration of excess vacancies may also be present, which could enhance diffusion rates. More importantly, a high density of dislocations were created and forced to move, leading to long-distance travel of Ni atoms associated with moving dislocations [7]. On the other hand, thermally activated diffusion through the Cu lattice before deformation and through boundaries and dislocations after deformation are negligible during storage at room temperature.

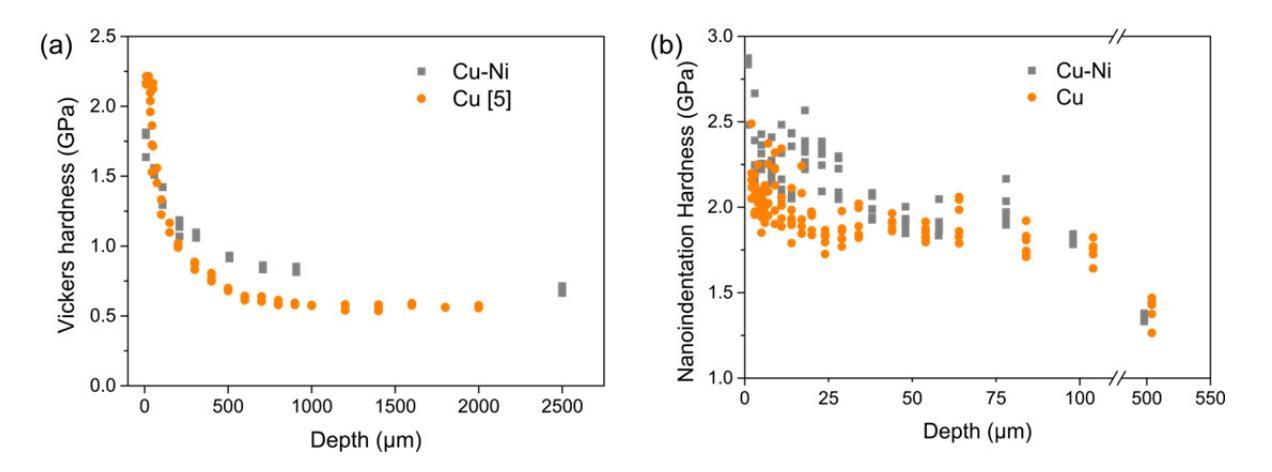
**Figure 6.** Vickers hardness (a) and nanoindentation hardness (b) profiles of two IFS processed Cu plates, one with Ni coating (Cu-Ni) and the other without Ni coating (Cu).

The hardness profile of the processed plate has been characterized by Vickers hardness and nanoindentation tests as shown in figure 6 (data in grey), where the Vickers hardness number has been converted to GPa by multiplying 0.0098, to be consistent with a previous study [5]. The hardness decreases gradually from the surface to the bulk interior. Nanoindentation tests resulted in higher hardness values than Vickers hardness tests due to both indentation size effects and different calculation algorithm [6], but the trend is nevertheless similar. The highest hardness ( $2.8\pm0.2$  GPa) was recorded 1 µm away from the surface by nanoindentation tests, probably due to the very fine microstructure and a mixture of Ni and Cu. The Vickers hardness at the thickness center ( $0.70\pm0.02$  GPa) has also increased from the fully recrystallized state ( $0.45\pm0.03$  GPa) as the entire plate was bent during deformation.

The diffusion of Ni in to the Cu gives rise to a solute strengthening. However, the direct strengthening contribution is typically considered to be small, and therefore the higher hardness measured at the top surface layer in the Ni-coated plate as shown in figure 6b is not likely to be due to solute strengthening. Compared to the Vickers hardness measurements, nanoindentation tests are more sensitive to residual stresses [6], and thus besides heterogeneity, the presence of higher compressive residual stresses in the current Cu-Ni plate may also contribute to the higher nanoindentation hardness measured in that plate.
