9<sup>th</sup> International Masonry Conference 2014 in Guimarães

# Earth-based mortars for masonry plastering

FARIA, PAULINA<sup>1</sup>; SANTOS, TÂNIA<sup>2</sup>; SILVA, VITOR<sup>3</sup>

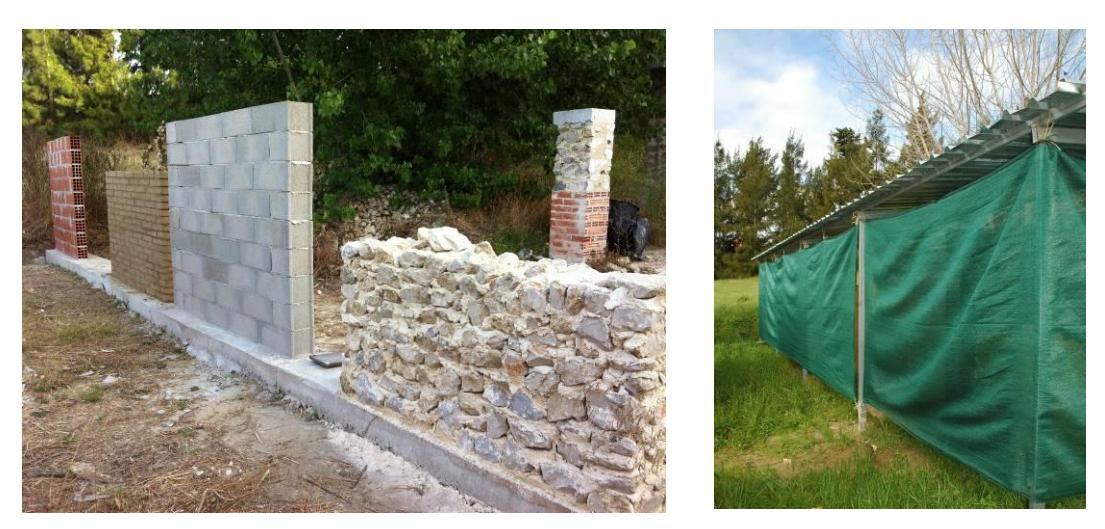
**Figure 1.** Four masonry test walls, yet unprotected – from the front to the back, rubble stone, concrete blocks, adobe and hollow bricks (left); protection of the experimental walls after plastered (right)

one month before the application of the plaster, during summer time, and were left unprotected. The dimensions of the surfaces of the walls varied between 1.0-1.8 m height and 1.2-2.2 m length and the experimental walls can be seen in Figure 1 - left.

The earth mortar was not chemically stabilized with any mineral binder and, for that reason, could be affected by rainfall. The plastered masonry test walls were protected by a continuous top covering with 2.2m two months after being completed. Fortunately there was not much rainfall during that period. Nevertheless and even with the top covering, as the South wind is very strong at the Experimental Station, it could be observed that degradation occurred at the underside of the south facing plaster panels, due to insufficient protection from rainfall. For that reason, a protection net was afterwards vertically positioned on the lateral sides of the test walls' covering (Figure 1 - right).

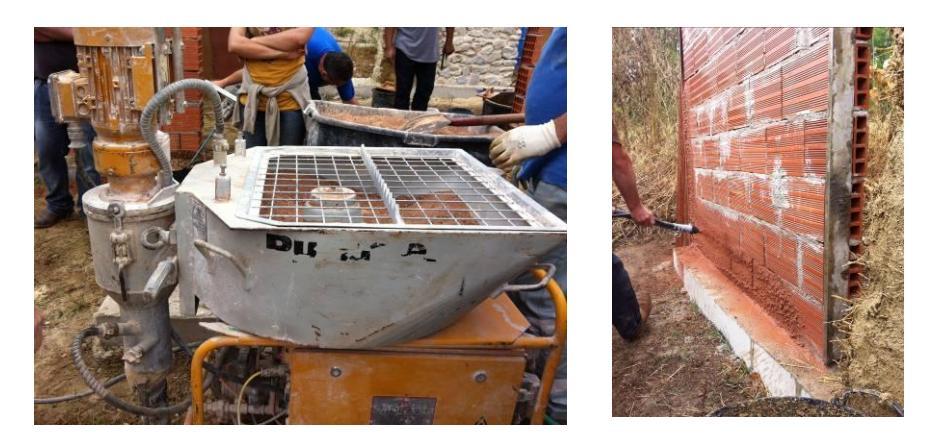
Figure 2. Mechanical mixing (left) and application (right) equipment

A simple concrete foundation was prepared and left to dry (Figure 2 – left). Four different masonry test walls were made over the foundation, without any damp proof layer: rubble stone with limestone and air lime mortar, concrete blocks with cement mortar, adobe blocks with earth mortar (the same earth used to produce the blocks) and hollow bricks with cement mortar. The test walls were made

A commercial earth mortar, constituted by a clayish earth, sand with particle size distribution between 0-2mm and oat fibres with 1-2cm longer, was mechanically prepared with a quantity of water to allow an easy application, by a mechanical equipment (Figure 2 - left), and finishing (Figure 2 – right).

The mortar was directly applied on the four masonry test walls, after being sprayed with water (Figure 2 – right, for the brick wall). The plaster was easily levelled with a screed (Figure3, for the brick wall). The thickness of all the plasters was around 2cm.

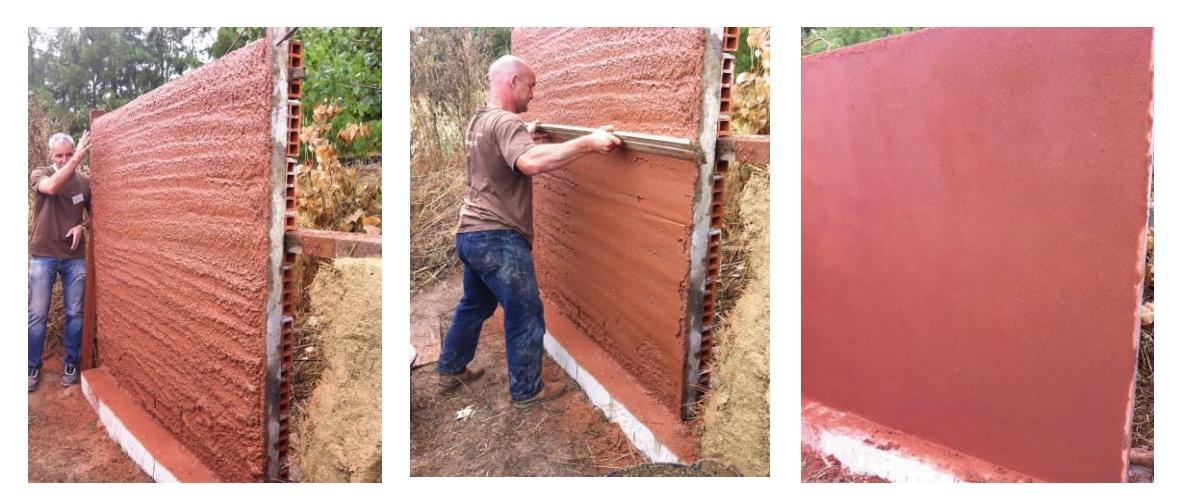
**Figure 3.** Commercial earth plaster on the hollow brick test wall after projection (left), being levelled (middle) and finished (right)

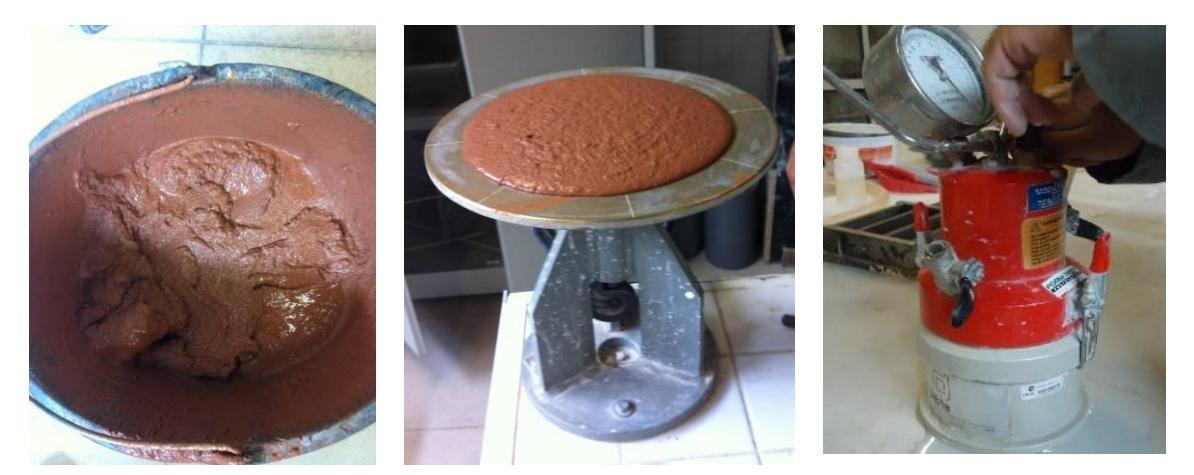
Figure 4. Fresh mortar (left), consistency flow table test (middle) and air content determination (right)

Alongside, the mortar was characterized in laboratory in the fresh state (Figure 4 – left), in terms of flow table consistency (Figure 4 - middle), bulk density, water content and air content (Figure 4 - right). Several mortar samples were produced with the same commercial earth mortar, from the same *in situ* batch. Prismatic 40x40x160 [mm] samples were mechanically compacted in two layers on metallic moulds and superficially levelled (Figure 5 – left). Circular samples, with 60mm diameter and 15mm thickness, were produced in plastic moulds and manually compacted (Figure 5 – middle). For the production of samples of mortar on hollow brick, the bricks were previously water sprayed, the mortar were left to fall from 70 cm height to simulate the *in situ* application energy and then superficially levelled, presenting a mortar thickness of 1.5cm (Figure 5 – right).

As said before, the mortar's workability was remarkably, both *in situ* and in laboratory. The flow table consistency was 178.8±2.5 mm (Figure 4).

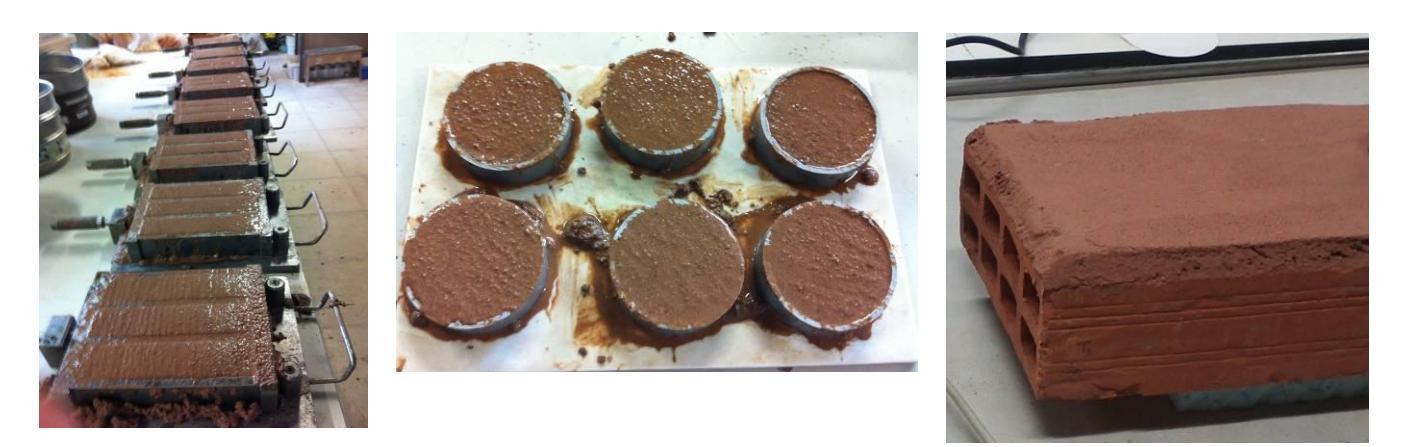
Figure 5. Prismatic (left), circular (middle) and on hollow brick mortar (right) samples

The prismatic and circular laboratory samples were let to dry for several weeks and then de-moulded. Together with the mortar samples on brick, they were placed in a laboratory with  $65\pm5\%$  relative humidity (RH) and  $20\pm3^{\circ}$ C temperature.

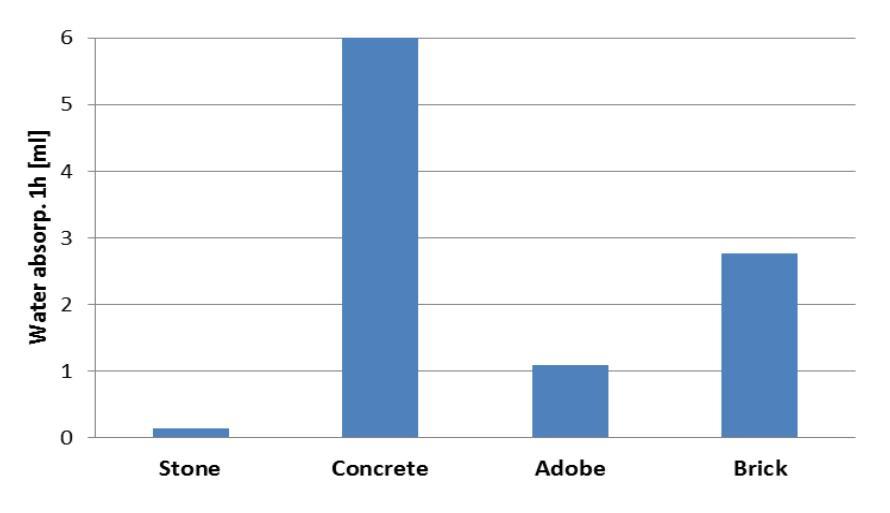
Figure 6. Water absorption under low pressure of the masonry materials

The water absorption under low pressure was determined by Karsten tubes for the four masonry units: the limestone of the rubble stone masonry, the concrete block, the adobe block and the hollow brick. Results of water absorption after 1 hour test are registered in Figure 6. The absorption of the concrete blocks was so high that turned difficult the measurement of the water intake. In fact the water of each karsten tube (4ml) was immediatly absorbed by the concrete blocks and the maximum water absorption presented in Figure 6 is only indicative.

Particularly the total water absorption of the rubble stone masonry (with higher percentage of masonry mortar) but also of the other masonries will be affected by the water absorption of the correspondent masonry mortars. For that reason, the masonry units water absorption (Figure 6) is only indicative of the water absorption global behaviour of the masonries.

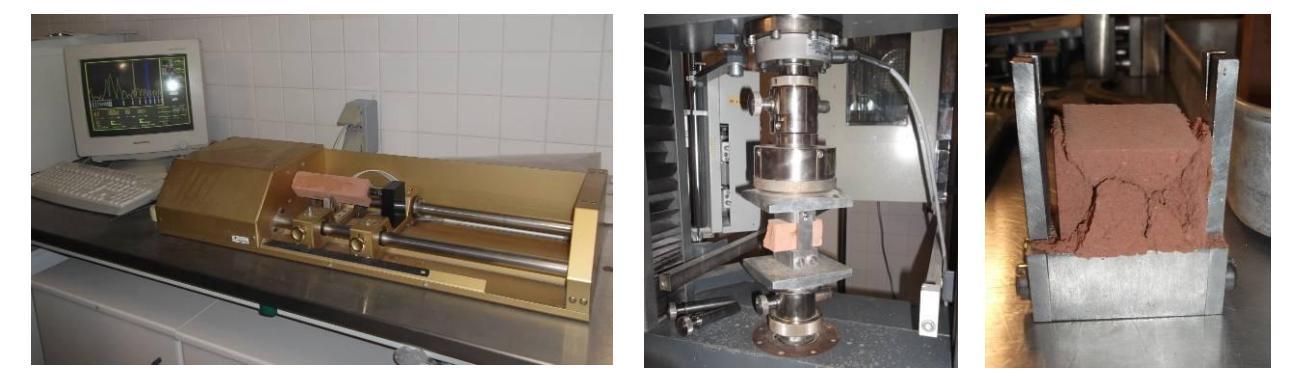
**Figure 7.** Sample being tested for dynamic modulus of elasticity (left) and for compressive test - being tested (middle) and conic fracture (right)

The dry bulk density D of the hardened mortar was determined based on DIN 18947 [4], by measuring and weighting of the prismatic samples, in equilibrium at 65% RH and 20°C temperature. The dynamic modulus of elasticity Ed was determined based on EN 14146 [10], using a Zeus Resonance Meter equipment (Figure 7 - left) and, according to DIN 18947 [4], the flexural and compressive strength, FStr and CStr (Figure 7 – middle and right), were determined based on EN 1015-11 [5]. Results, in terms of average and standard deviation, are presented on Table 5.

According to Table 1, the mortar is classified in dry bulk density class 1.8. In terms of strength class, the mortar cannot be classified, as the adherence test had not been performed. But flexural and compressive results indicate that the mortar may be classified as S I.

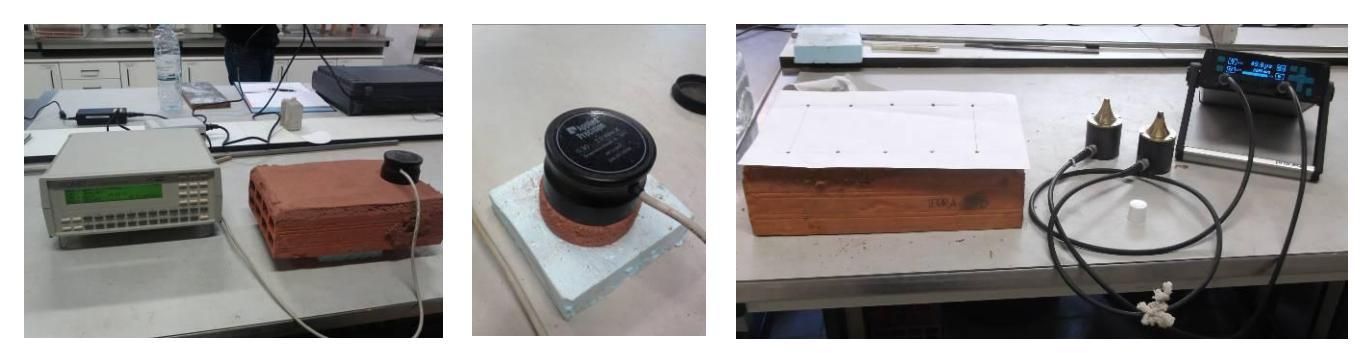
**Figure 8.** Mortar on brick (left) and circular samples (middle) being tested for thermal conductivity and equipment for ultra-sound determination (right)

The thermal conductivity of the earthen mortar on laboratory samples was determined at 65% RH and 20°C temperature by a Heat Transfer Analyser Isomet 2104 equipment, with a 60mm contact probe API 210412. The equipment test specification requires a minimal thickness of 1.5cm of the sample. The thermal conductivity  $\lambda$  was determined with the circular samples but also with the mortar samples on hollow brick (Figure 8 – left and middle). Results, in terms of average and standard deviation, are registered on Table 6.

The ultra-sound velocity on the samples of mortar applied on brick (Figure 8 – right) and on plaster panels on the experimental wall (Figure 9 - left) was determined with a Proceq Pundit Lab equipment, conic transducers and a frequency of 54 Hz, based on LNEC test specification Fe Pa 43 [14]. Through this test the compactness and the presence of eventual defects (like cracks or detachments) can be detected. The thickness (from the surface) of material that is analyzed depends on the

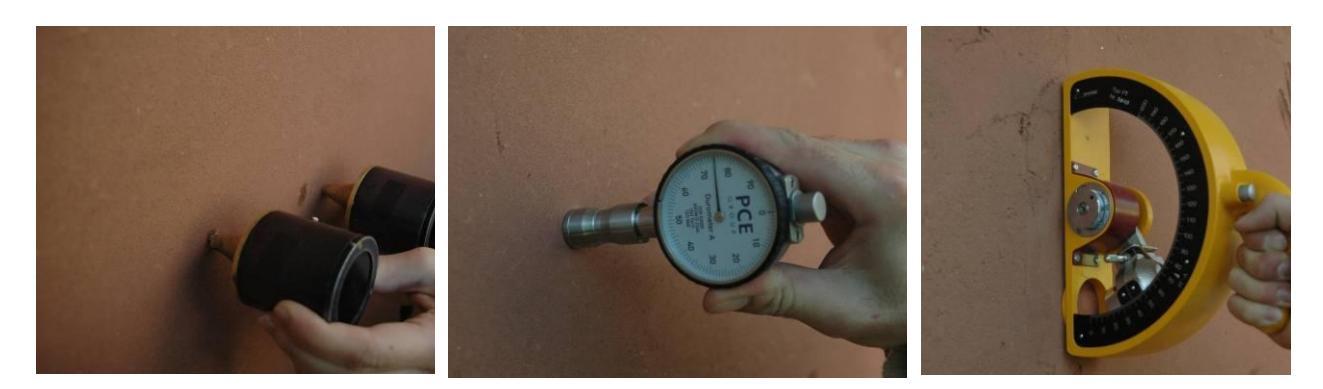
Figure 9. Ultra-sound (left), durometer (middle) and sclerometer (right) tests on plasters on the masonry test walls

The surface hardness was determined with a PCE durometer Shore A (Figure 9 - middle), based on ASTM D2240 [15], and with a pendular sclerometer Schmidt PT (Figure 9 - right), based on ASTM C805 [16]. The sclerometer was only applied on the plaster panels and not on the brick mortar samples because the impact of the test could damage these last samples.

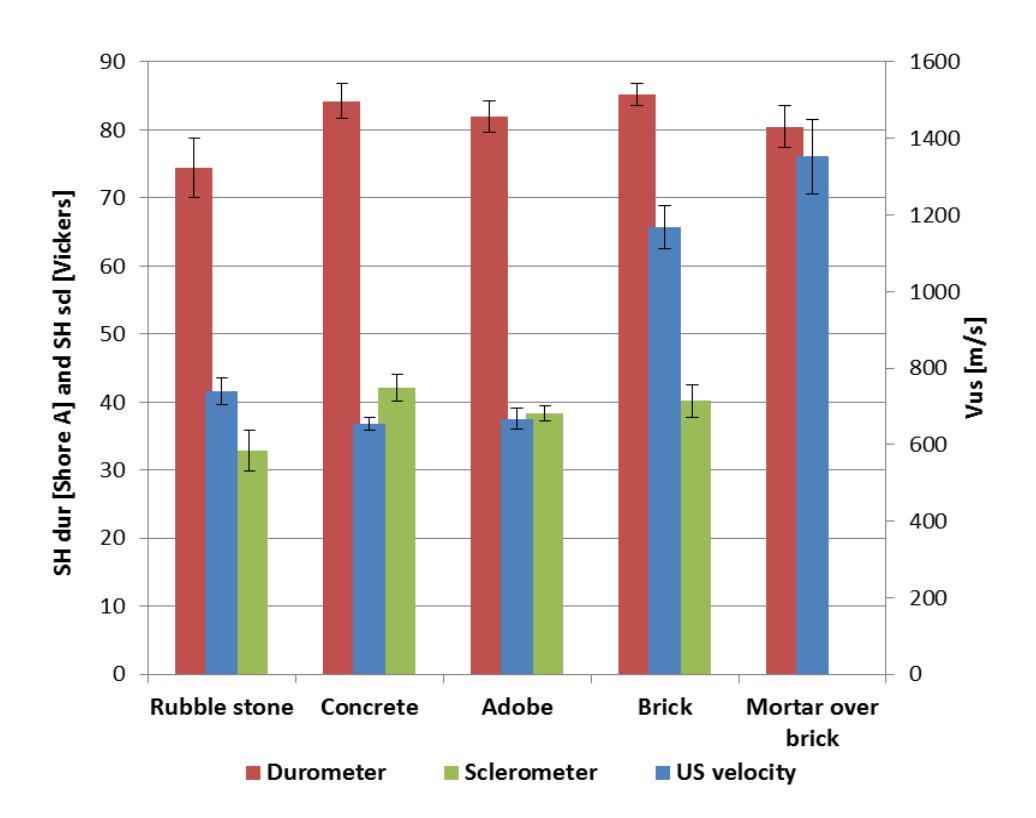
**Figure 10.** Ultra-sound velocity ( $V_{us}$ ) and surface hardness by durometer (SH<sub>dur</sub>) and by sclerometer (SH<sub>sc</sub>) of the plasters on the masonry test walls and on samples of mortar on brick

The average and the standard deviation results of ultra-sound velocity, surface hardness by durometer and sclerometer are presented in Figure 10.

It can be noticed that the ultra-sound velocity is much higher when the mortar is applied on brick masonry (and on brick samples), compared to the other types of masonry. This may be due to the fact that rubble stone and adobe masonries are compact walls. The concrete blocks also present a much higher thickness of the superficial face, compared to hollow brick, which ceramic shell does not even achieve 1 cm thickness. Comparing the brick masonry with the concrete block masonry it can also be due to the fact that the water absorption under low pressure of the concrete blocks is much higher than the one of the bricks (Figure 6). For that reason, the mortars' microstructure may be differently affected by the type of masonry. This aspect will have to be further studied, namely by porosimetric tests, in the continuity of the present study. It can also be mentioned that the standard deviation is higher for brick samples. That can be due to the fact that, when the transducers are more distant from each other, it is more probable that the ultra-sound can reach the shells of the individual bricks in the samples. This is due to the fact that the mortar layer is a little less thick compared to the plasters on the brick masonry wall.

Concerning the superficial hardness, both by durometer and pendular sclerometer, it can be noticed that results, although in different scales, indicate the same tendency: the surface hardness seems to be lower for the plaster applied on the rubble stone masonry, while it is similar for the plasters applied on concrete, adobe and brick masonries.

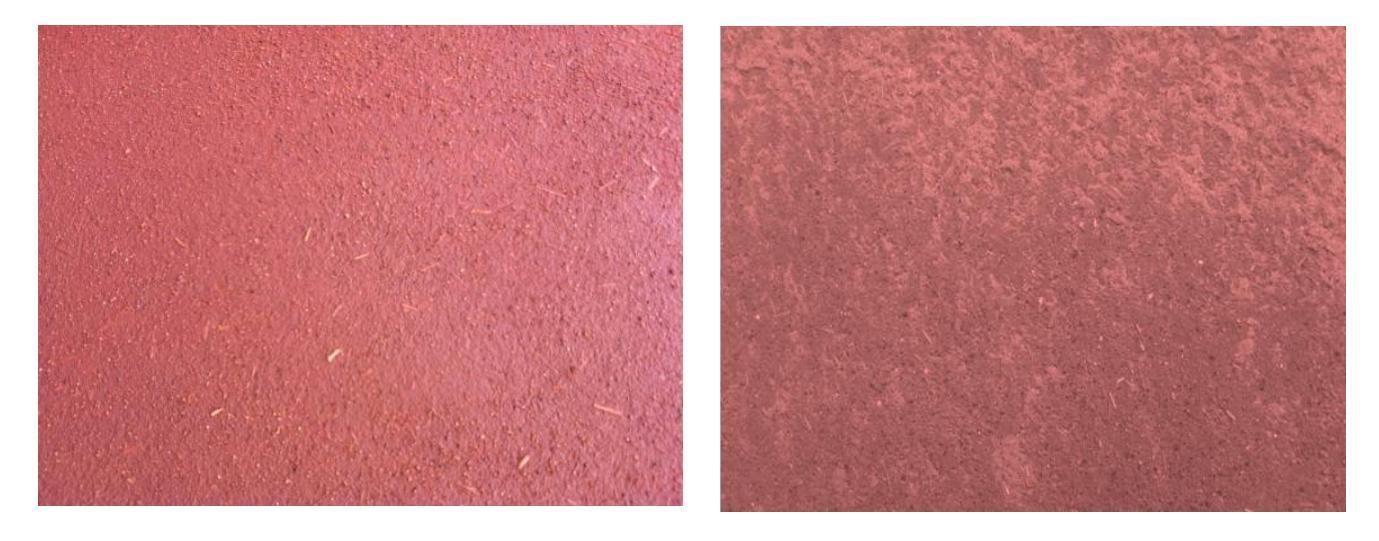
**Figure 11.** Visual observation of the plaster applied on one of the experimental masonry walls: protected area (left) and unprotected area (right)

The plasters applied on the test walls were visually observed throughout six months and the following points should be mentioned. As said before, degradation occurred on the underside of the plasters facing south, due to rainfall projected by wind before the protective net was applied. A reduction of clayish particles could be observed, being the particles of sand more visible (Figure 11 – right) in comparison with the same plaster but in protected area (Figure 11 – left). As expected and defined by the producer, this mortar can be applied as plaster but not currently as render. As render it can only be applied when completely protected from rainfall. In all the surfaces, in exterior environment but water protected, no degradation was noticed.

Finally, the natural pigmentation of the plaster and its texture, with the effect of the vegetal fibres, must be mentioned (Figure 11- left). The fact that it does not need to be coated by a paint system for aesthetic reasons may eliminate the consumption of resources. At the same time the uncoated surfaces of the plasters will be able to contribute for the regulation of the relative humidity of the interior environment [17].
