Munoz Cuartas, Victor and Perrin, Marianne and Pastor, Marie-Laetitia and Welemane, Hélène and Cantarel, Arthur and Karama, Moussa *Application of non destructive testing to the detection of aeronautical defects in composite structures*. (2013) In: International Conference of Nonconventional Technologies, 12 June 2013 - 15 June 2013 (Sibiu, Romania).

# APPLICATION OF NON DESTRUCTIVE TESTING TO THE DETECTION OF AERONAUTICAL DEFECTS IN COMPOSITE STRUCTURES

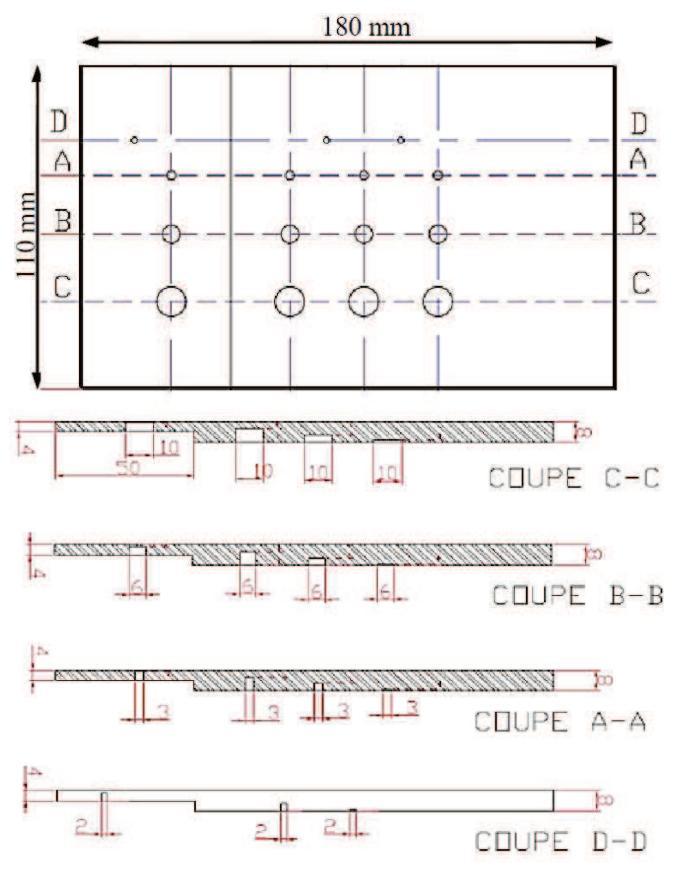
Figure 1. Manufacturing drawing of the specimen A

The specimen used to compare the detectability and accuracy between the IRT and the US is a carbon/epoxy laminated composite with flat bottomed holes defects and variable thickness. It is called specimen A (figure 1). This sample is divided in 2 sections. The first one is 4 mm wide in 50 mm long. The second section is 130 mm longwith 8 mm wide. This sample contains 15 holes with diameters ranging from 2 mm to 10 mm. These holes have different depths (from 0.52 mm to7.5 mm). The aim of these holes is to simulate discontinuity on the specimen that is considered as a continuous medium.

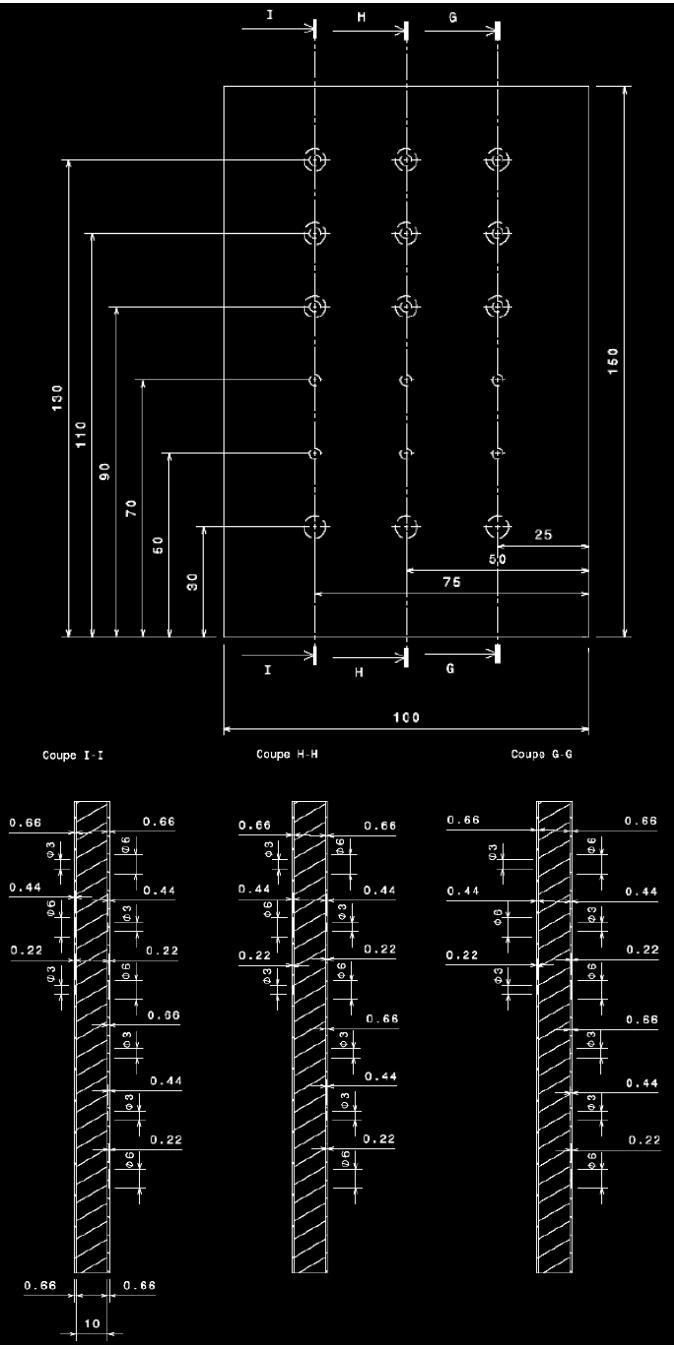
Figure 2. Manufacturing drawing of the specimen B

The second sample, called specimen B, was only tested with infrared thermography because of its material properties. This specimen is a carbon-glassepoxy skin with foam-core sandwich composite including Teflon inserts. Its skin is 0.66 mm thick. It has been demonstrated that the foam-core is a sound insulation; thereby the ultrasonic waves cannot penetrate this specimen and be detected by the receiving transducer [5]. This specimen contains 18 defects. These simulated flaws are Teflon inserts ranging from 3 mm to 6 mm. They are located at the skin section. These inserts were placed during the stacking of the tissues so that they simulate as well as possible a delamination within the sample. The manufacturing drawing of this specimen is shown in figure 2.

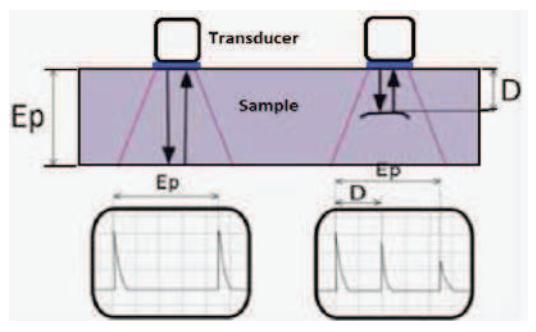
Figure 3. US configuration

In ultrasonics, the sound energy is introduced and propagates through the material in the shape of waves. When there is a discontinuity (such as inclusion, delamination or disbonding) in the wave path, part of the energy will be reflected back from the flaw surface. The reflected wave signal is turned into an electrical signal by the transducer and is displayed on a screen. The configuration used on this US testing is called reflection mode(figure 3). One transducer is used to send and receive the wave at the same time.

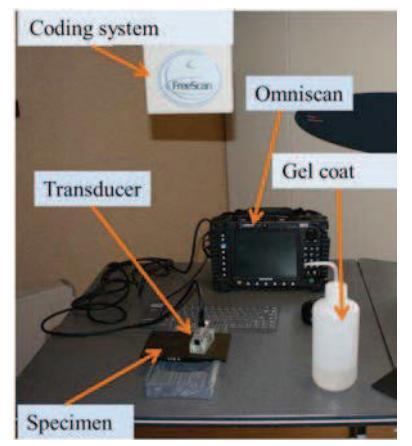
Figure 4. Ultrasonic measurement

In this study, anOmniscan 32: 128 PR is used with a 5L64-NW1 multi-elements transducer connected to it. The transducer is both ultrasonic source and receiver at the same time. The frequency ofit is 5 MHz, which is the common frequency in aeronautics NDT [5]. For specimen A, the wave velocity is 2983 m s<sup>-1</sup> with a standard deviation of 5.7 m s<sup>-1</sup>. This experiment was carried out by contact; therefore it is necessary to use a coating gel between the sample and the transducer. Ultrasonic testing enables two-dimensional mapping, accordingly a coding system is used to detect the position of the transducer. Specimen A was placed in a support to hold it while the experiment was being carried out. Figure 4 shows the ultrasonics device.

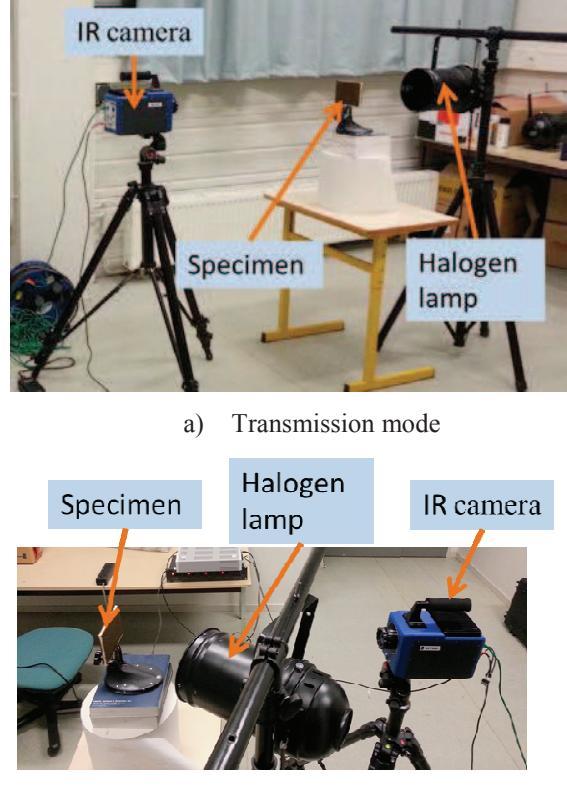
b) Reflection mode Figure 5. Infrared measurement

The heat source is a 1000 W halogen lamp. It is used configurations: transmission two and in reflectionmode (figure 5). Specimen A and B were tested in both modes (figure 5a and 5b). The infrared sensor was an IR camera with thermal resolution of 20 mK. A 30 s and 50 Hz movie was recorded in which 15 s corresponds to the heating of the sample and the 15 last seconds to its cooling. These times are long enough to heat the sample and make defects to appear in the thermal mapping. Defects are visible while the heating and cooling of the sample. The treatment of the movie was done with the ALTAIR software. The analysis of the movie is done in relative mode with the purposeto remove the ambient temperature and all environmental noise.

On the other hand, it is clearly noticed that IRT is very limited to large thicknesses. Defects are not visible beyond 2.8 mm in a carbon-epoxy laminated composite because heat diffusion inside the material does not reach the inspected surface in transmission mode (figure 5a). However, by the use of lock-in IRT, the thicknessreachedcomes to 5.2 mm in reflexion mode (figure 5b). At any rate, diameter of defects also affects the detectability in IRT. Figure 8b and 9 show that flaws located in the same range of deepness with different diameter are not all detected. The heat diffusivity inside the materialdoes not lead to enough temperature difference in the surface of the sample.

For the carbon-glass-epoxy skin with foam-core sandwich composite, the use of infrared thermography is quite difficult since the foam is a thermal insulator. It is recommended to control the 2 skins of the sandwich separately and in reflection mode (figure 5b).Otherwise, the heat flux may not arrive to the detection surface.

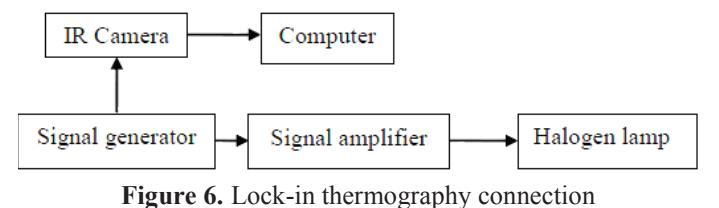
Lock-in IRT was also used on both specimens. In lock-in IRT temperature modulation induced at the surface of the inspected component from the outside propagates as a harmonic thermal wave. Lock-in IRT allows a better defect inspection than common IRT and it is less sensitive to environmental conditions [8]. The connection of the lock-in IRT is detailed on figure 6. A signal generator is also needed in addition to the classical IRT.

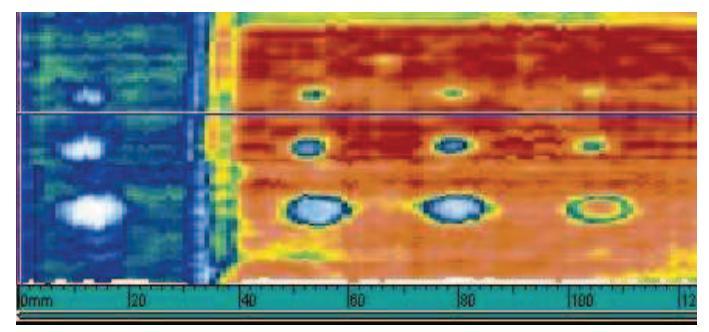
Figure 7. C-Scan mapping on specimen A

Figure 7 shows the C-Scan mapping for this specimen in which measurements were done.

The size of defects was measured with a visual rule. In this case it is said that there is a defect where the colour of the health part changes and becomes a circular spot with another colour.

The C-Scan mapping in US shows that detectability is more affected by the diameter of defects rather than thickness. This detection becomes more difficult when the defect is close to the detecting surface and to the backwall(less than 1 mm). In this case the defect echo is coincident with the echo of the detection surface.

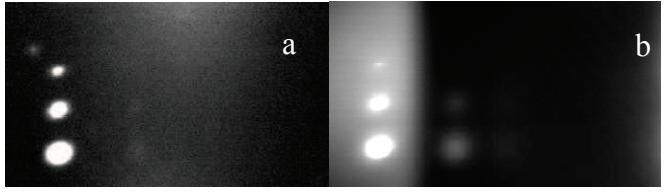
Figure 8. IRT mapping of specimen A

As in US test, two parameters were taken into account to analyse the results: detectability and accuracy. A single picture must be selected from the recorded film. That selection depends on the quality of the image for each defect. In this study, for specimen A, 2 different images in transmission mode (figure 8) were selected to measure 2 ranges of defects located in two different sections of the specimen. These ranges of defects are located at 0.52 mm and 2.8 mm deep respectively and they are in the 4 mm width section and 8 mm width section of the sample. Figure 8 shows that only 6 from the 15 defects, were detected using classical IRT in transmission mode.

Defects at 0.52 mm deep were measured using image 8a and those at 2.8 mm deep using image 8b. In figure 8b it is noticed that heat saturation is generated after a short period of time. The 4 mm width section is rapidly saturated and in the 8 mm width section, no other defect is revealed with the increasing temperature.

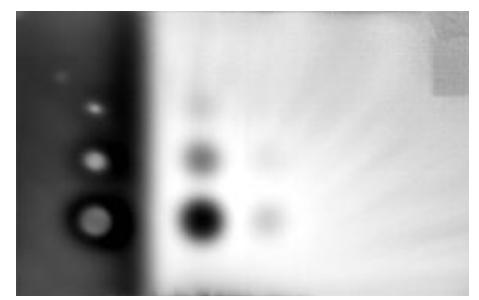
In lock-in IRT, the number of detected defects in specimen A increased. Best results were obtained in reflection mode and with 0.1 Hz frequency. However, no measurement of their size was done because of the poor temperature contrast. In addition to classical IRT (with transmission mode), 3 mm diameter defect at 2.8 mm deep and 5.2 mm deep defects (6 and 10 mm diameter) were visible as shown in figure 9.

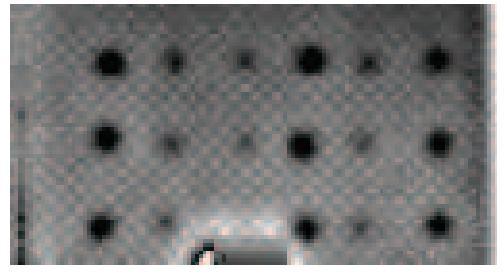
Figure 10. Lock-in IRT in specimen B

In the case of specimen B, lock-in IRT leads to similar results as classical IRT. All defects were detected and they could be measured in diameter (figure 10).

Better results were obtained at 0.1 Hz for both specimens tested in lock-in IRT. It was found that the textured surface of specimen B was confounded with the defects in IRT mapping. Measurements

Defects located at the camera side were easily distinguished whereas, defects located on the opposite side of the camera, were difficultly detected. That is way both skins of the sandwichwere tested. In addition, the dimension of the measurements was 2 or 3 mm larger than the real size of the defect. Table 3 shows the measured size for each range of defects.
