Case report

Microsurgical re-treatment of an endodontically treated tooth with an apically located incomplete vertical root fracture: a clinical case report

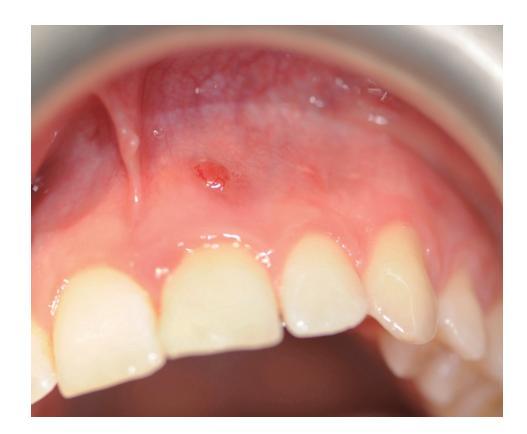
Figure 1. Clinical presentation at baseline. The presence of a sinus tract is evident.

A clinical examination showed a moderate swelling on the vestibular side in the region of tooth #21, as well as the presence of a sinus tract in the same area, approximately 4 mm from the gingival margin (Figure 1). A narrow periodontal defect 7 mm in depth was present on the buccal side, as evaluated using a periodontal probe. A radiographic examination performed before surgery using both periapical radiographs and CBCT (J. Morita MFG Corp., Kyoto, Japan) revealed a root-end resection, a periapical radiolucency, and a widening of the periodontal ligament space at the mesial aspect of the root, although no hair-like fracture line radiolucency was noted in the tooth, except in the CBCT horizontal projection that showed an incomplete VRF 3 mm from the apex (Figure 2).

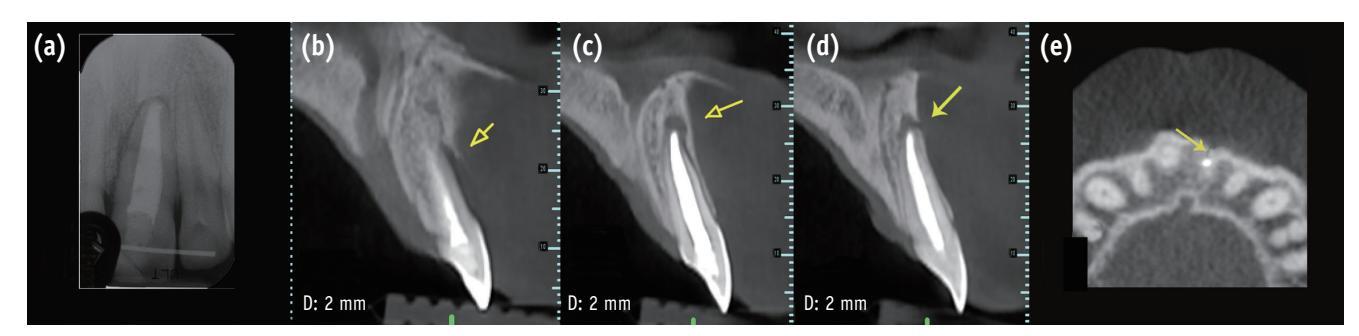
Figure 2. (a) Periapical radiograph and (b, c, d, and e) cone-beam computed tomography (CBCT) sections showing the presence of a periradicular lesion. (b, c, and d) The sagittal sections show the periapical bone defect; (e) the CBCT horizontal projection demonstrates the fracture line.

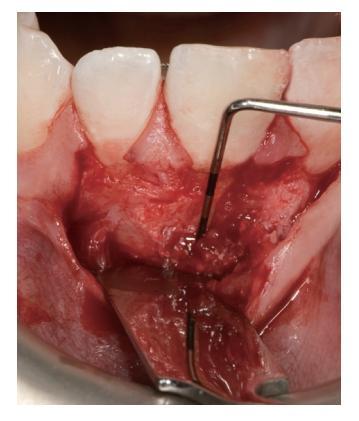
Figure 3. After flap elevation, the presence of the lesion was clearly detectable.

Following flap elevation, evidence of buccal bone fenestration was clearly detected (Figure 3). The granulation tissue was removed until the anatomical structures of the exposed root portion and the alveolar bone margins were clearly visible. After exposure of the root, the type of the fracture was determined using the microscope as a magnification device. In order to detect the extent of the fracture, 1% methylene blue dye was used as a marker (Figure 4).

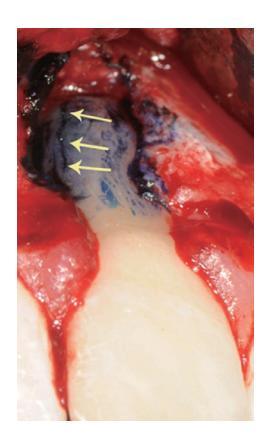
Figure 4. Visualization of the vertical root fracture on the root.

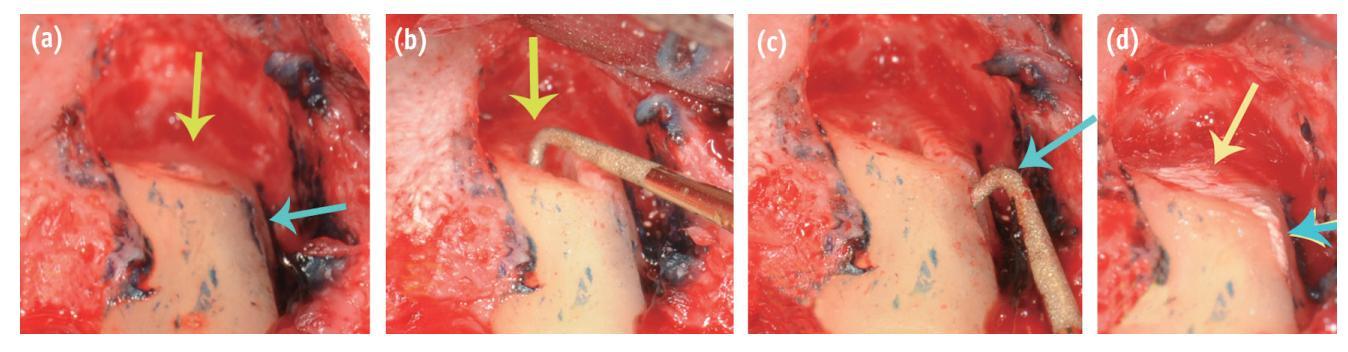
Figure 5. (a) After root resection, the root canal orifice is clearly visualized (yellow), as well as the small residual fracture line (blue); (b) The root-end preparation using a piezoelectric device is shown; (c) Groove preparation following the residual fracture line; (d) Filling of the created cavity.

A VRF involving the apical and partially the medial portion of the root was identified. The root end was removed by abrasion using a fissure bur at the desired angle (approximately 25°, in order to ensure direct visualization), removing more than two-thirds of the fracture line. A root-end cavity was prepared using a zirconium nitrate retro-tip (Dentsply Maillefer, Ballaigues, Switzerland) driven by an ultrasonic device unit (Piezon Master 700, EMS, Nyon, Switzerland, Figure 5).

The remaining part of the fracture line (approximately 2 mm) was treated using the abovementioned retrotip, and a groove was made following the remaining fracture line. In this way, an L-shaped cavity was created. The morphological integrity of the intracanal structure was carefully checked using a microscope (Carl Zeiss, Oberkochen, Germany) in order to avoid the possibility of fracture propagation on the other sides of the root.

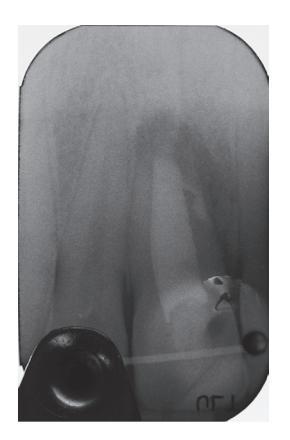
Figure 6. Radiograph taken immediately after surgery.

In order to mobilize the flap and facilitate its repositioning, periosteal incisions were performed, releasing muscle tension. The reflected tissues were then replaced into their original position and sutured with a non-resorbable 5-0 suture (Ethicon Inc., Piscataway, NJ, USA, Figure 6).

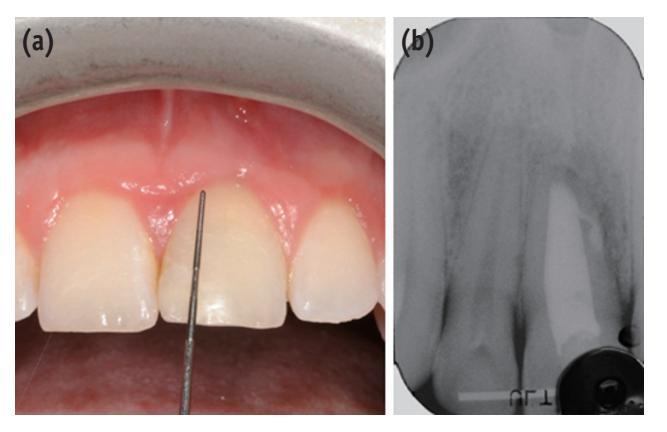
Figure 7. Results of clinical (a) and radiographic (b) examinations six months after surgery.

After 24 months of follow-up, the tooth was asymptomatic on clinical examination and a radiographic evaluation showed that healing was in progress (Figures 7 and 8).

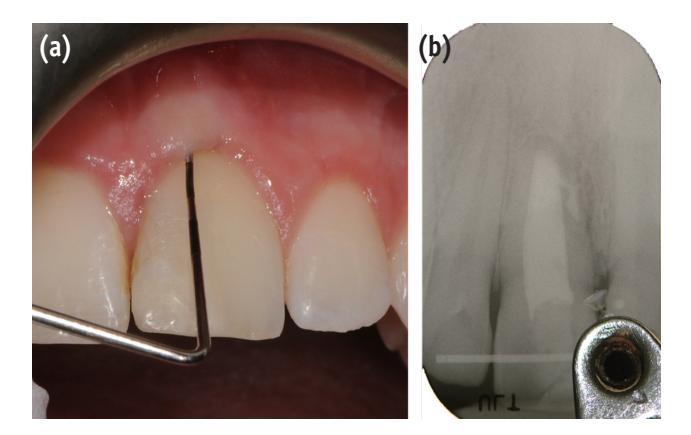
Figure 8. Results of clinical (a) and radiographic (b) examinations 24 months after surgery.
