# **RF BEAM DEFLECTION MEASUREMENTS AND CORRECTIONS IN THE SLC LINAC**

JOHN T. SEEMAR, MARC C. ROSS, JOHN C. SHEPPARD AND RAE F. STIENING

Stanford Linear Accelerator Center Stanford University, Stanford, California, 94905

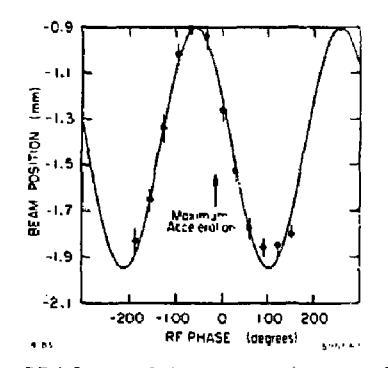
Fig. 1. RF deflections of a beam in an accelerator are observed as beam position changes downstream.

Small radial asymmetries in the RF fields in an accelerator will deflect beams transversely. The effects of these fields can be observed as beam trajectory errors downstream of an accelerator section, driven by a klystron. An example is shown in Fig. 1. In the SLC, both electrons and positrons are deflected in the same direction. Special static magnetic bumps are used to compensate for these deflections. Fluctuations in the RF power or phase will cause trajectory errors which cannot be corrected. Using the tolerances stated above and the fact that klystron phase and amplitude jitters can be kept below 0.5 degrees and 1%, respectively, RF deflections must be kept below 50 keV/c per klystron immediately downstream of the damping rings<sup>3</sup>, i.e., the RF fields must be aligned to one part in five thousand.

Measurements of RF deflections in the linac were made using the apparatus shown in Fig. 7. Without RF power the beam was steered to the center line of the girder under test. When the RF was applied the beam trajectory deviated (in general) from its nominal positions in two position monitors immediately downstream. From knowledge of the outgoing trajectory two effective RF kicks located at the one quarter and three quarters points inside the girder could be determined. Measurements were made as a function of RF phase allowing separation of the in-phase and out-of-phase components of the deficients. An example of a measurement is shown in Fig. 1. The beam energy in these tests was about 1 GeV. There were no magnetic fields in the region.

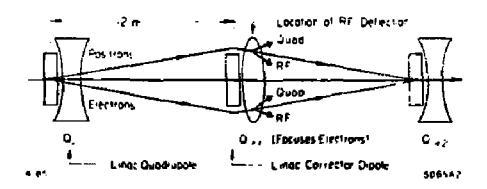
Fig. 2. A "magic" dipole bump corrects for static RF deflections given to electrons and positrons.

Identical RF deflections given to both electrons and positrons can not be corrected by a single dipole magnet which steers the beams in opposite directions. However, several dipole magnets with interspersed quadrupoles can form a "magic" dipole bump which can be used to correct the deflections. Several magic bumps have been invented<sup>4,5</sup>. An example is shown in Fig. 2. The bump capitalizes on the out-of-phase beta functions of the two oppositely charged beam in the linac FODO lattice. The three dipole correctors form a closed beam bump.

\*Work supported by the Department of Energy, contract DE-AC03-76SF00515 The kicks of the two beams in the central quadrupole exactly cancel those of the lumped RF deflections located there if the bump sign and amplitude are properly chosen.

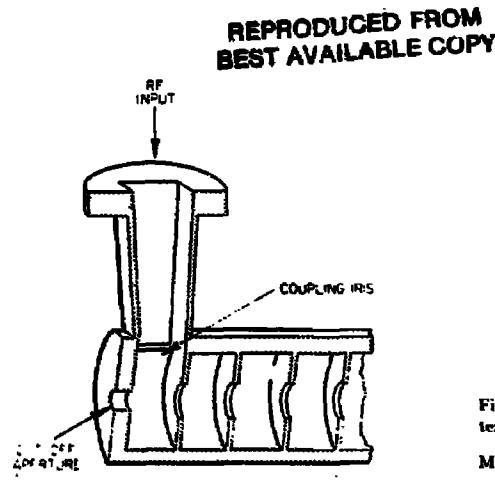
Fig. 3. SLAC diskloaded accelerator showing a cross section of the cavities and end coupler.

The power from a klystron is divided to feed equally four ten foot accelerator sections which are mounted on a forty foot girder. The single sided horizontal input and output couplers produce asymmetries in the RF fields in the first and last cells in the each section. A coupler and accelerator cavities are illustrated in Fig. 3. The deflections have been minimized in the SLAC accelerator by displacing the first and last cell radially and by orienting the eight couplers on a girder so as not to produce a net deflection or offset. Nevertheless, effects of the couplers have been observed<sup>6</sup>. A calculation<sup>7</sup> for SLC SLED II 50 MW conditions gives 20 keV/c deflections per coupler.

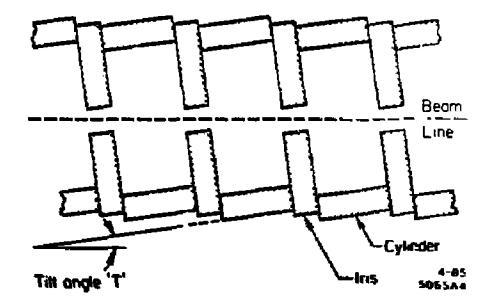
Fig. 4. Observed tilting (exaggerated) of the irises and cylinders of the SLAC disk-londed waveguide.

tilted as shown in Fig. 4. These tilts cause RF deflections. The tilted irises originated during manufacture from the tilts of the end coupler assemblies upon which the remainder of the accelerator was stacked before brazing, accumulations of small maching errors, or small captured dirt particles.

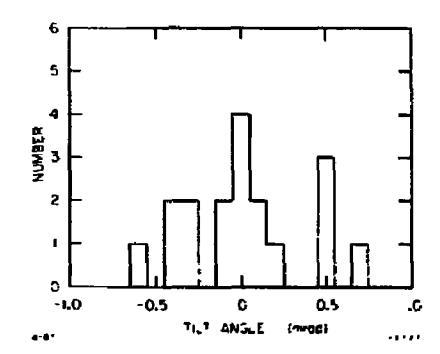
Fig. 5. Spectrum of measured tilt angles of an al SLAC ten-foot accelerator sections.

where c is the speed of light, a is the number of cells, and  $T_i$ and  $\delta E_i$  are the tilt angle and energy gain, respectively, for cell *i*. The SLC tolerances require that the average tilt angle for an accelerator girder be below 0.21 mrad early in the linac. The tilt angles for several ten foot sections have been measured<sup>8</sup> and the spectrum is shown in Fig. 3. Several of the accelerator sections exceed the specifications and must be exchanged.

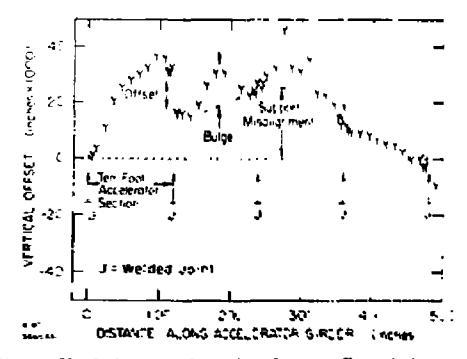
Fig. 6. Vertical survey of a girder, showing offsets, bulges, and intragirder support misalignments before corrections.

Mechanical misalignments can cause RF deflect vns. A laser monitoring system is used to slign the ends of the girders to better than 100  $\mu$ m over the length of the 3 km linac. Within a girder a local survey is used. Figure 6 shows the survey data of a girder with several problems: the wolded ioint between two accelerator sections has an offset, one acctit has a internal bulge, and the intragrider supports are misadjueed All of these effects have been removed from the first 300  $^\circ$  of the unact to a level of  $\pm 100 \ \mu$ m or about  $\pm 10 \ XeV/c$ .

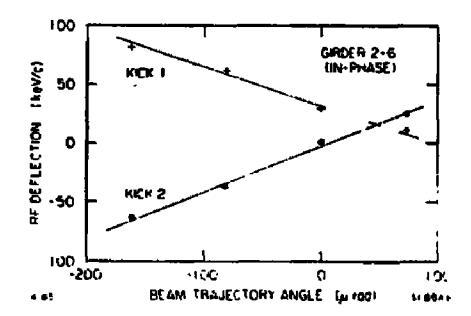
Fig. 8. Measured RF deflections versus beam trajectory angle through a girder extrapolated to SLED II 50 MW conditions.

'the RF kicks from beam trajectory errors in a girder have been studied on one girder. The measured kicks as a function of trajectory angle are plotted in Fig. 8. Additional measurements show that beam offset data look nearly the same. Clearly, beam trajectory errors (or girder misalignments) can cause sizable RF steering.
