Isle of Wight County, Virginia - Shoreline Inventory Report: Methods and Guidelines

Comprehensive Coastal Inventory Program Center for Coastal Resources Management Virginia Institute of Marine Science, College of William and Mary Gloucester Point, Virginia December 2017

Special report in Applied Marine Science and Ocean Engineering No. 465 of the Virginia Institute of Marine Science

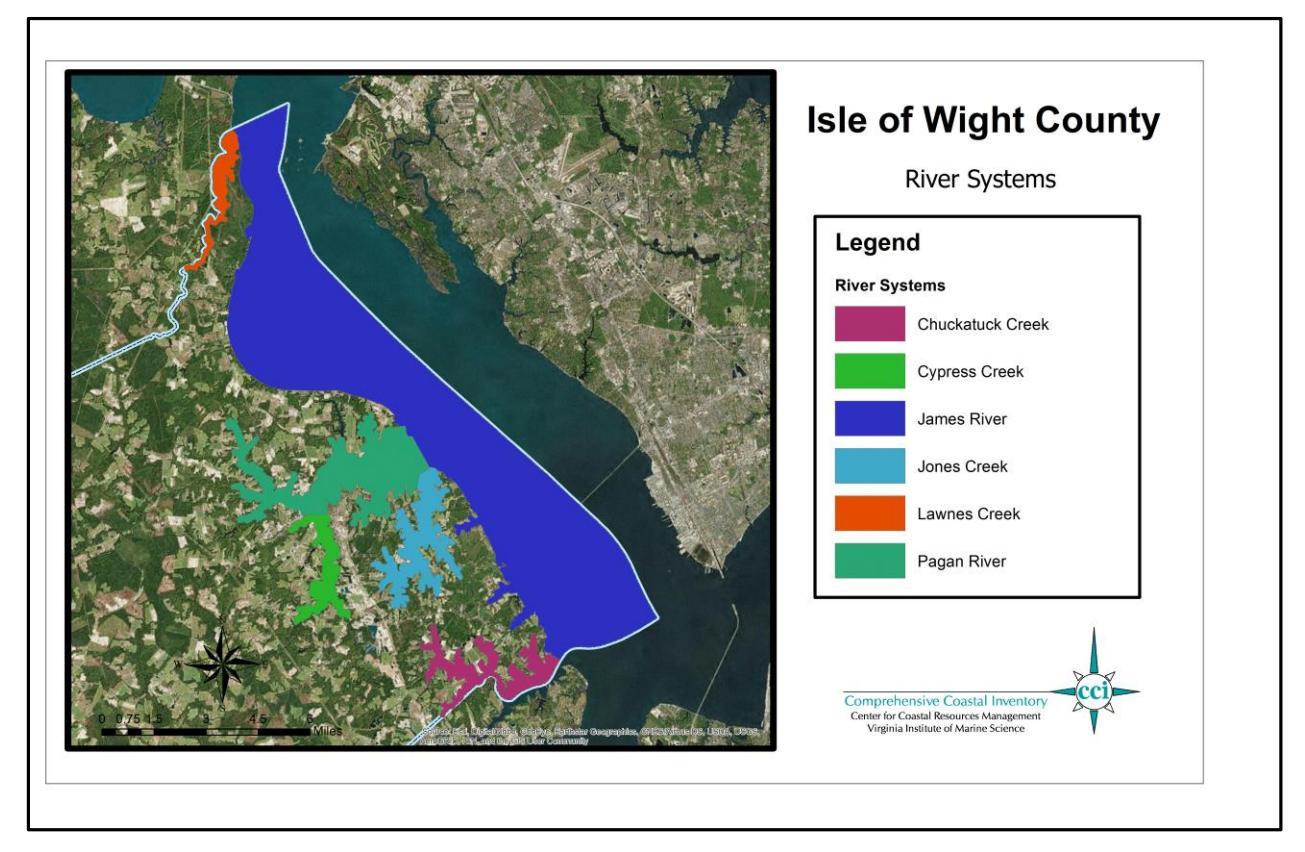
Figure 2. River Systems in Isle of Wight County

Summary tables (Tables 4-7) quantify conditions observed on the basis of river systems (Figure 2). Refer to Figure 2 for the location of these rivers systems. Note, river systems do not correspond to watershed boundaries. They were developed for convenience in reporting data.

The top toolbar also includes tabs to access some important status information for the locality. By clicking on the "River System Pie Charts" button, users can obtain a statistical summary distribution of the riparian land use and amount of hardened shoreline for a specific water body selected from the drop down menu in the upper left (Figure 7). More detailed results in table format can be found by clicking the Isle of Wight County Summary PDF button also in the window. The summary statistics are reported by river systems (Figure 2).
