Article · January 2015

HYBRID MANGANATE-BASED CONVERSION COATING ON ALUMINIUM

Makanjuola Oki Department of Mechanical Engineering Landmark University, Omu-Aran, Kwara State, NIGERIA

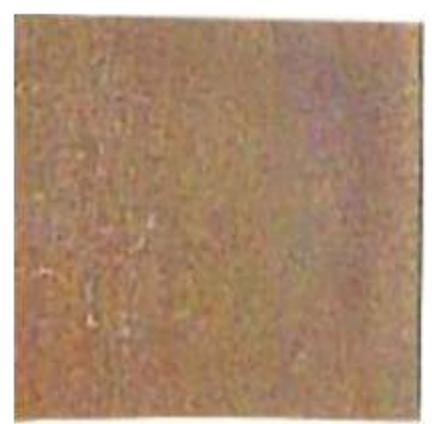
Fig. 1 Optical macrograph of aluminium specimen treated for 3mins in manganate conversion coating solution at 30°C.

As displayed in Fig. 1, which is the surface of aluminium specimen treated for, 3 minutes in the manganate conversion coating solution, the coating is comprised of light and dark coating materials which developed over the initially lustrous, shiny finish of etched and desmutted aluminium substrate. These two shades are related to the colour of the coating which is a mixture of green, purple and brown as observed under the optical microscope at magnification of about 700 times. The coating has developed over inclusions and pits that may have been present in the metal.

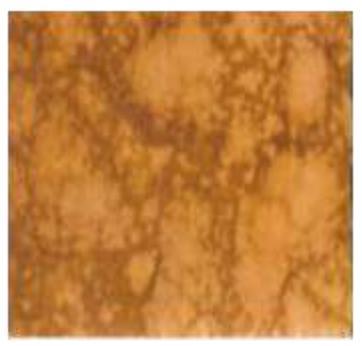
Figure 2: Optical macrograph of metal side of manganate coated specimen after adhesion test.

The failure path demonstrated by the manganate/lacquer which is mostly cohesive in the lacquer indicates that after protracted exposure in the humidity cabinet, the forces within the lacquer weakened such that for the most part the adhesion between the lacquer and the manganate coating was superior.

From Figs. 2 and 3, which are macrographs of the metal and tape sides for the manganate specimen after adhesion test, it can be observed that on the metal side, there are tufts of resin, whereas the left over resin on the tape side showed depression replica of the metal side. This confirms that the failure path was cohesive in the lacquer. The failure path for the 'bare' lacquer coated aluminium was adhesive and it occurred mostly at the lacquer/aluminium interface which indicates that the air-formed film on the aluminium substrate is a poor surface to receive paints. From Fig. 4, it can be observed that the metal surface, displayed at the top left hand side of the macrograph revealed only incipient pits developed during interaction with the hot humid environment in the cabinet. However an occasional let over resin, which appears darker than the rest of the surface is displayed at the bottom right hand corner of the figure.

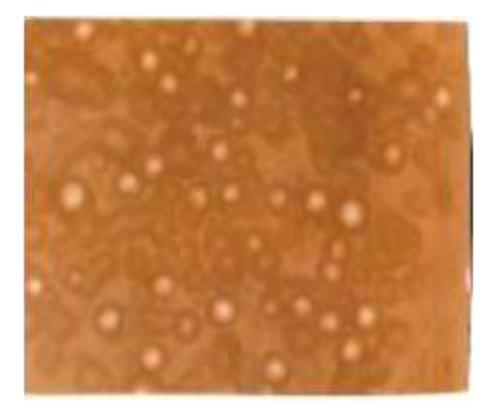
Figure: 3 optical macrograph of tape side for manganate coated specimen after adhesion test.

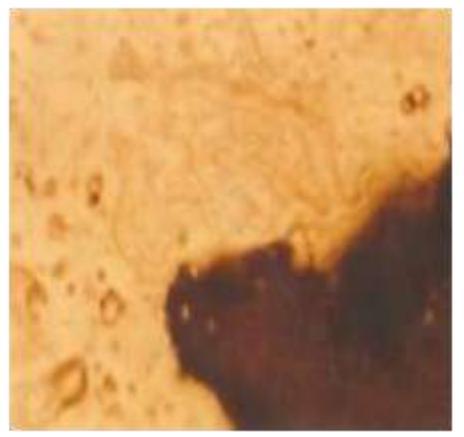
Figure 4: Optical micrograph of metal side of 'bare' aluminium after adhesion test

Water from the humidity cabinet had gained entry to the interphase and displaced the bond between the substrate aluminium and lacquer. Whereas the manganate conversion coating had formed an inert barrier between the aluminium substrate and the environment in addition to providing a good keying surface to bond favourably with subsequently applied lacquer.
