# An Experimental Investigation of Torque Loss in a Die Cast Aluminum Threaded Fastener Joint

# AN EXPERIMENTAL INVESTIGATION OF TORQUE LOSS IN A DIE CAST ALUMINUM THREADED FASTENER JOINT

The intent of this study was to investigate experimentally the root cause of torque loss in a die-cast aluminum threaded fastener joint that is used to assemble an engine mount to the front cover of an automotive engine. The primary goal was to develop a practical experimental method to characterize threaded fastener joints in situ. Using installation torque measurements, hardness test results, and a DC nut runner, joint attributes were measured, and the data was evaluated. This investigation demonstrated that the incompatibility of the mechanical properties at the interface of the housing and fastener resulted in significant torque loss. Further investigations are planned to study cost effective design modifications.

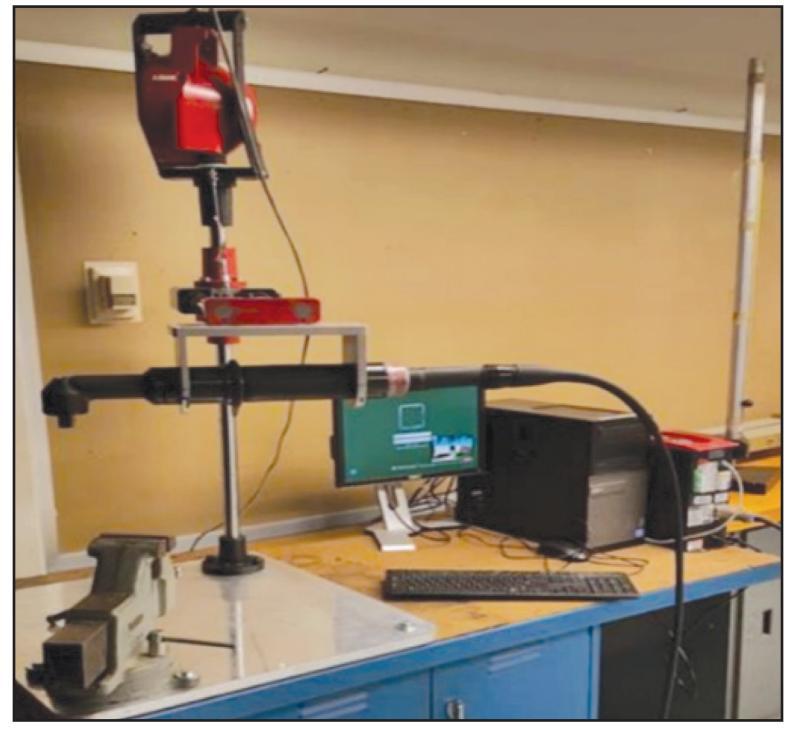
Figure 1. DC electrical tool system equipment and set up.

Referring to Figure 1, the electric wrench had a torque capacity of 280 Nm. For operator safety, the wrench was secured by a 300 Nm torque reaction arm. This prevented tool forces from being transferred to the operator. For additional operator safety, the sockets contained protective sleeves that rotated freely, which mitigated the potential for fingers being trapped on the socket. The controller allowed the operator to program a variety of fastener tightening strategies, including up to 15 different steps. It also measured the corresponding torque versus time (angle) curves and torque trace. This allowed us to replicate and evaluate real world joint behavior.

The initial challenge was to design and install the infrastructure to support the systematic investigation of threaded fastener joints. To this end, a state of the art threaded fastener testing lab was designed and commissioned (Figure 1, below). The primary feature of the threaded fastener lab was the DC electrical tool system. Auxiliary measuring equipment included

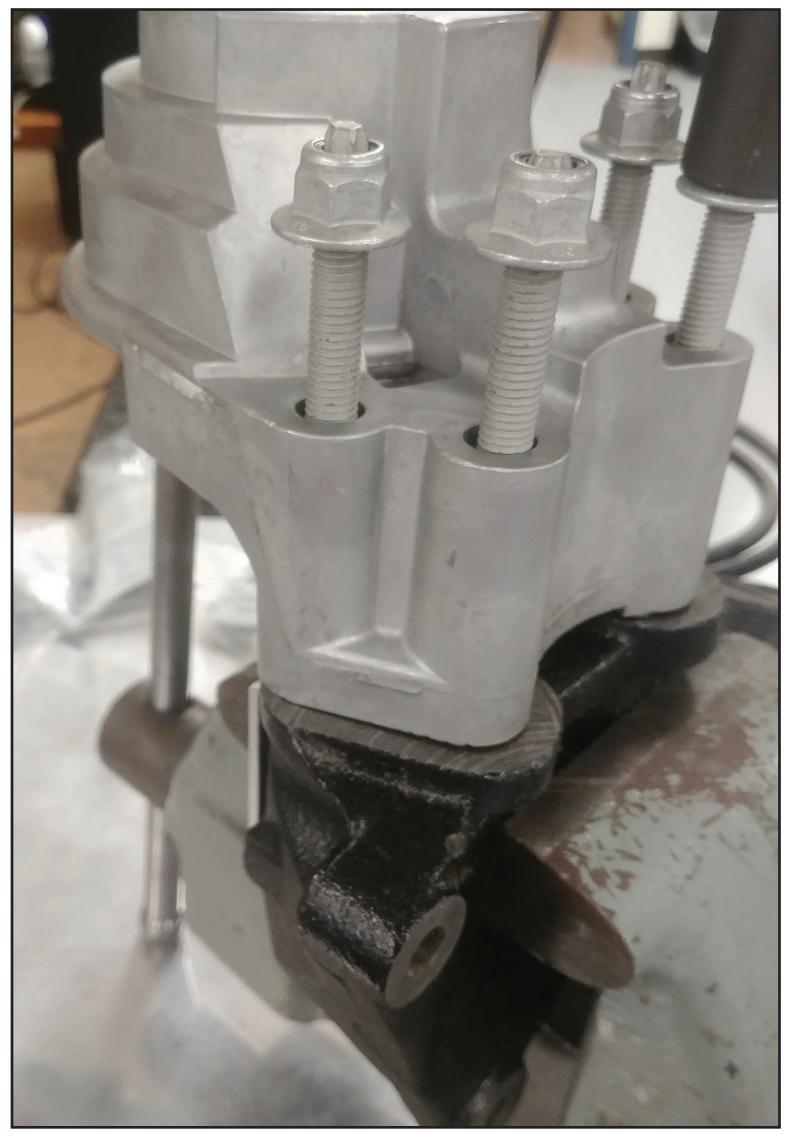
The engine mount housing and engine front cover bracket were manufactured from die cast aluminum A380 and cast iron, respectively. The bolts' holes on the engine mount housing consisted of 1 – locating hole (10.2 mm diameter) and 3 – locating holes (10.5 mm diameter) (Figure 2). The threaded fastener joint was secured by tightening the four nuts to the nominal value of the torque specification,  $62.5 \pm 9.4$  Nm, using a torque wrench. To minimize the effects of elastic interactions, several tightening passes were performed. Note that a similar tightening process was used during the prototype vehicle build. For production, however, the nuts were secured simultaneously, using an automated nut runner system. After one week, the residual torque of each nut-stud assembly was measured to determine the percentage of initial torque loss in each bolt. The percentage of initial torque loss was calculated using the following equation: Green-Warren: An Experimental Investigation of Torque Loss in a Die Cast Alumin

Figure 2. Die Cast Aluminum Joint: The image above represents the initial test set up

Evaluating the torque trace is critical to the design of threaded fastener joints. The torque trace is a measure of the bolts' strength and behavior within the joint. Typical design characteristics that can be identified from the torque trace include, but are not limited to: prevailing torque, hole bottoming, friction, stiffness, thread stripping, and surface hardness mismatch (soft clamped materials). The torque trace was measured on a current production engine mount housing. The test specimen consisted of as-manufactured design intent components, (Figure 2.), including:

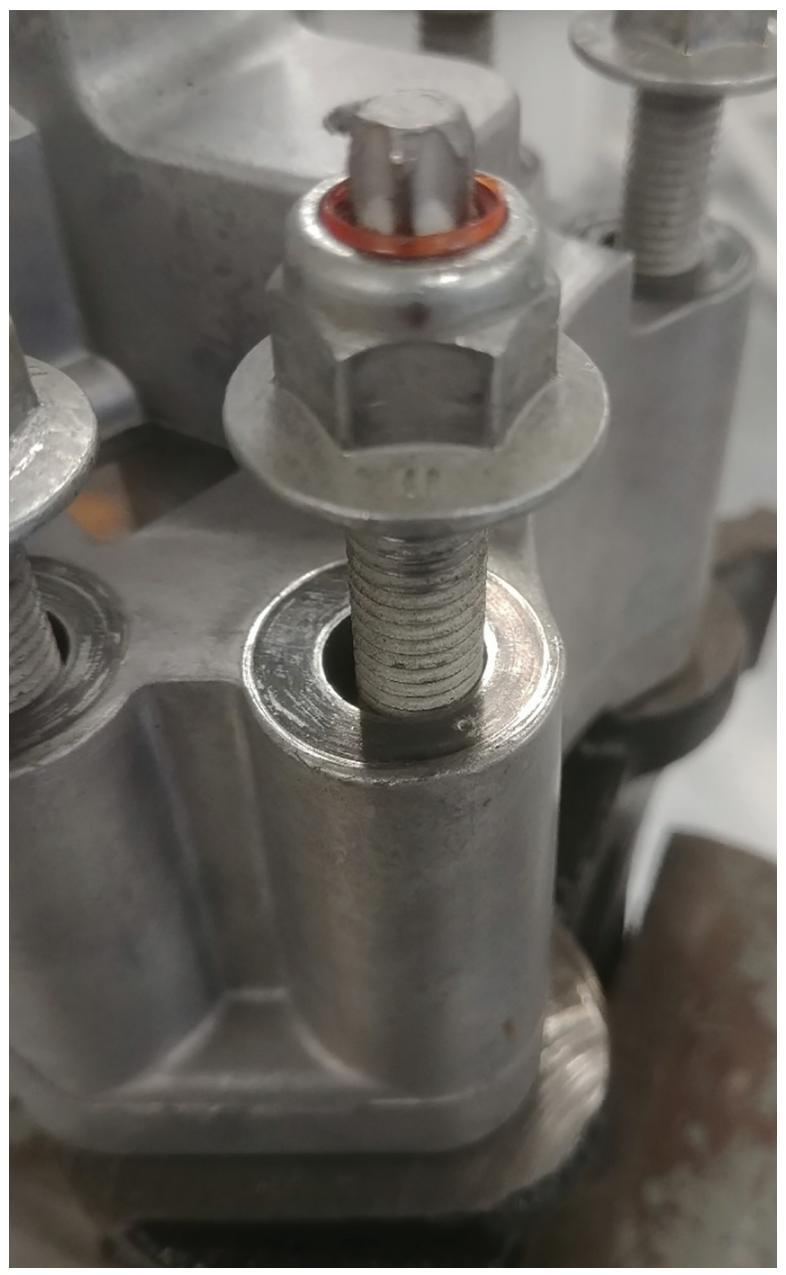
Figure 3. Die Cast Aluminum

Using the experimental methods, as stated above, the replication of the torque loss phenomenon was achieved. It was found that, on average, up to 59% of the initial torque load was lost. Upon investigation, brinelling, or plastic deformation on the surface of a part due to an applied load, was found on the die-cast aluminum joint between the nut and joint interface (Figure 3). The locations that indicated brinelling were approximately equal to those of the bottom surface area of the M10 nut used in the bolt-joint assembly (Figure 4). Through
