MINING ENVIRONMENTS: THE GOOD, THE BAD, AND THE UGLY¹

Bernd G Lottermoser²

¹Paper was presented at Mining and the Environment IV Conference, Sudbury, Ontario, Canada, October 19-27, 2007.

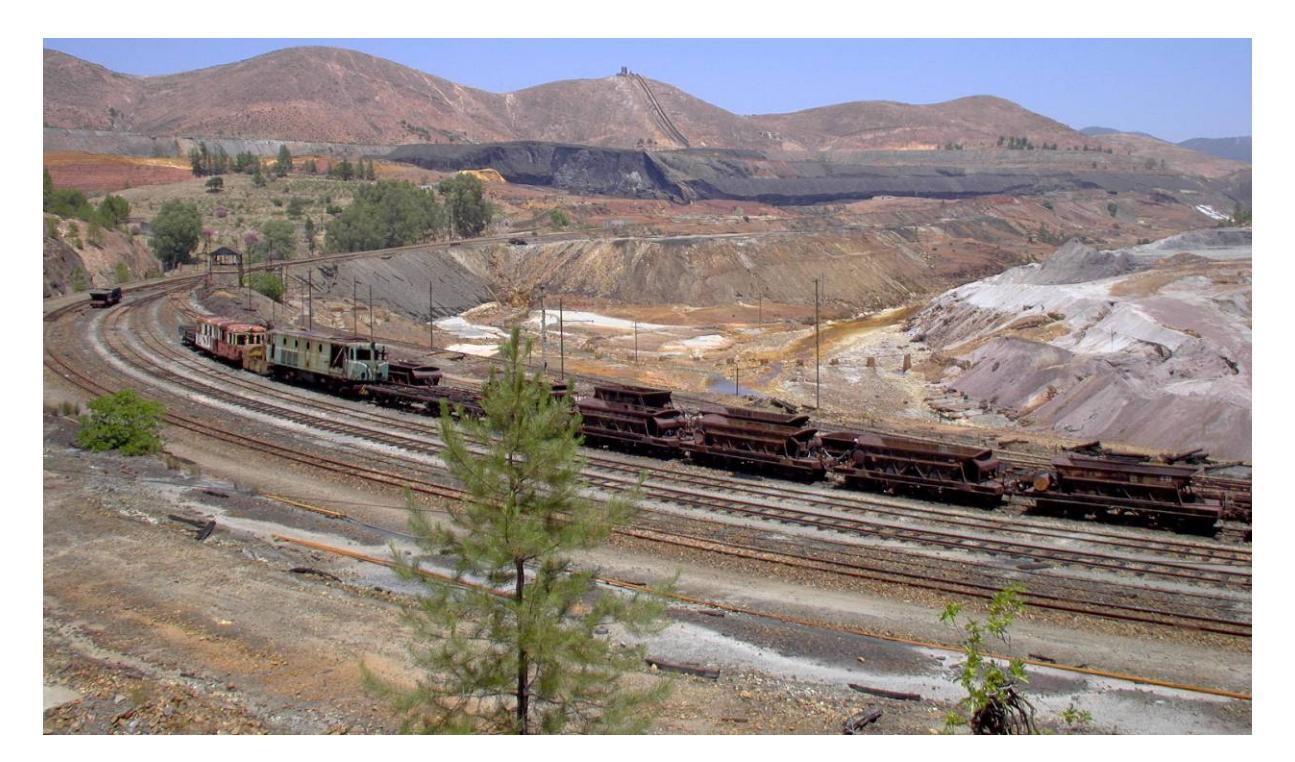
Figure 1: Slag heap, sulfidic waste dumps, and abandoned railway carriages at Rio Tinto, Spain. The mining activities have left uncountable waste rock heaps, ore stockpiles, tailings dumps, slag deposits, and settling ponds, most of which do not support any vegetation. The exploitation of sulfidic ores has created a unique "mining landscape" and caused massive ARD flowing into the Rio Tinto.

At Rio Tinto, successive mining activities have resulted in the creation of a unique "mining landscape" (Fig. 1). The region has numerous abandoned mine workings and is littered with derelict buildings and disused mining and processing equipment. There are also uncountable waste rock heaps, ore stockpiles, tailings dumps, slag deposits, and settling ponds, most of which do not support any vegetation. The lack of vegetation on sulfidic wastes and local soils increases erosion rates into the headwaters of the Rio Tinto. Pyritic waste particulates are transported into the river tens of kilometers downstream of the mine and processing sites (Hudson-Edwards et al., 1999). The erosion processes exacerbate the "moonscape appearance" of the area affected by mining, mineral processing and smelting activities. Most importantly, the Rio Tinto mining district is characterized by uncontrolled pyrite oxidation in exposed mine workings and waste materials (Romero et al., 2006). The oxidation of pyrite causes formation of sulfuric acid and the dissolution of many metals. Mine waters are quite acid (pH 2 or less) due to the oxidation of abundant pyrite.

The Rio Tinto mining district is drained by the Odiel and Tinto rivers (Fig. 1). The Tinto river is 90 km long and remains strongly acid (pH <3) for its entire length (Leblanc et al., 2000; Braungardt et al., 2003). Tinto is Spanish for "red wine" and clearly refers to its turbid red, acid water. The stream's distinct turbidity is the result of abundant iron-rich suspended colloids and gelatinous flocculants. The river also carries very high dissolved sulfate, metal, and metalloid loads (As, Fe, Cu, Cd, Ni, Pb, Zn) from the headwaters to its estuary (España et al., 2005). Part of this dissolved metal load is precipitated into fluvial and estuarine sediments. Another part of the metal load enters continental shelf sediments and waters of the Gulf of Cadiz and contributes to the metal content of the Mediterranean Sea through the Strait of Gibraltar. The waters and sediments of the Rio Tinto are strongly polluted with metals and metalloids. In fact, the Tinto river is one of the most polluted streams in the world. Despite its pollution, the Rio Tinto acts as an ecological niche for at least 1300 different microorganisms including algae, fungi, bacteria, yeast and protists (e.g. Ariza, 1998).

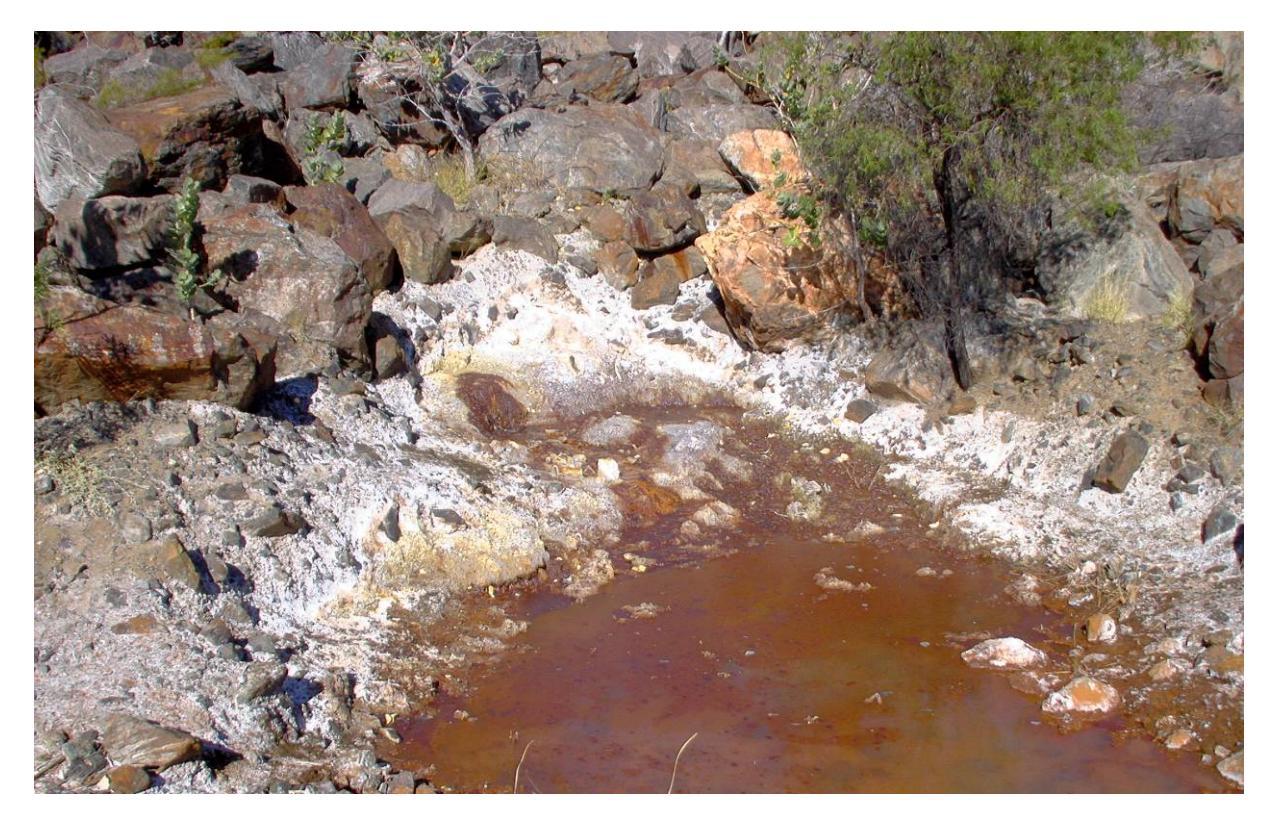
Figure 2: Seepage point at the base of the tailings dam wall, Mary Kathleen, Australia. Abundant sulfate efflorescences and Fe-oxyhydroxide precipitates form from the acid, saline, radioactive seepage water (pH: 5.5; salinity: 0.31 %). Bolders in the retaining wall are approximately 1 m in diameter.

Seepage water from the TSF is slightly acid (pH 5.5), metal- and SO₄-rich, and radioactive (Fig. 2). There is rapid precipitation of Fe oxyhydroxides, with absorbed U, REE, Y, As and radionuclides. Further downstream, surface and groundwaters become near-neutral, but increase in salinity such that there is widespread precipitation of sulfates. Although release of U and other metal/metalloid contaminants from the TSF is insignificant, concentrations of TDS, U and SO₄ in surface waters exceeds livestock water guidelines.

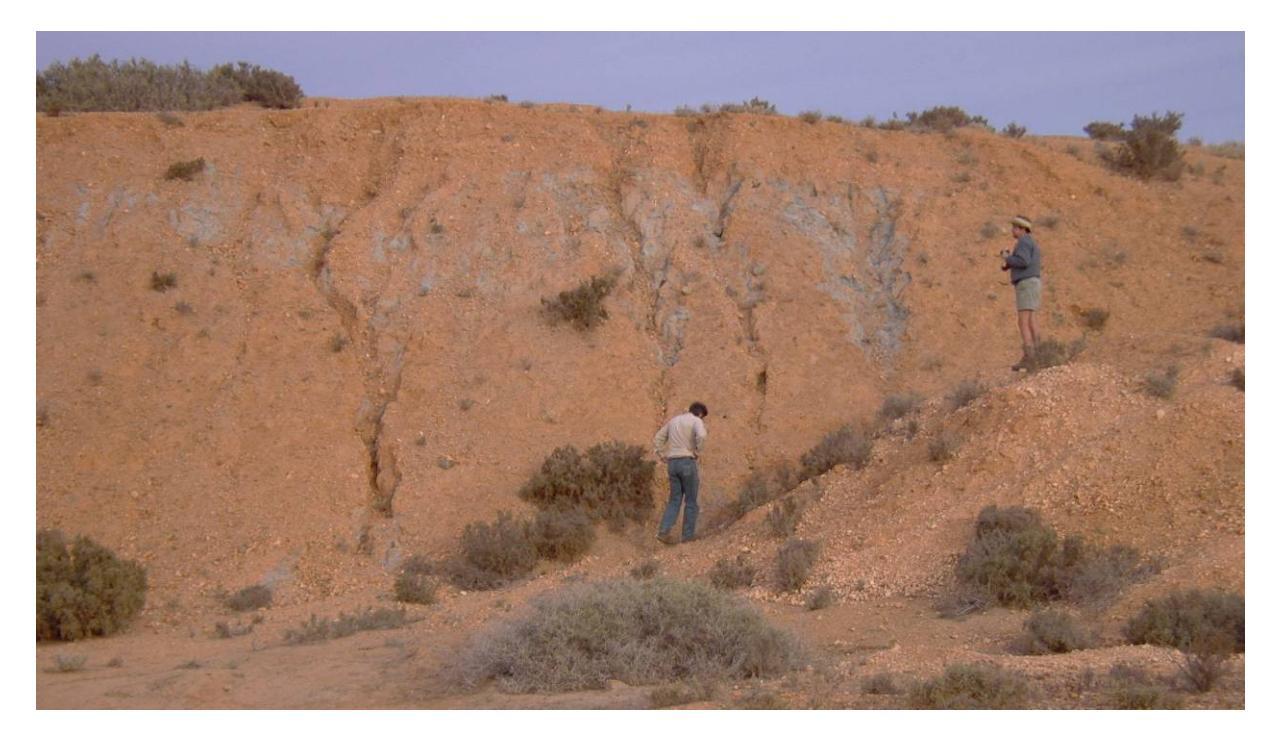
Figure 3: Rill erosion of the soil capped tailings storage facility, Radium Hill, South Australia (height of facility approximately 6 m). The soil capping is being removed, resulting in the exposure of radioactive tailings in rills.

At Radium Hill, rehabilitation efforts have been restricted to capping of tailings, but following a 20 year period of prior extensive wind dispersal of exposed tailings that has impacted local soils. Physical erosion of waste repositories is of on-going concern (Lottermoser and Ashley, 2006). It is evident that the capped tailings repositories will degrade in time, causing increased erosional dispersal unless further remediation measures are implemented. The erosion of capped waste repositories, particularly by infrequent rainstorm events, highlights the fact that dry capping of waste dumps in semi-arid terranes may not necessarily lead to the permanent containment of wastes.

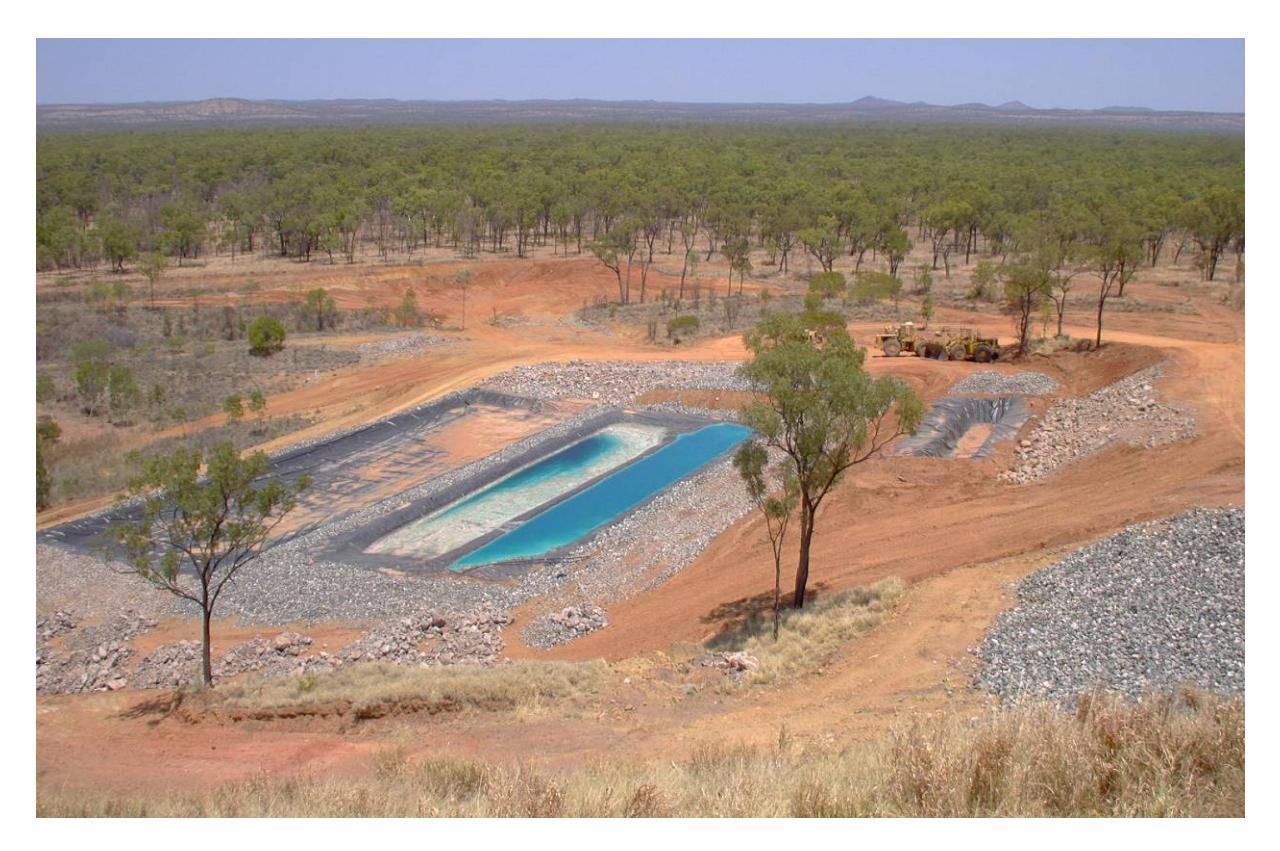
Figure 4: View from the tailings storage facility, Red Dome gold mine, Queensland, Australia. Cyanide-bearing seepage waters (~200-500 mg/l total cyanide, 80-300 mg/l WAD cyanide, 200-600 mg/l Cu) emanate from the capped tailings repository. The seepage is collected via a series of ponds where chemical degradation of cyanide and precipitation of copper cyanide salts occur. The passively treated effluent is discharged to the local stream system.

In 2001, seepage from the Red Dome Mine TSF was characterised as being relatively alkaline, saline and containing high concentrations of cyanide and Cu (Fig. 4). The seepage was collected via a series of tanks and ponds where chemical degradation of the cyanide occurred. Monitoring carried out within the heap leach impoundment system illustrated that degradation and dilution of cyanide to below

EMOS (Environmental Management Overview Strategy) criteria readily occurred. However, EMOS criteria require that the concentration of Total Cyanide (TCN) and Cu in water do not exceed a limit of 1 mg/L and 2.3 mg/L, respectively. While disposal and treatment of the seepage via the tanks and ponds were effective, it required regular pumping. Hence, the State Government advised the lease holder to set up a more appropriate and fail safe system of treatment and disposal that required less human intervention. To date, such a fail safe treatment system for Cu-cyanide rich mine drainage waters remains to be identified.

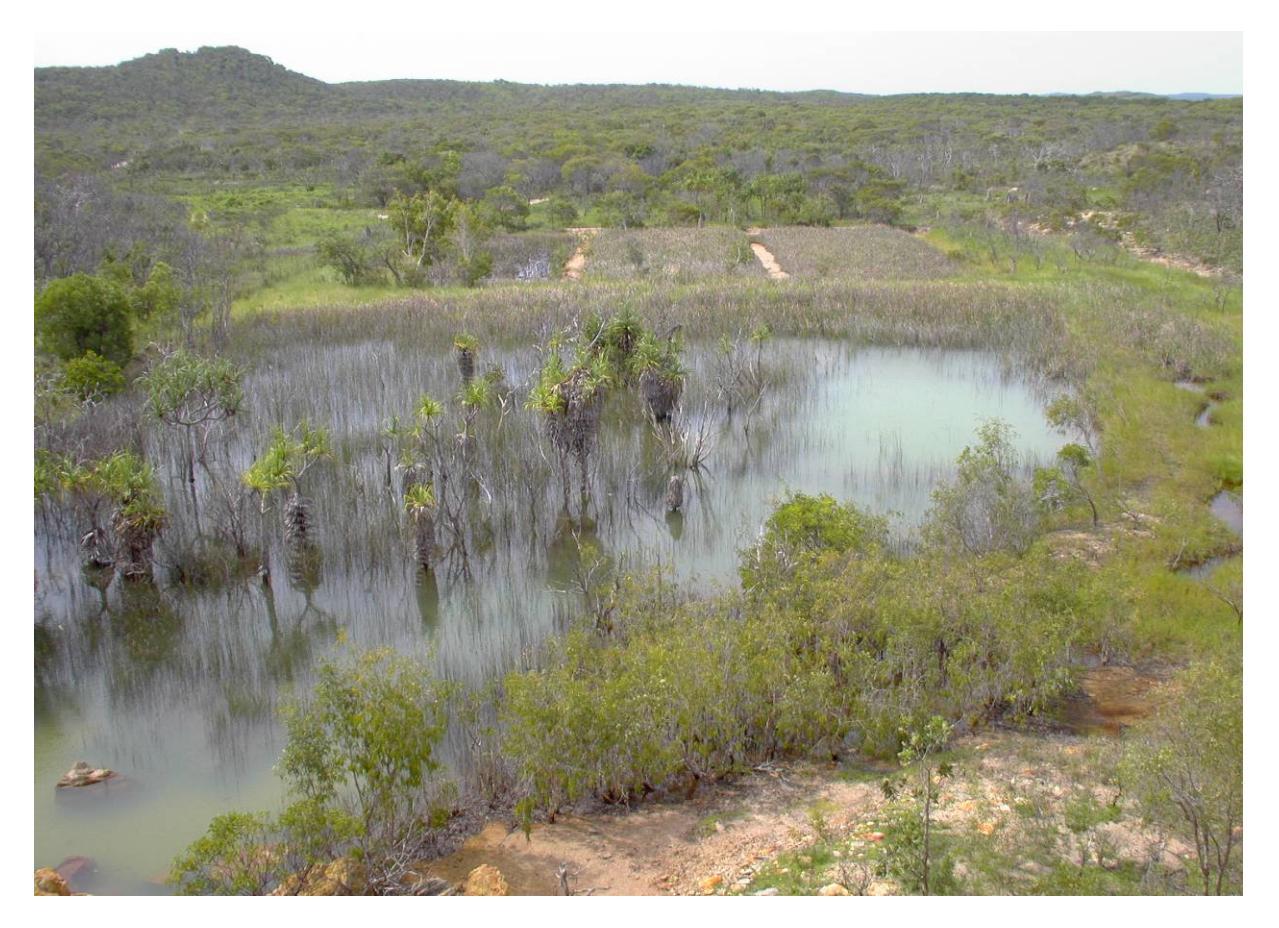
Figure 5: Wetland at the Horn Island gold mine, Australia. The wetland has failed because an adjacent damwall was constructed using acid generating waste rocks (foreground), which resulted in significant ARD and caused plant death.

In 1989, the mining operation went into liquidation and the State Government became responsible for its restoration. Rehabilitation efforts to date include dry capping of the tailings storage facility and ore dump, creation of wetlands and diversion of creeks to fill the open pits with freshwater. These rehabilitation efforts have been of very limited success. While the rapid filling of the open pits with

freshwater has resulted in acceptable water quality, there is ARD from the ore stockpile and waste rock dumps, affecting vegetation and possibly littoral marine fauna and flora of the Great Barrier Reef. Also, tailings placed into a shallow water pond (max. ~6 m deep) release metals into the overlying water column. Moreover, the installed wetland has failed as materials used for the construction of the wetland and adjacent dam are acid generating (Fig. 5). Additional rehabilitation would be necessary. However, the lack of suitable capping materials in the Torres Strait region, its remote location and seasonal rainfall pattern, and the intended return of the mined land to indigenous landholders pose an extraordinary reclamation challenges.
