Energy performance evaluation of a nearly Zero Energy Building and the reasons for the performance gap between expected and actual building operation

Published in: 1st Nordic conference on Zero Emission and Plus Energy Buildings

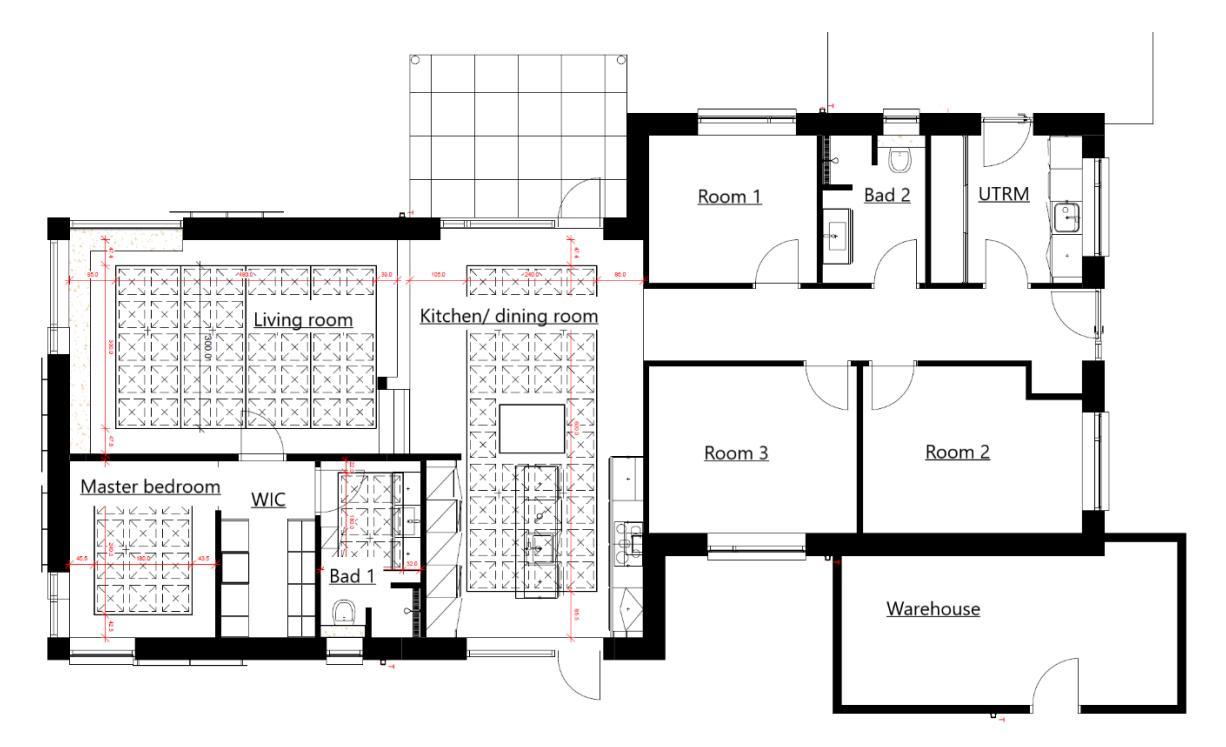
Figure 1. Floor plan of the study case.

The dwelling has a total floor area of 160 m^2 . It is constructed on two levels, with a height difference of 0.5 m. It includes 4 bedrooms, 2 bathrooms, 1 kitchen, 1 dining area, 1 living room, and a utility room. The kitchen, dining area and living room are connected to form an open space. There is also an unheated storage space attached to the building. There are windows towards all directions, while the openings in the South, East and West façades are equipped with sunscreens. Figure 1 shows the plan of the dwelling, while Figures 2 and 3 give an external view of the house.

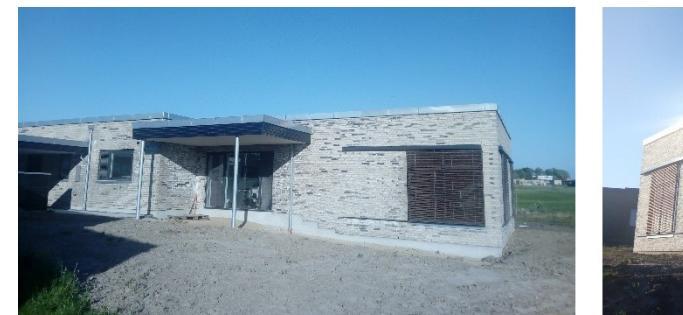
Figure 2. External northwest view.

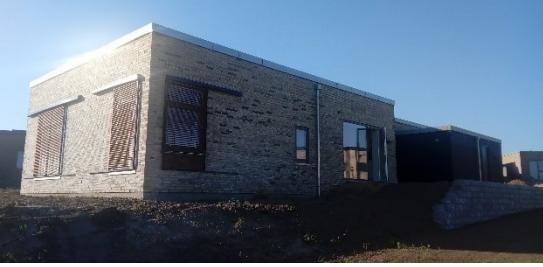
Figure 3. External south view.

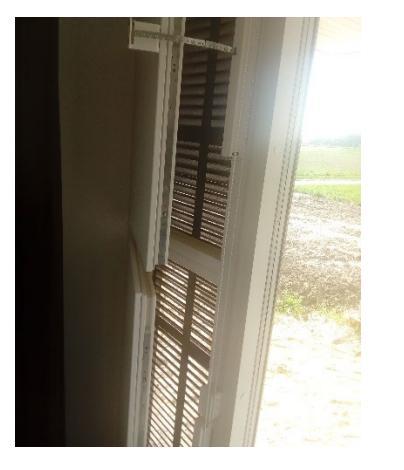
Figure 4. Ventilation louvers.

Natural ventilation and sun protection can be activated in order to create a pleasant indoor environment and minimize energy usage. Natural ventilation can be achieved through the skylights and a novel ventilation system with louvers incorporated in several windows in rooms with overheating risk. The external solar shadings are installed at the windows of the master bedroom and living room, with east, south and west orientations. In order to encourage the use of these systems, the solar shades are designed so that they allow good view to the outside, even when activated, while the ventilation louvers are providing theft and rain protection so that they can be used even when the dwelling is not occupied. In Figures 4 and 5 are shown the ventilation louvers and solar shades. At the end of November 2018, the natural ventilation and sun protection systems were connected to the control system, so that they can be

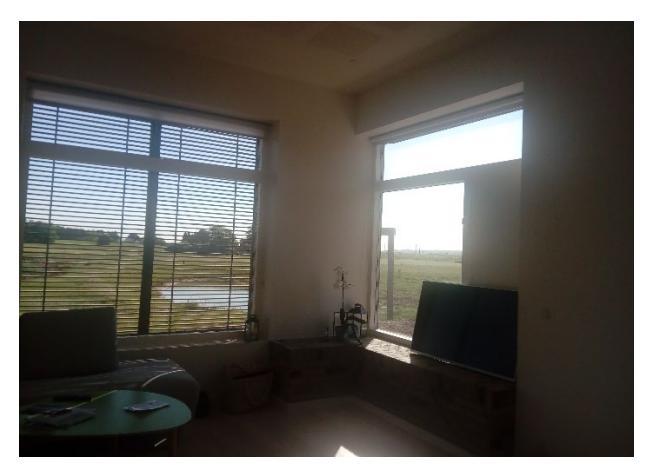
Figure 5. Solar shades and view to the outside.

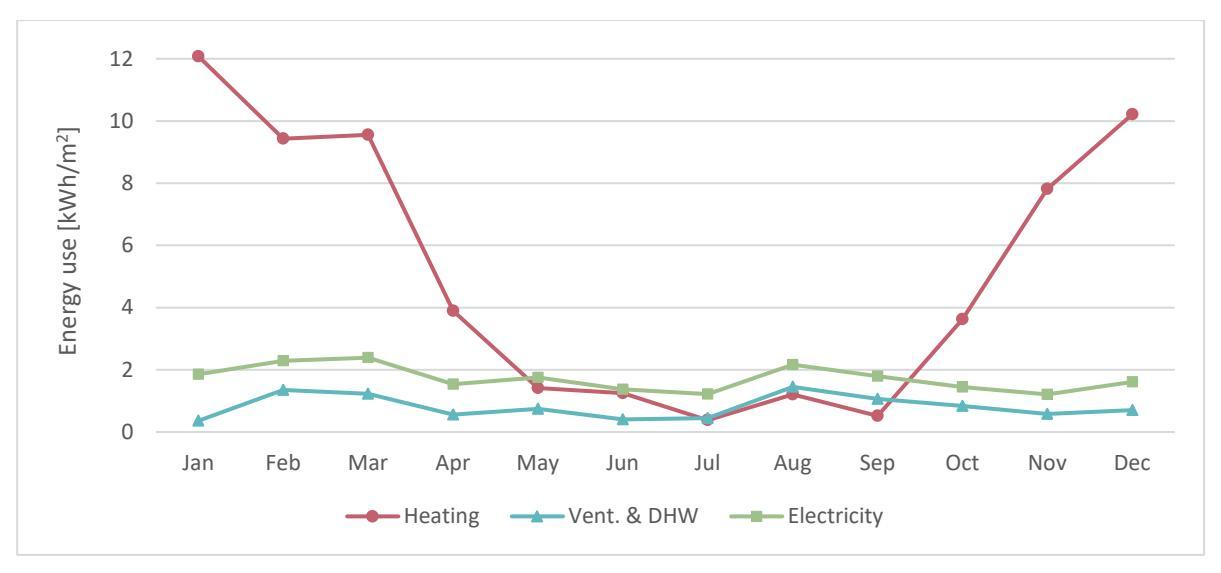
Through analysis of the monitored values, the energy needs of the building are assessed and the actual yearly energy use is compared to the expected one. Figure 6 presents the measured monthly delivered energy for heating, ventilation and production of sanitary hot water, as well as the total electricity use. The electricity use of the compact ventilation unit is shown both as part of the total electricity use and separately, as it accounts for 47% of the total amount. The rest of the electricity use is given by the white goods (cooking plate, refrigerator, dishwasher, cooker – for boiling water, washing machine and dryer), storage tank, floor heating pump, control system, and all the rest connected to the occupants' activities (household appliances and lighting). The white goods contribute to the total amount with 29%, the control system with 11%, and the storage tank and floor heating pump with 10.5%. A more detailed analysis of the electricity use by the different appliances can be found in the study of Carpino et al. [17], conducted for the same building.

Figure 6. Energy use in 2018.

In order to compare these values with the numbers given by the European standards and simulation tool Be18 (which was used to calculate the total energy requirement during the design phase), the conversion from delivered to primary energy use is made with a primary energy factors in Denmark of 1.8 for electricity and 0.6 for district heating. The results are summarized in Table 3. As one can see, the total energy use of the building for heating, cooling, ventilation and hot water is higher than expected by 89%. This mismatch may be due to several reasons. Firstly, simulation program Be18 is not meant for detailed energy analysis, but rather as an estimation of the energy frame, using a standard occupancy profile [17]. Additionally, during the design phase, assumptions had to be made, which in several cases might have been quite far from the reality. Finally, during the first year, the building's operation does not comply entirely with the intended, due to necessary adjustments or corrections to the systems, and also due to the fact that some of the equipment or control has not been implemented yet. On the other hand, electricity use is much lower than expected, resulting in smaller internal gains and thus higher heating needs. In [17], it was estimated that the reduced effective heat gains from people and equipment load could explain an increase in the heating energy use of about 10 kWh/m² per year.

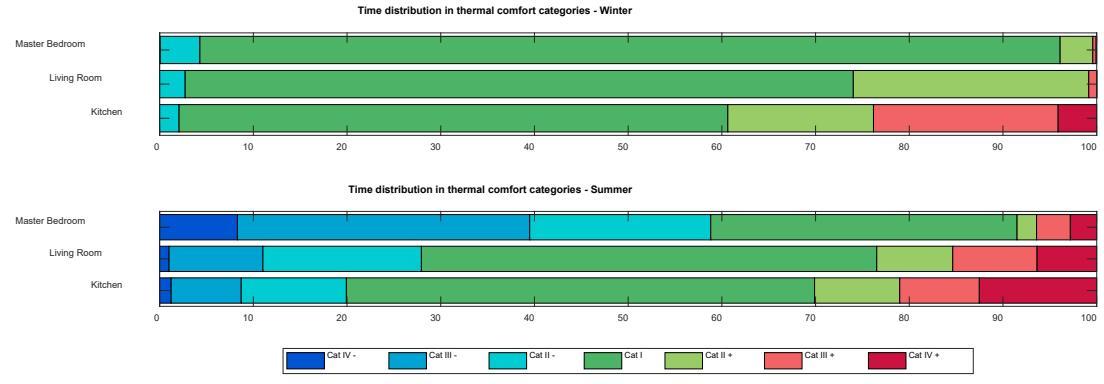
As one can observe in Table 5, thermal comfort remains in Category I and II during most of the time, with 77% and 85% for the bedroom and living room, respectively, while in the kitchen / dining room a percentage of 70% is achieved. In Figure 7, the aforementioned categories are divided into winter and summer period, in order to create a better visualization of the situation. It is worth mentioning that during

the heating period, the achieved thermal comfort level is very high. That is not exactly the case for the kitchen / dining area, where the large glazed areas towards the east and west can create a bit of overheating, even during the winter. Nevertheless, a decrease in the temperature set-point could be suggested, in order for the energy consumption for heating to be reduced. On the other hand, during summer, the temperature in the bedroom and living room seem to be quite low. It can be concluded that during the cooling season, the occupants prefer lower temperatures in the bedroom, which is probably achieved through the opening of windows at night time. Consequently, the temperatures in the living room and kitchen are also affected by these practices.

Figure 7. Time distribution in thermal comfort categories for winter and summer periods [%].
