A real parametric characterisation of ex-service compressor blade leading edges

Wear

Areal parametric characterisation of ex-service compressor blade leading edges

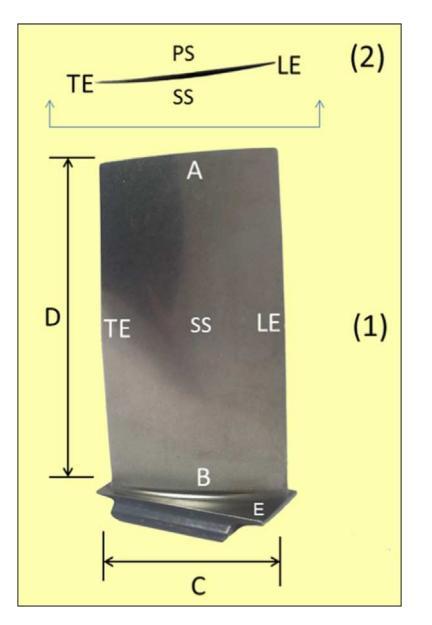
Fig. 1. Generic compressor blade nomenclature; (1)-side view and (2)-tip view(x section) showing; LE-leading edge, A-tip, B-root, C-chord (chordwise direction), TE-trailing edge, D-Span (spanwise direction), SS-suction side (convex), PS-pressure side (concave), E-end wall.

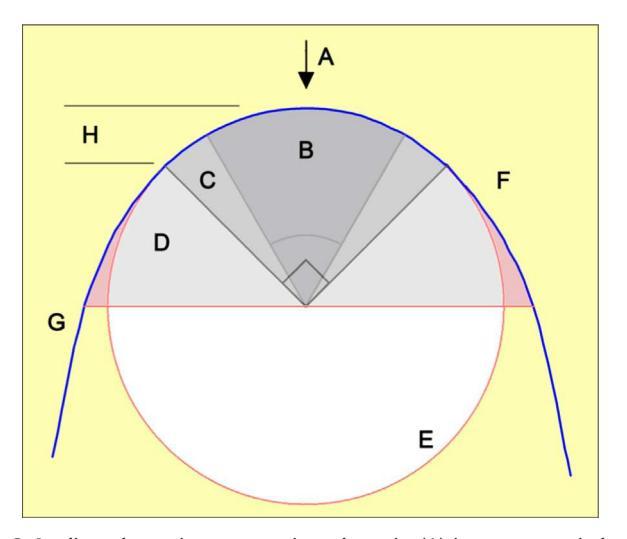
Fig. 2. Leading edge region cross-section schematic; (A) instrument optical axis (zero angle of attack) (B) central 60° frontal field of leading edge, (C) central 90° frontal field of leading edge, (D) nominal frontal field of whole leading edge, (E) circle fitted to nominal leading edge circular profile, (F) approximate blend point of leading edge into blade suction or pressure side (see Fig. 1), (G) leading edge flank, (H) approximate depth of measurement field.

Fig. 2 details the approximate frontal (zero angle of attack) projected region of a typical leading edge that it is possible to capture both practically and with robust surface roughness data. Additionally the flanks of the edge can be captured, but this must be done with a minimum of two extra measurement fields perhaps 60° either side of zero. Due to the complex geometry of leading edges see Fig. 5 it is not practical to combine or spatially register the resulting fields, thus limiting their usefulness. Additionally, section 3.1 indicates these flank regions exhibit a transitional (non-uniform) surface roughness character and thus are not homogeneous; homogeneity being a prerequisite for areal parametric characterisation [16] Hence

with a single instrument field employed at close to zero angle of attack the central 60° to 90° arc of the edge (corresponding to central 1/2 to 2/3 of the projected frontal leading edge area) was captured, see Fig. 2. Surface regions at flanks angles extending beyond this range offer increasingly poor data quality, and increased residual form to remove. Suitably fixed and aligned by goniometer for; pitch, yaw and angle of attack, a minimum vertical scan height and maximum traverse length were achieved for a given measurement traverse (see Fig. 5).

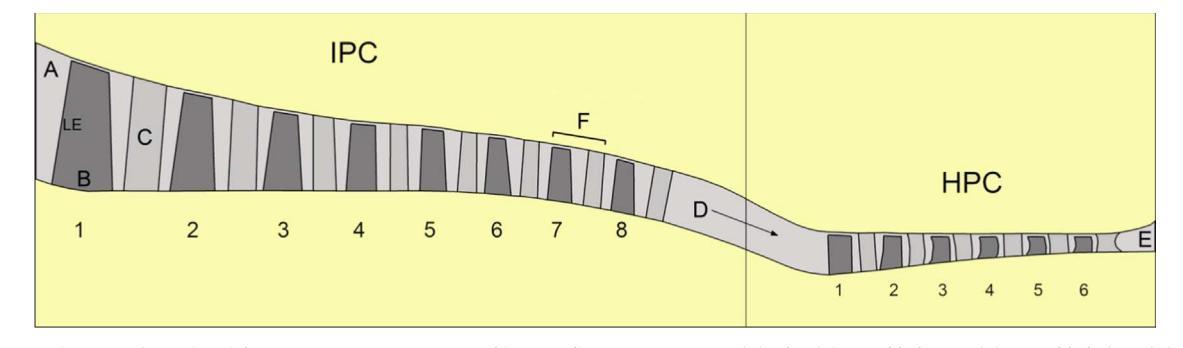
Fig. 3. Compressor jet core schematic; High pressure compressor HPC and intermediate compressor IPC (A) Inlet, (B) rotor blade root, (C) stator blade (vane), (D) compressor core flow, (E) combustion chamber, (F) single compressor stage, (LE) leading edge. Inset numbers indicate blade number.

To date the large majority of investigations into compressor degradation have focussed on military or power generation applications. In civil aero engines the levels of degradation are more modest, and unlikely to be safety critical, but can have a significant effect on fuel burn. The fact that they are not safety critical means that there is little published data of leading edge metrology. The compressor blades investigated have circular leading edges; typically with nominal leading edge radii less than 1 mm and high flank angles (see Fig. 2 (G)). A flank angle of 90° means the surface is parallel to the optical axis and not measurable; measurements become optimal as this angle approaches 0° . In practice imperfections arising during manufacture as well as the deterioration in-service, means that the leading edges are rarely circular in practice and as such, their dimension is typically described as 'half thickness'. This study focuses on the leading edges of the rotor blades from a single engine see Fig. 3; one blade

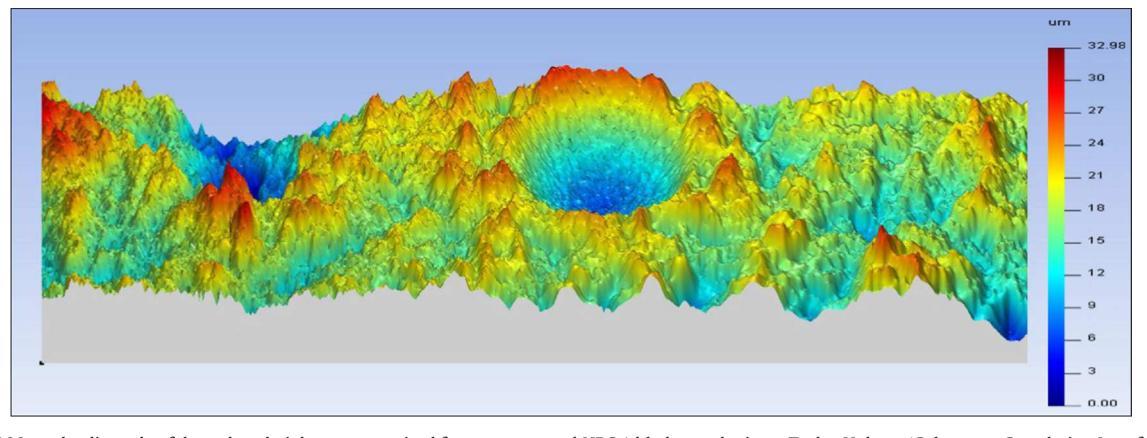
Fig. 4. 250 × 1000 µm leading edge false colour height map, acquired form a recovered HPC 1 blade employing a Taylor Hobson 'Coherence Correlation Interferometer' (CCI) and SurfStandTM software.

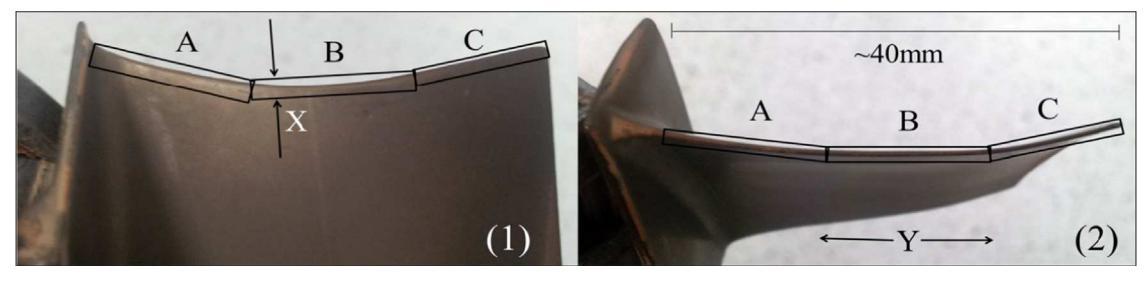
Fig. 5. Typical leading edge measurement traverses (spanwise), (1) leading edge profile from pressure side (2) leading edge viewed edge on from pressure side, showing 3 typical measurement fields A, B and C, field B having traverse length Y and scan height X. (see Fig. 1 for blade nomenclature).

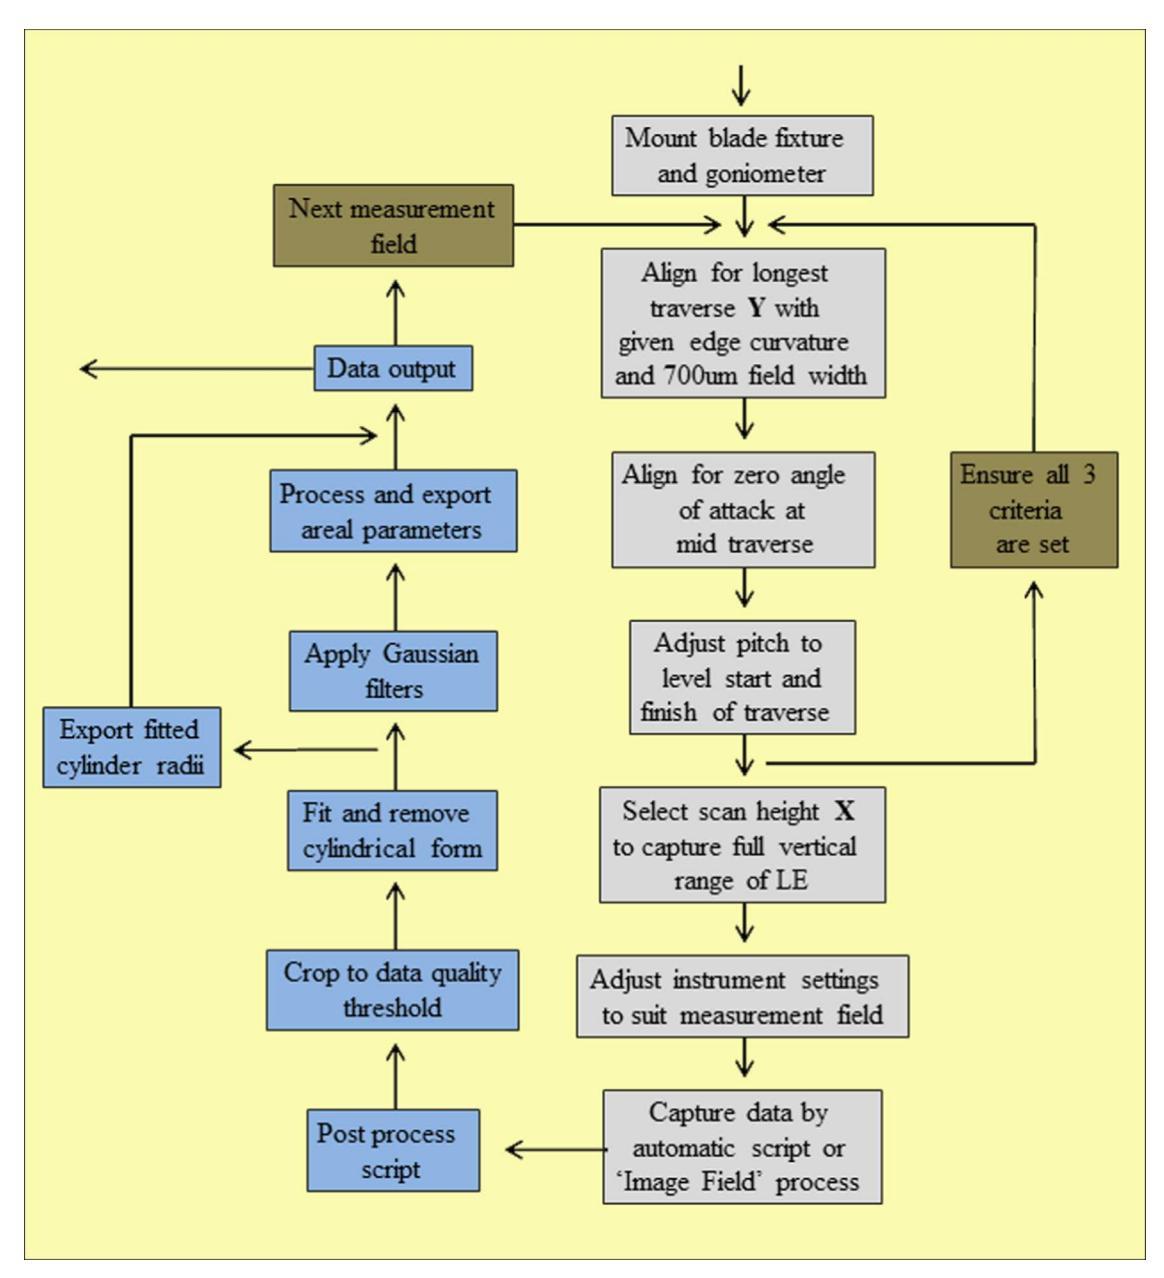
Fig. 6. Measurement and post processing flow chart (detailed with respect to Fig. 5).

Dependent on specific curvature and geometry, one or more automated (spanwise) traverses were required to acquire data for the length of the leading edge in individual 500 µm fields, leading edges being \sim 180–30 mm long (IPC1-HPC6). Using this approach the desired leading edge region occupied varying areas and positions within a measurement field, consequently extraction of the required central data region proved subjective. Automation of this task was therefore necessary to allow for the scale of measurement envisaged and ensure repeatability. Alicona captured data has associated with each data point an uncertainty value (data quality) expressed in terms of the vertical distance over which the measurement is estimated to be repeatable within a two standard deviation confidence interval. It can be seen in Fig. 7 that as the leading edge flank angle increases, holes in the image begin to appear, representing data falling below the instrument default minimum quality value. It was seen that using data quality as a metric and assigning a suitable value the data field could be thresholded at any desired level, leaving only the high quality data from the central region of interest. It was then possible, employing script written for this purpose and implemented with respect to [17] [4], [18], to systematically; threshold for data quality, fit to and remove nominal cylindrical form, capture fitted cylinder radius, filter and compute areal parameters from the captured data sets. The $300 \,\mu m$ Gaussian L filtration in the script (see Fig. 7) was applied to attenuate the effects of longer surface wavelengths not removed by cylindrical form removal. Given the wide variation in surface character of individual leading edges or sections thereof it proved necessary to tailor the quality threshold values to suit, consequently extracted field sizes varied somewhat from those intended, in the approximate range 100–700 µm. Fig. 6 shows a measurement process flow chart.

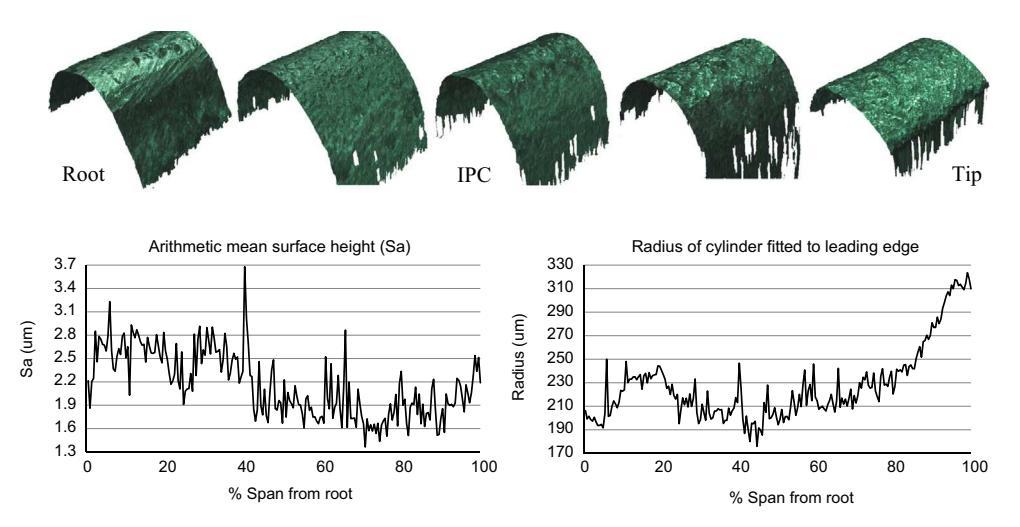
Fig. 7. Excerpted microscopic photographic images of a typical IPC blade, with charts detailing Sa (arithmetic mean surface height)[22] and fitted cylinder leading edge radius for each measurement field. Acquired with Alicona G4 IFM; X20 objective, lateral resolution 2.9 µm (sample spacing 1 µm), vertical resolution (quantisation) 100 nm, Gaussian L filter nesting index 300 um (high pass surface filter) [23].

Fig. 7 shows microscopic images of individual measurement fields for an example IPC blade spaced equally along the leading edge, and plots of Sa and fitted radius with % span from route. For proprietary reasons no comparative as manufactured edge half thickness values are quoted, though as a general trend these values decrease from root to tip. The data is plotted for individual captured fields \sim 450 μ m of leading edge; this has the effect of showing the local variations due to the scale of impact features and deposits. This may or may not be desirable, and the data could be filtered or averaged to give a more general trend to suit another application. Fig. 7 illustrates the usefulness of fitted radius as a basic metric of leading edge profile change and hence the extent of wear; the tip region of this typical IPC blade is seen to have a significantly flattened profile and correspondingly elevated values of fitted radius in this region. Visual assessment confirms a positive correlation between deviation from the expected plot of a progressive reduction in fitted radius from root to tip and gross leading edge geometry change due to erosion. It was anticipated that a positive correlation would exist between peak leading edge wear and surface roughness, Fig. 7 clearly shows this not to be the case. Low wear (erosion) of the root half of the leading edge is seen to be associated with higher Sa values than the tip region which exhibits high wear. As a general rule abrasive particulates in the core flow tend to be centrifuged towards the blade tips [19] hence the characteristic tip biased wear pattern. It is noted that where erosion is the dominant in the IPC that a general positive correlation exists between peak regions 'Autocorrelation length' (Sal)¹ [20] [21] and Sa, meaning, as might be expected, that larger particulate impacts produce surface features of larger amplitude and lateral length scale (wavelength). This is to some extent borne out by visual inspection of Fig. 7. When deposition becomes apparent and erosion less dominant from the late IPC onwards

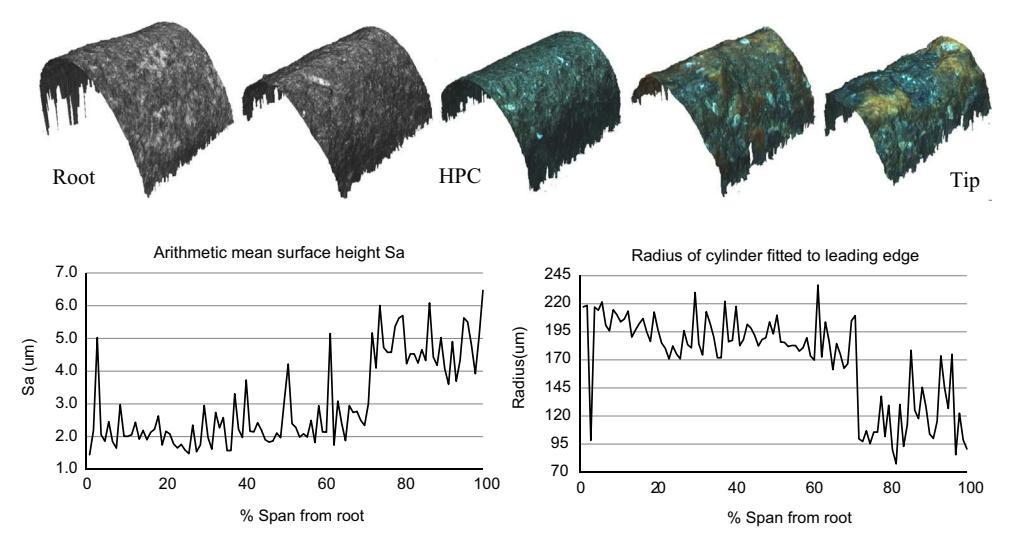
Fig. 8. Excerpted microscopic photographic images of a typical HPC blade, with charts detailing Sa (arithmetic mean surface height)[22] and fitted cylinder leading edge radius for each measurement field. Acquired with Alicona G4 IFM; X20 objective lateral resolution 2.9 μm (sample spacing 1 μm), vertical resolution (quantisation) 100 nm Gaussian L filter nesting index 300 um (high pass surface filter) [23].

Fig. 8 shows the same elements as Fig. 7 but shows an example HPC blade. The appearance of deposits at the leading edge tip is most notable and visible here. Fitted radius and surface roughness are strongly negatively correlated, and both are erratic, demonstrating large variations over short spanwise lengths of the leading edge. Deposits in this tip region are seen to be highly variable and often asymmetric, causing the resulting changes in fitted leading edge cylinder radius. It is suggested that surface impact features may, by way of flow disturbance at abrupt changes of profile (such as that seen in the lee of a road vehicle) result in this deposition, or conversely deposits may be partially spallated by surface impacts.

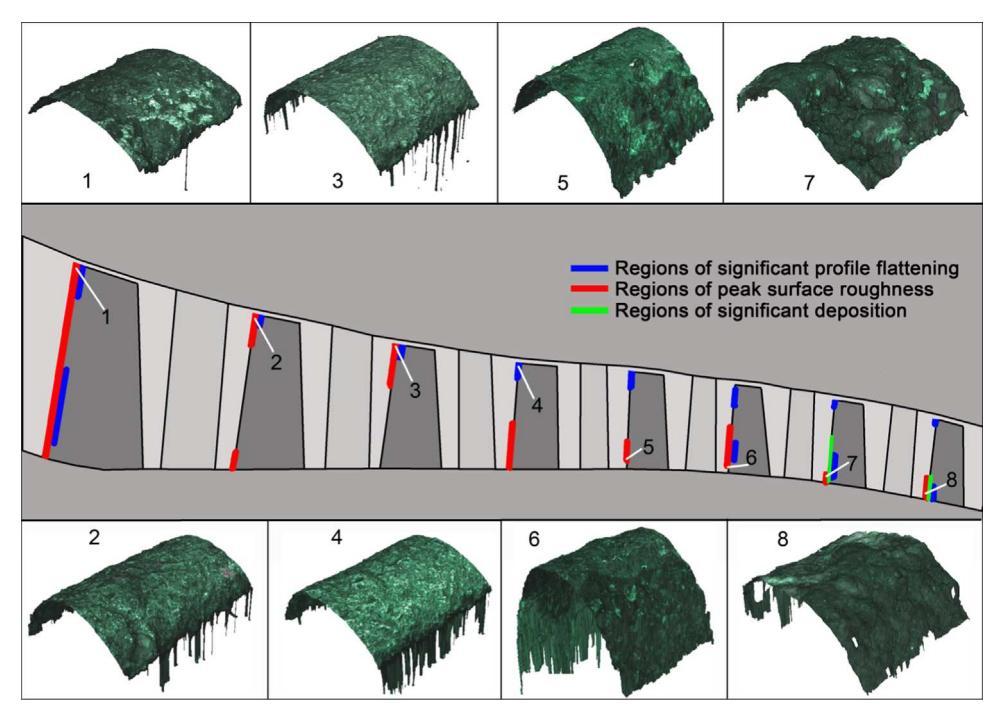
Fig. 9. Schematic annulus diagram of the IPC showing blade number. In red are regions of peak surface roughness. In blue are regions of (relative) pronounced increase of fitted radius due to erosion of profile. Above and below are leading edge fields from the numbered blades in the LE positions indicated by the white lines.

Fig. 9 shows colour coded details for the IPC of the spatial arrangement of leading edge peak roughness and regions of profile flattening (fitted radius increase) due to erosion of the leading edge. A single field image is included for each blade to illustrate typical features of the surface character and geometry. IPC1 shows essentially uniform roughness with the highest mean value in the IPC only exceeded in the compressor as a whole by that of HPC2. This pattern was attributed to the particulates entering the compressor not having yet been subjected to any significant fragmentary or centrifugal action, and hence being relatively large and uniformly distributed. Prior to the onset of deposition at IPC7 (see Fig. 9) it is only the effects of erosion that are characterised in the results.

All IPC blades exhibit some profile flattening erosion at the tip, IPC1–3 exhibit peak roughness at the tip, whereas IPC4–6 show peak roughness nearer the root. IPC7+8 begins to show deposition at the root where peak roughness is seen, it being highest on IPC7. Hence there is no clear correlation between peak erosion and peak roughness, and where deposition occurs it is associated with the highest roughness values.

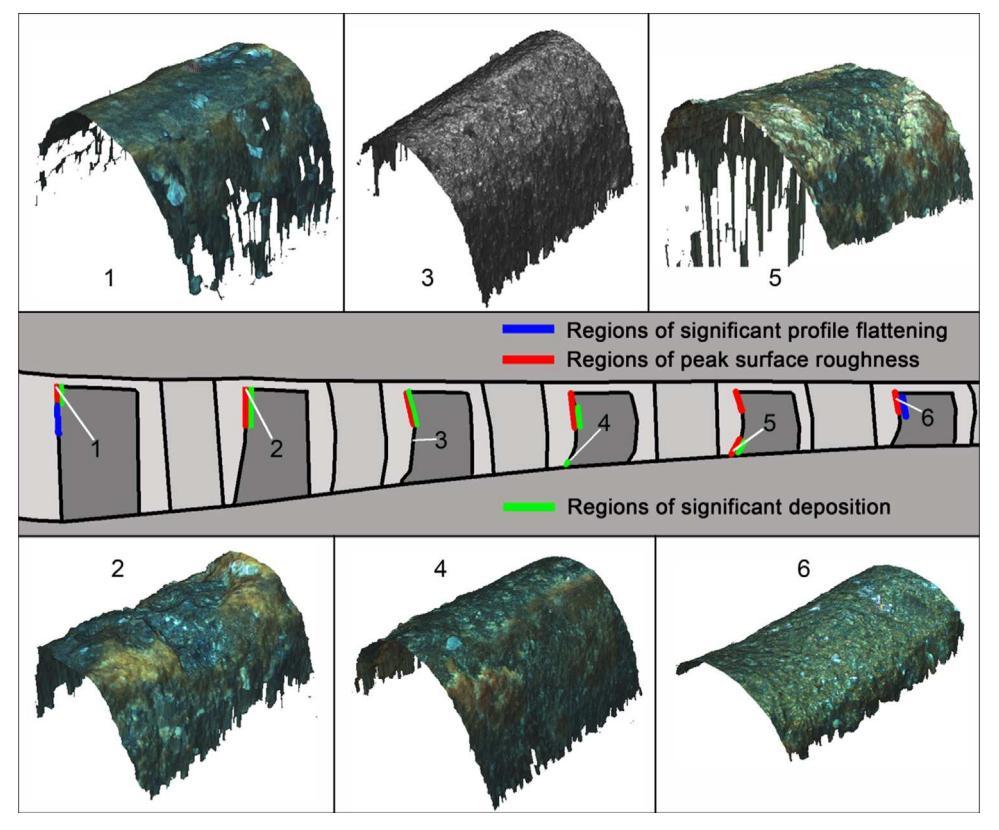
Fig. 10. Schematic annulus diagram of the HPC showing blade number. In red are regions of peak surface roughness. In blue are regions of (relative) pronounced increase of fitted radius due to erosion of profile. Above and below are leading edge fields from the numbered blades in the LE positions indicated by the white lines.

Figure 11 details the same information as Fig. 9 but for the HPC, peak roughness always occurs towards the blade tips, and is seen to be associated with erosion and deposition. Little profile

flattening erosion is evident, HPC1 having the most notable region and to some extent at the tip of HPC6. The much reduced erosion levels in the HPC are attributed to the aggregated fragmentation effects on the flow particulates of the blades from the proceeding compressor rows. This explains the erosion seen on HPC1 but it is not clear why erosion is noted at HPC6. Deposits are also seen extensively at the blade roots of HPC (4)+(5), see Fig. 10 (4)+(5), with the mid spans in general showing little evidence of significant erosion or deposits, typified by HPC3 (Fig. 10 (3)).
