Influence of Immersion Lithography on Wafer Edge Defectivity

K. Jami, I. Pollentier, S. Vedula and G. Blumenstock ¹KLA-Tencor ²IMEC ¹USA ²Belgium

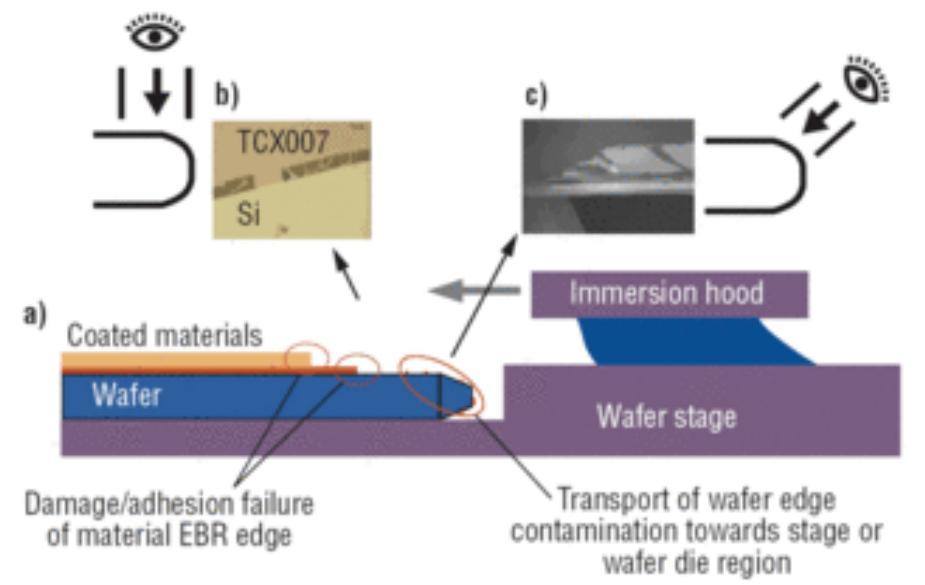
Fig. 1. a) Schematic representation of possible defect issues with immersion lithography; b) example of damaged photoresist material inspected with top-down optical microscope; and c) example of damaged residues at the wafer edge, inspected by tilted SEM (45°).

Immersion lithography [1-4] has changed the way we view defectivity issues at the wafer edge significantly. During the immersion exposure sequence, the wafer edge is in contact with the water from the immersion hood (IH), introducing additional concerns beyond direct contact of resist with the scanner. First, when the IH is scanning in the EBR region, its movement can damage material edges (Fig. 1a). IMEC's program on immersion lithography found that, for example, photoresist material can partially peel off during the IH pass (Fig. 1b).

A second concern involves the cleanliness of the wafer edge outside the EBR edges. The IH pass wets not only the near-edge top surface, but also the curved wafer edge and even part of the bottom surface. Defects can be released from this area and re-deposited either on the wafer or on the wafer stage. In the first case, there will be a direct impact on the wafer defectivity. In the latter case, defects present on the wafer stage can be transported onto wafers in subsequent wafer processing. IMEC's program on immersion lithography found that resist residues left on the curved wafer part by an incomplete EBR step can be damaged by the IH pass, releasing fragments into the system (Fig. 1c).

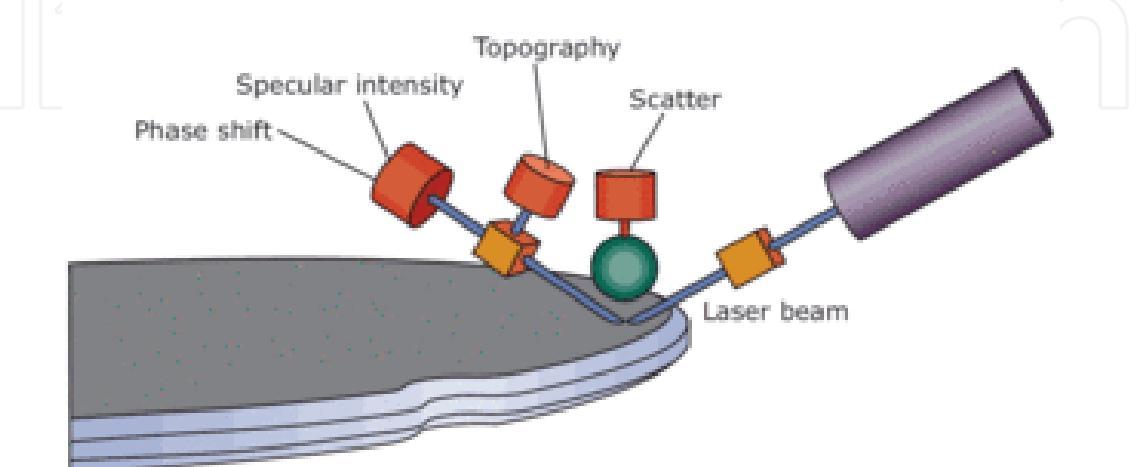
The new measurement system for wafer edge defect inspection (Fig. 2) is based on a laser source directed to the wafer edge surface. Three detectors simultaneously collect the scattered light, the specular or reflected light and the phase difference between different polarization states. As the laser scans the wafer edge surface, each signal can be converted into an image. Each type of defect produces a specific combination of signals from the three detection channels, allowing automated defect classification.

Fig. 2. Schematic representation of the VisEdge measurement principle.

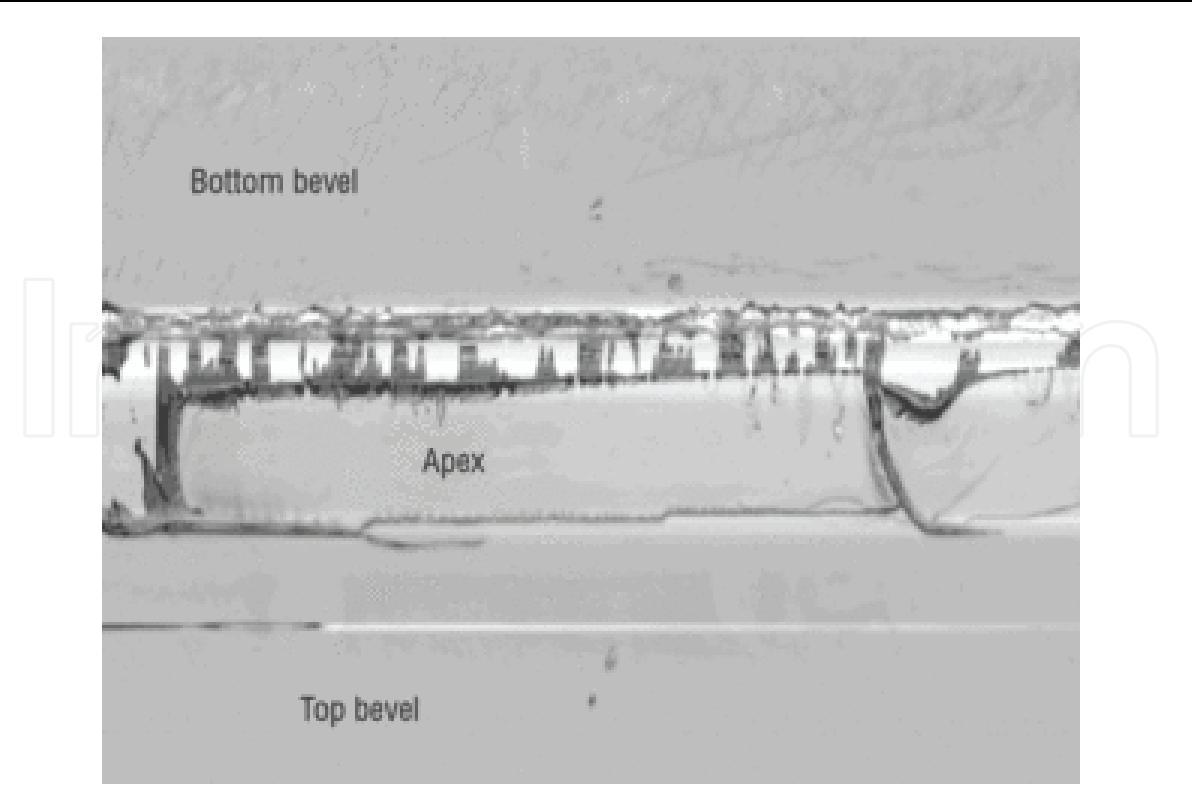
Fig. 3. Example of a specular image using the new technology showing part of the bevel/ apex region. This kind of representation is valuable for the evaluation of wafer edge quality.

For wafer edge cleanliness, a high-resolution view of the wafer edge is typically more useful. Here, the images view only a few millimeter of the edge. Figure 3 uses this representation to show resist flakes observed along the apex-bevel regions in the specular channel.

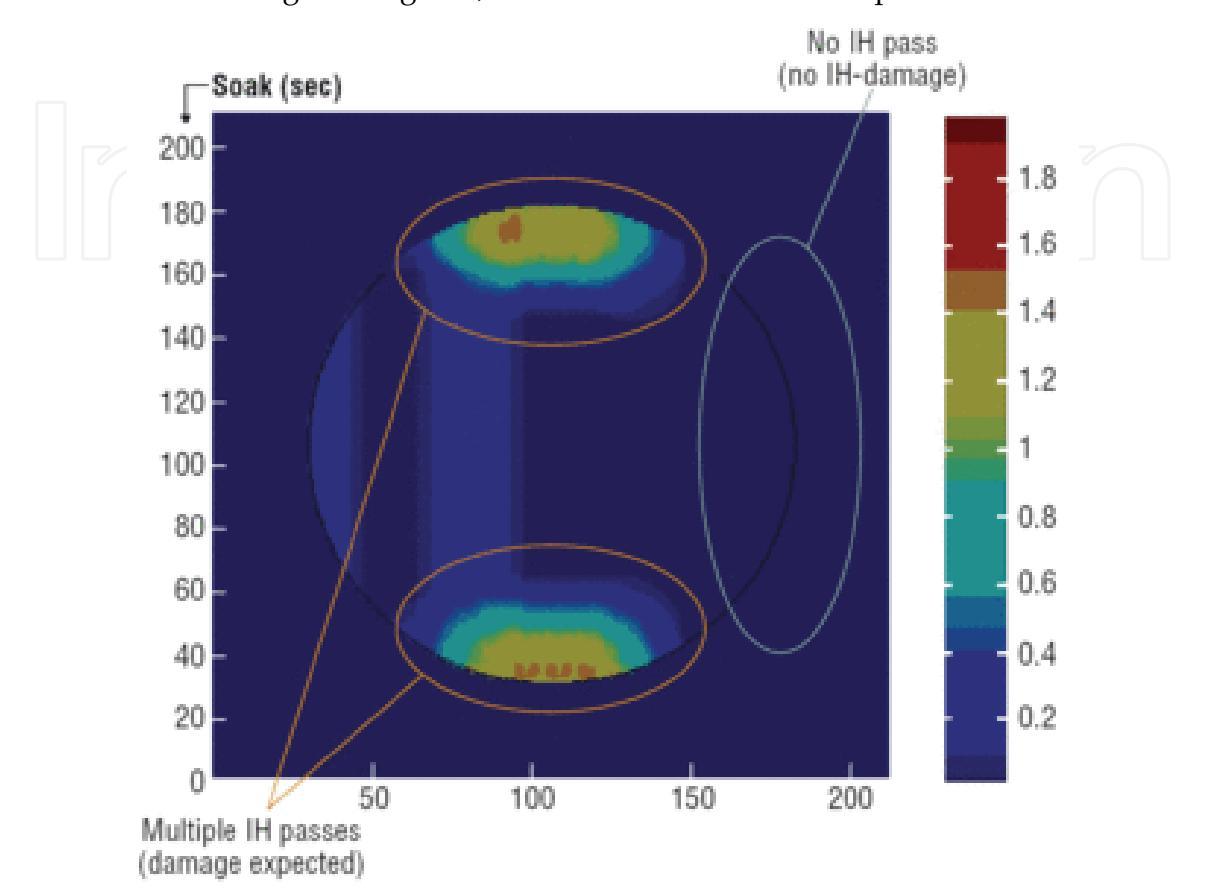
We experimented with three resists with different chemistries (**Fig. 4**). Sensitivity to edge damage was expected to vary across the three resist types. A dedicated exposure job spatially separated the areas where flakes are expected and where they are not expected. One section, consisting of two rows of 11 fields, was exposed close to the wafer edge at the opposite side of the notch. A similar area of two rows of 11 fields was exposed in the region of the notch. During the exposure of these 2×11 sections at both locations near the wafer

edge (Region II), the IH makes continuous up- and down-scans over the wafer edge area, increasing the probability of defect generation. The exposure job was also designed so that on another part of the wafer (Region I, on the right hand side), the immersion hood did not pass over the wafer edge. In Region I, no flake-like defects were expected.

Fig. 4. IH exposure sequence for edge flake characterization.

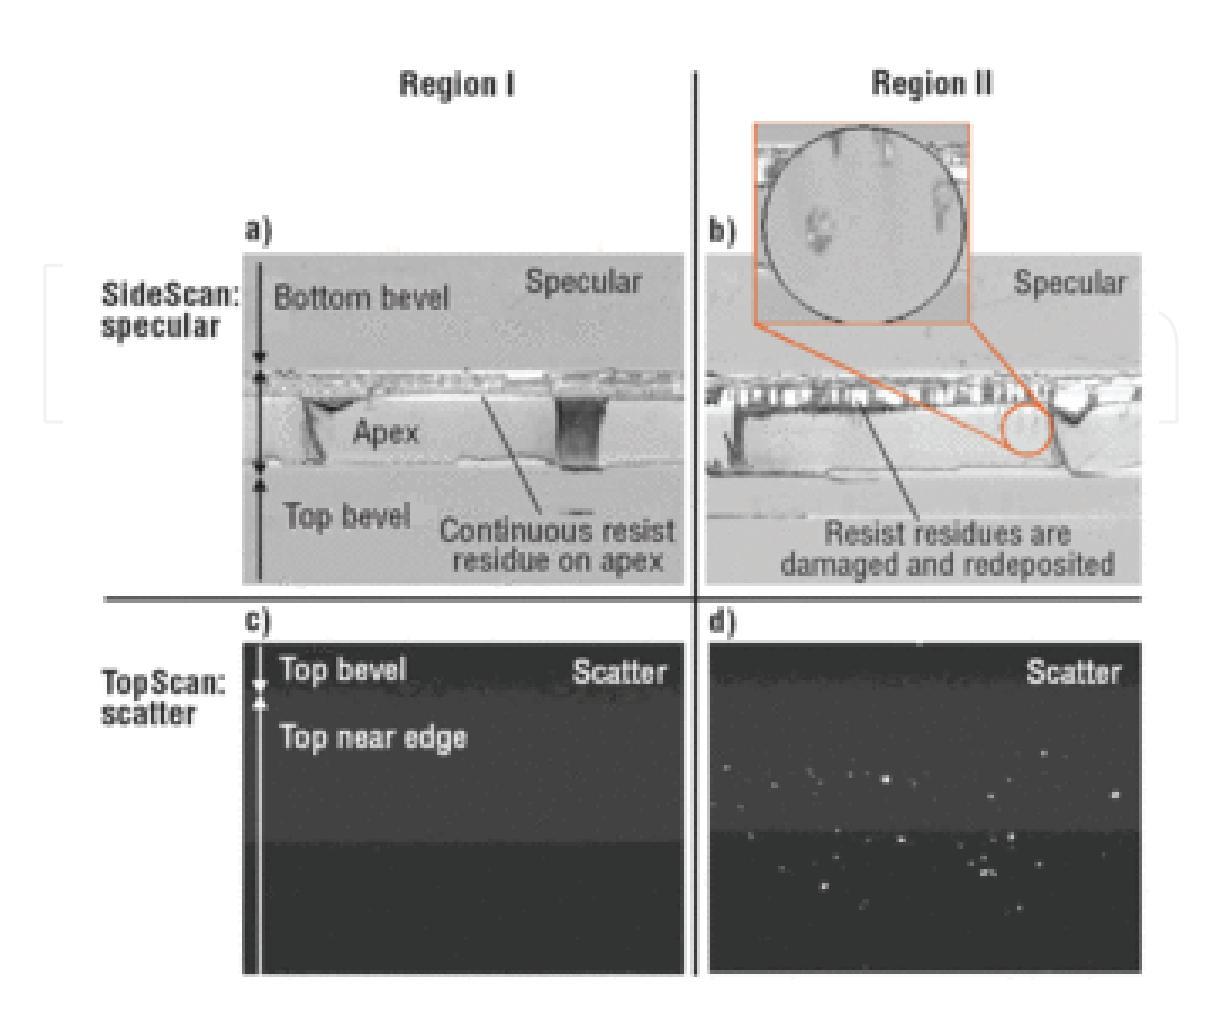
We compared the SideScan images of areas where the IH did and did not pass. Figure 5a is a typical SideScan specular image for region I (where the IH did not pass). Differences in thick and thin resist residues are visible, but no fragments of the resist residues are evident. In contrast, in Fig. 5b, taken from Region II, indicated that parts from the thick residue at the bottom of the apex were released. The close-up in the image indicates that some of these edge flakes were re-deposited on the apex closer to the top.

To determine whether any of these edge flakes end up on the top region (where edge die can be damaged), we analyzed the TopScan image of the corresponding areas of Fig. 5a and 5b using the scatter channel, as shown in Figs. 5c and 5d. In Region II, a lot of particles were detected, while in Region I, no particles were observed in the images. This observation was encouraging for further ADC work.

Fig. 5. Specular and scatter images from Region I (a and c) and Region II (b and d) of a test wafer. IH damage is more likely in Region II.

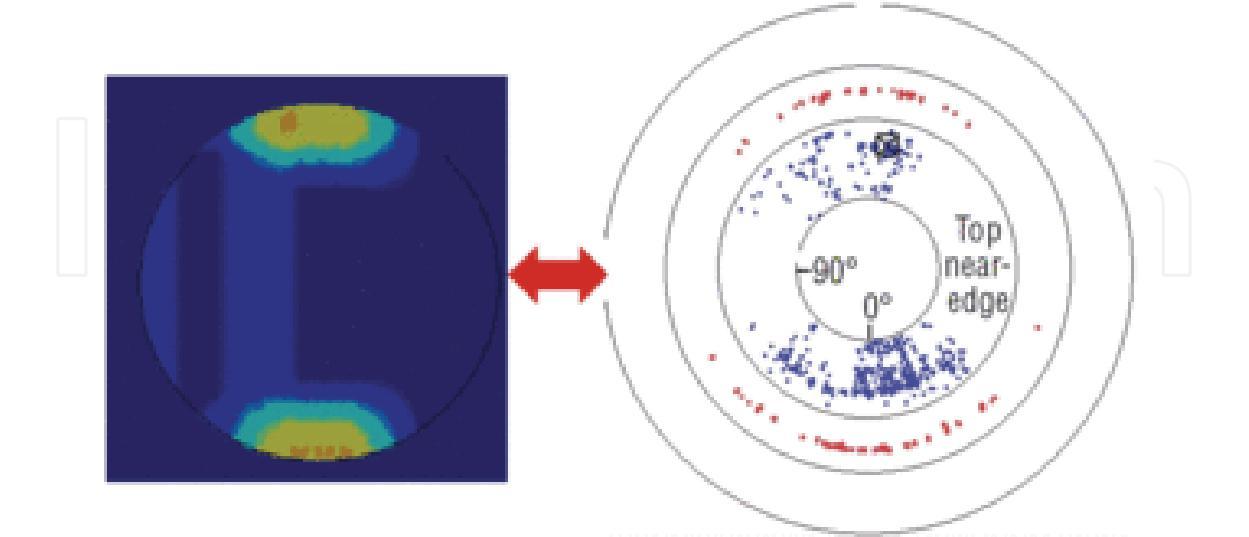
Fig. 6. Immersion characterization (quantification of edge flakes at wafer edge); the flakes on the apex and top near edge can be quantified by composite analysis of SideScan and TopScan signals.

channel of the SideScan image. For re-deposited defects in the top near-edge region, a combination of signals in the specular and scatter channels gave more accurate classification. Once all the measurement parameters for both areas are fixed, they can be combined in a single measurement sequence that provides defect classification and mapping for all the wafer edge areas of interest. (Fig. 6).

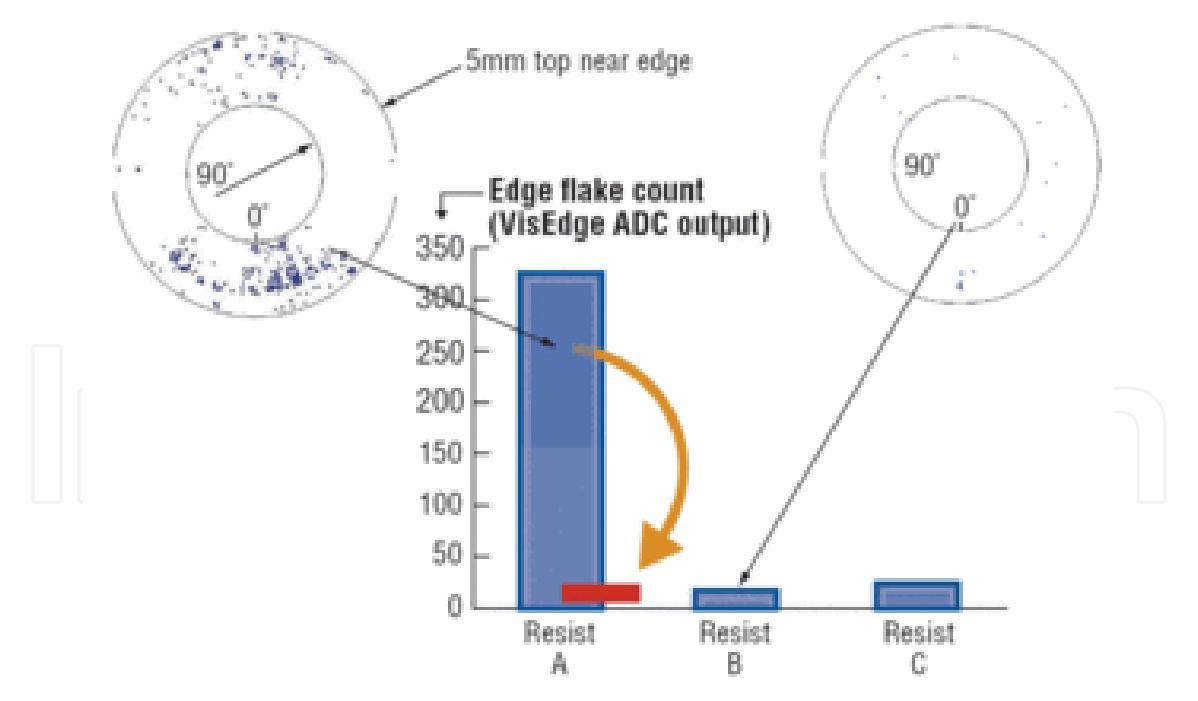
When the same immersion exposure was used, significantly fewer edge flakes were detected in the near top region for Resist B and C than for Resist A (Fig. 7). Moreover, the residual defects were less confined to the exposure zone, so some of these defects might be caused by coating and wafer handling. In the TopScan images, no clear sign of damage was seen. Clearly the choice of resist chemistry can be important to prevent these kinds of defects.

As indicated earlier, resist residues can be optimized by changing the EBR recipe on the coat track. Resist A showed several hundred defect flakes with the regular (short) EBR sequence. After optimization, this resist achieved defect values similar to the background values obtained with the non-flaking resists B and C.

Fig. 7. Edge flake defects as a function of resist chemistry and EBR recipe.
