Brazing Titanium-Vapor-Coated Zirconia

High-strength braze joints were obtained through the use of titanium vapor coatings to promote wetting on partially stabilized zirconia

BY M. L. SANTELLA AND J. J. PAK

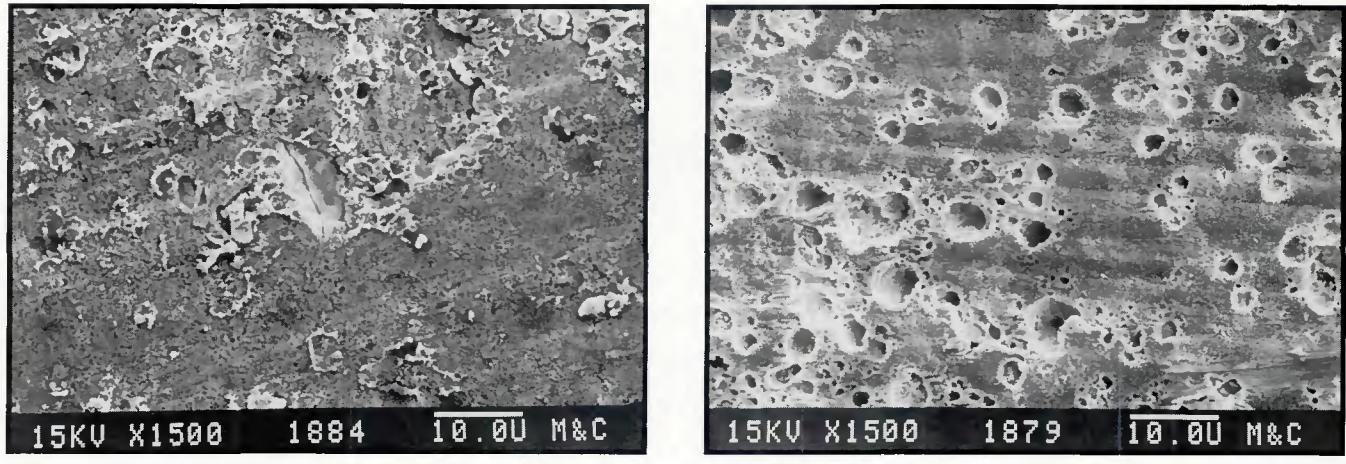
Fig. 1 — SEM micrographs. A — ZrO₂ surface ; B — braze filler metal surface after fracture by shear testing at 25°C.

All of the ZrO_2 -Fe and ZrO_2 -Ti joints fractured at the interface between the ZrO_2 and the braze filler metal, and these surfaces were examined in detail in an SEM. Figure 1A shows the typical appearance of a sputter-coated ZrO_2 surface after joint fracture at either test temperature. Small fragments of braze filler metal remained bonded to the ZrO_2 , but, overall, the surface appeared to be relatively undisturbed by brazing and shear testing. The appearance of the mating braze filler metal surface (Fig. 1B) showed that a considerable amount of porosity formed at the interface between

the ZrO_2 and the braze filler metal during brazing. This condition was observed over the entire area of contact for all of the braze filler metal interfaces regardless of whether the ZrO_2 was brazed to nodular cast iron or Ti. In some cases the contact area of the braze filler metal on the ZrO_2 was reduced by as much as 60%. This situation would be detrimental to joint strength and integrity at any temperature.

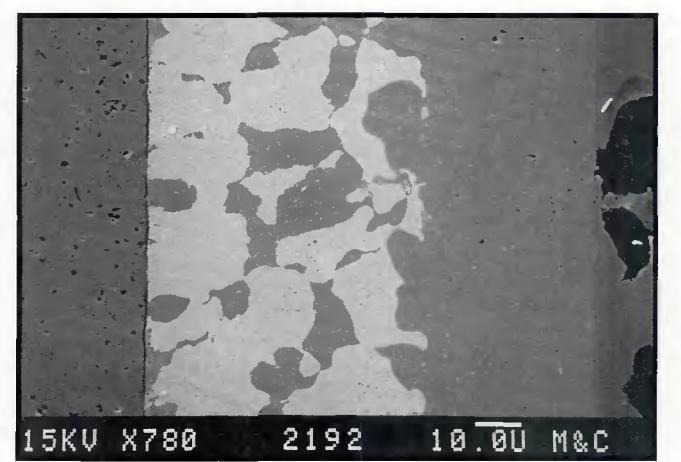
Fig. 2 — Microstructure of Ti-vapor-coated ZrO_2 brazed to Cu-plated nodular cast iron.

A cross-sectional view of the microstructure of a ZrO2-Fe joint is shown in Fig. 2. The total thickness of the joint including the Cu coating was about 100 µm. The thickness of the Cu coating and the braze filler metal foil was the same (50 µm) before brazing, but after brazing, the thickness of the Cu coating was about 40 µm, indicating that it dissolved partially in the braze filler metal. The thicknesses of braze layers in the ZrO2-ZrO₂ joints were typically in the range of the original thickness of the filler metal foil. Both the ZrO2-Fe joints and ZrO₂- ZrO₂ joints were virtually porosity-free when examined metallographically.

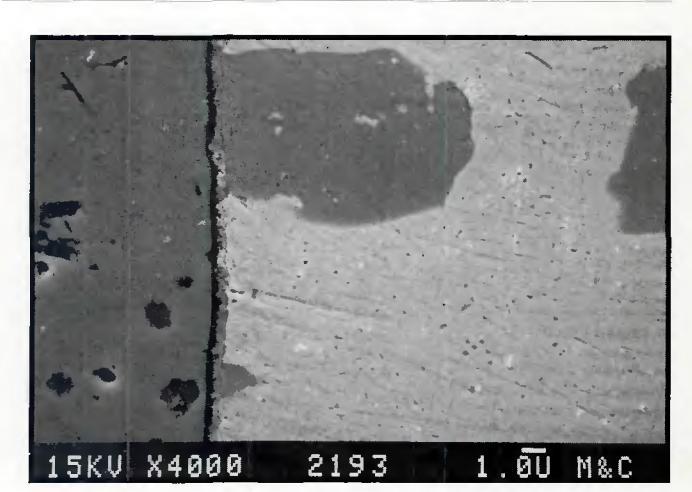
Fig. 3 — Microstructure at Ti-vapor-coated ZrO_2 surface after brazing with a Ag-30Cu-10Sn wt-% filler metal.

At higher magnification (Fig. 3) two layers can be seen at the Ti-vapor-coated ZrO₂ surface after brazing. Microchemical analysis in the SEM indicated that the dark layer directly in contact with the ZrO₂ was the remnant of the original Ti vapor coating. The second layer, which formed between the Ti vapor coating and the braze filler metal, had an average composition of 22Ag-30Cu-25Sn-19Ti-4Zr wt-%. Figure 3 indicates

that the Ti vapor coating isolated the ZrO_2 from direct contact with the liquid filler metal, and that wetting was accompanied by reaction of the braze filler metal with the Ti coating to form a metallic or intermetallic reaction layer. The combined thickness of the two reaction layers was approximately the same as the thickness of the Ti vapor coating before brazing, nominally 0.6 µm.

The other features shown in Fig. 3 are the Ag-rich and Cu-rich braze filler metal phases, which appear as light and dark regions, respectively, and the ZrO_2 . The dark features in the ZrO_2 are actually pores, which were not eliminated during sintering of the oxide. The microstructure at the brazed ZrO_2 surface was the same for joints of ZrO_2 - ZrO_2 and ZrO_2 -Fe.

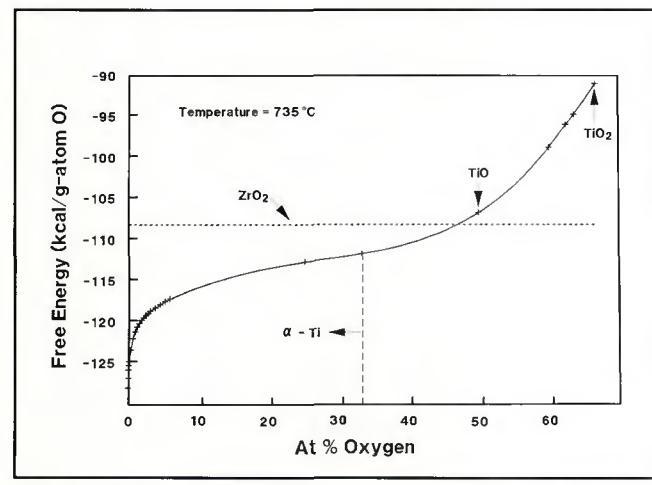
Fig. 4 — Free energy of ZrO_2 and titanium oxides (Ref. 21) and Ti-O solutions (Ref. 23).

On the other hand, diffusion of oxygen from the ZrO2 into the Ti was considered likely because O is relatively mobile in ZrO2, and because it is interstitially soluble in α-Ti up to 34 at.-% (Ref. 22). Insight into this possibility was gained by examining the free energies of Ti-O solutions, and comparing them to the free energy of formation of ZrO₂ at 735°C. Figure 4 plots the variation of partial molar free energy of oxygen in Ti-O interstitial solutions (Ref. 23) against O concentration, and indicates both the limit of O solubility in Ti at 735°C and the free energies of formation of stoichiometric titanium oxides (Ref. 21). The dashed horizontal line indicates the free energy of formation of ZrO₂ at the same temperature (Ref. 21) As Fig. 4 shows, Ti-O solutions are more stable with respect to ZrO₂ than are Ti oxide phases. The high thermodynamic stability of Ti-O solutions coupled with the high gradient of O concentration across the ZrO₂/Ti interface and the good mobility of O indicate that the for-

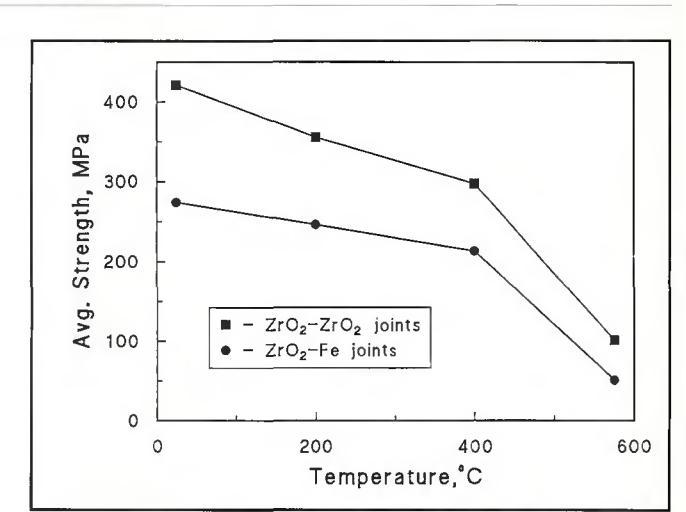
Fig. 5 — Average strength of ZrO_2 - ZrO_2 , ZrO_2 -Fe, and ZrO_2 -Ti joint test specimens vs. test temperature.

Specimens from both ZrO_2 - ZrO_2 and ZrO_2 -Fe joints were used for flexure testing, and a summary of the fracture strength (σ_f) data is given in Table 2. The average joint strength is plotted against test temperature in Fig. 5, and the strength data from tests at room temperature and 400°C are plotted using the Weibull distribution function in Fig. 6 for the ZrO_2 - ZrO_2 joint specimens, and in Fig. 7 for the ZrO_2 -Fe joint specimens. Linear regression analysis was used to determine the Weibull modulus numbers, m, and to fit straight lines through the data.

Figure 5 shows that the average strength of the ZrO_2 - ZrO_2 and ZrO_2 -Fe joints decreased moderately with increasing temperature up to 400°C, and then showed a more marked decrease at 575°C. Also, the strength of the two types of joints converged somewhat as the test temperature was increased.

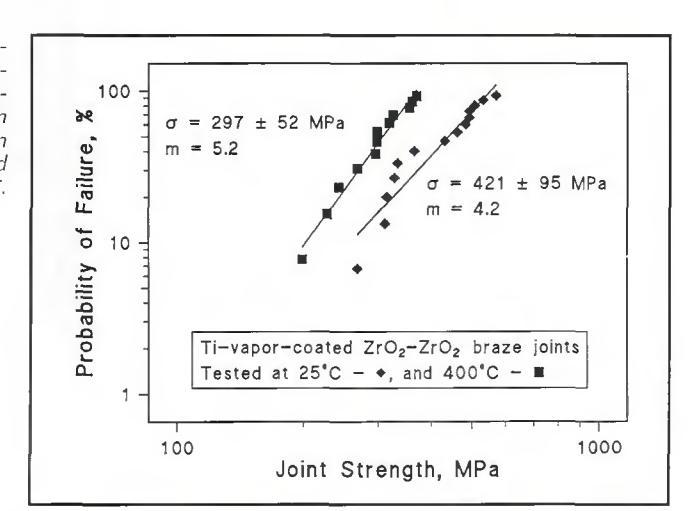
Fig. 6 — Weibull distribution plot of ZrO₂-ZrO₂ braze joint fracture strength data from tests done at room temperature and 400°C.

The Weibull plots show graphically the distribution of joint strengths at room

temperature and 400°C. Not only did the joint specimens fracture at stress levels below the average fracture strength of monolithic ZrO_2 , but the scatter in the joint strength data was also much greater. Typical Weibull modulus values for this ZrO_2 are in the range of m = 20, which corresponds to a standard deviation in strength near 30 MPa (4.35 ksi).

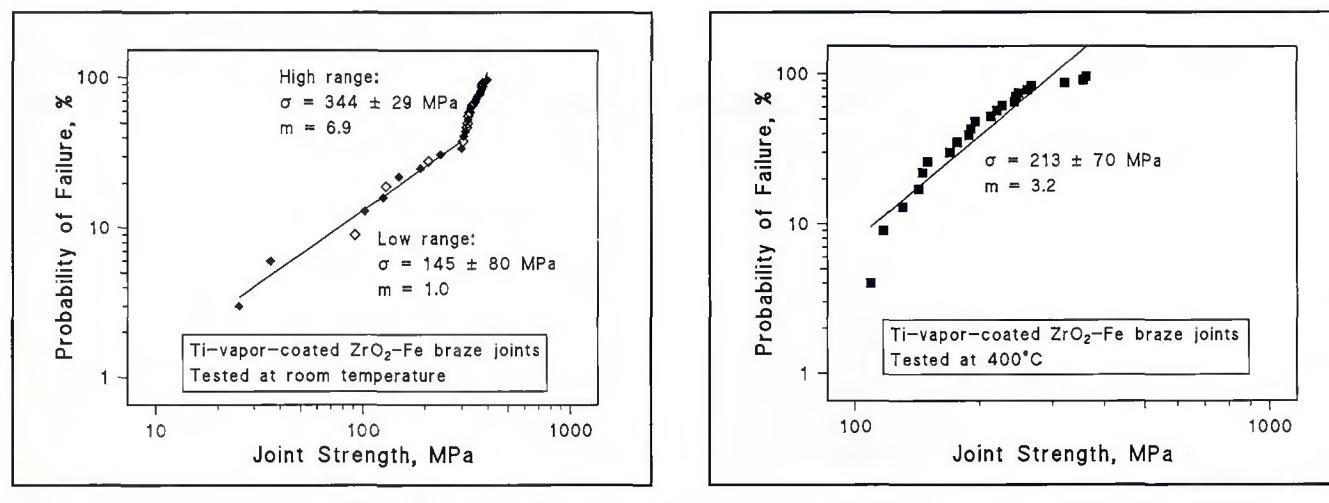
Fig. 7 — Weibull distribution plot of ZrO₂-Fe braze joint fracture strength data from tests done at: A — room temperature; B — 400°C.

For the ZrO_2 -Fe joints tested at room temperature, some of the specimens had joint surfaces that were left in the asground condition, while others had joint surfaces that were lapped to a 1-µm-diamond finish before vapor coating with Ti. The Weibull plot of these data, shown in Fig. 7A, indicates that lapping of the joint surfaces did not improve joint strength. Another interesting feature of this data set was that the best linear regression fit was obtained with two lines rather than one. This implies there were two flaw populations responsible for the strength behavior of these joints.

The ZrO₂ half of a ZrO₂-Fe joint specimen tested at room temperature is shown in Fig. 9, and the appearance of this fracture surface is representative of specimens from the high range of joint strength referring to Fig. 7A. These specimens were characterized by relatively flat regions near the tensile faces of the flexure bars, and other areas where large fragments of ZrO2 were pulled out of the base metal. Detailed examination indicated that the fracture path in the flatter areas was through either the ZrO₂ or the intermetallic layer near the ZrO2/Ti interface. The fracture surfaces of ZrO2-Fe specimens with polished joint surfaces did not exhibit the large pulledout ZrO2 areas. Nevertheless, failure in these specimens was primarily through the ZrO₂ near ZrO₂/Ti interfaces. Failures of ZrO₂-Fe specimens in the low range of joint strength were the result of debonding at either the ZrO₂/Ti interfaces or the cast Fe/Cu interfaces, or of incomplete bonding during brazing.

The data in Fig. 7A also clearly show that there is no advantage to lapping the joint surfaces compared to using them in an as-ground condition. No surface microcracking was observed on metallographically prepared specimens of ZrO₂ or by dye penetrant examination. Nevertheless, some concern remained about the possible effects of surface damage owing to the findings of Mizuhara and Malley (Ref. 29) and some of the ZrO₂-Fe tests coupons were made with lapped ZrO₂ joint surfaces. Lapping removed 50 to 100 µm of material from the ZrO₂ surfaces and should have removed any machining damage that may have been present (Ref. 30). The only explanation that can be offered for this behavior is that the superior toughness of the MS-ZrO₂ compared to other ceramics (*e.g.*, Al_2O_3 or Si₃N₄) was responsible for its relative insensitivity to surface damage induced by grinding.

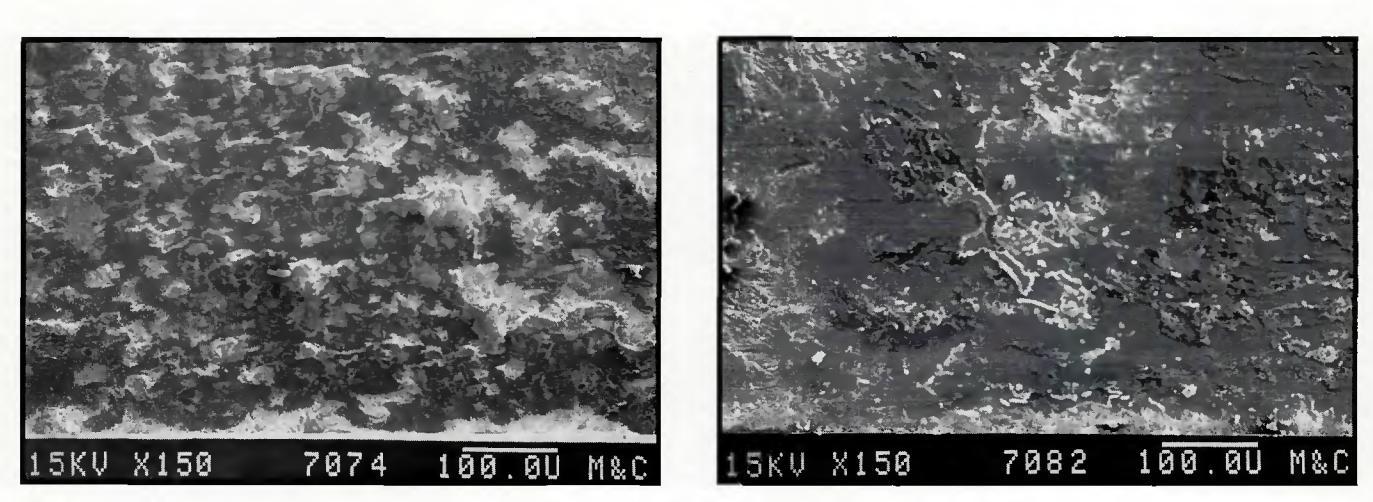
Fig. 8 — SEM micrographs of ZrO_2 - ZrO_2 joint specimens tested at 25°C: A σ_f = 571 MPa; B — σ_f = 269 MPa.

The fracture surface of one half of a high-strength ($\sigma_f = 571$ MPa; 82.8 ksi) ZrO₂-ZrO₂ joint tested at room temperature is shown in Fig. 8A. The fracture surface was relatively planar. However, closer examination showed that the fracture appearance of most of the surface was similar to that of monolithic ZrO₂. Further examination and microchemical analysis confirmed that failure in this specimen occurred in the ZrO₂ just below the ZrO₂/Ti vapor coating interface. The fracture appearance of a lower strength ($\sigma_f = 269 \text{ MPa}$; 39 ksi) specimen tested at room temperature is shown in Fig. 8B. In this case, some fracturing occurred in the ZrO2, but the relatively large smooth areas shown in Fig. 8B indicate that failure also was accompanied by a large amount of debonding between the ZrO₂ and the Ti vapor coating. No quantitative metallography was done on the fracture surfaces, but examination of several specimens suggested that fracture strength varied inversely with the amount of debonding at the ZrO₂/Ti interface.

Debonding, or loss of adhesion, at ZrO₂/Ti-vapor coating interfaces was clearly an important factor in determining ZrO2-ZrO2 joint strength. The SEM observations from ZrO2-ZrO2 joint specimens tested at 25°C indicated that the highest strengths were associated with partial or complete fracturing of the ZrO2 beneath the Ti-vapor-coated surfaces. The high-strength ZrO2-ZrO2 joint specimens failed almost entirely through the ZrO₂. In contrast, the trend for lower strength specimens was for failure to occur by debonding at the ZrO₂/Tivapor coating interfaces. The frequency of debonding at ZrO2 interfaces as a failure mode increased at 200°C, and debonding was the predominate failure mode at 400°C. Joint strength decreased progressively with temperature, and as was observed for room temperature testing, joint strength at a particular elevated temperature was roughly an inverse function of the debonded area on the ZrO₂ surfaces. Taken all together, these observations show that the ZrO₂-ZrO₂ joint strength had a strong dependence on the adhesion of the Ti vapor coating to the ZrO₂ surfaces.
