Intra-Pelvic Migration of Sliding Hip Screw During Osteosynthesis of Hip Fracture: A Rare Avoidable Intraoperative Complication

Case Report: We report a case of a 90-year old Caucasian woman who had an unusual intraoperative complication during osteosynthesis procedure for extracapsular hip fracture fixation. In fact, the sliding hip screw went deep into the pelvis during surgery. This mishap required an abdominal surgical approach by the general surgeon to remove the screw.

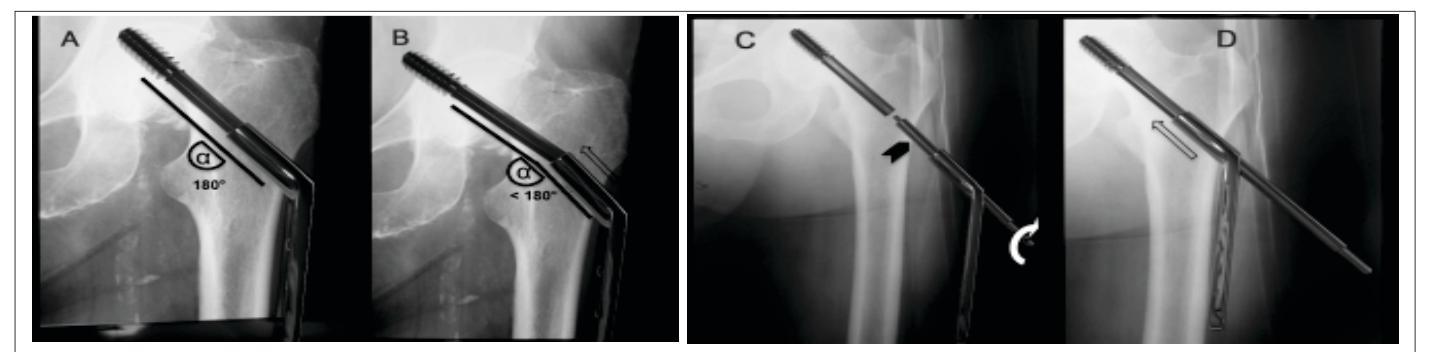
Figure 2: Scheme showing the positioning of the DHS with and without a lag screw extender: A-B: without a lag screw extender - A) Normal sliding of the plate onto the cephalic screw, with an angle of 180°.

B) Incongruence between cervical screw and plate, with an angle of less than 180°. In this situation, when the surgeon pushes the plate to engage the screw (the empty arrow indicates the direction of the force), the acetabulum could break.

C-D: with a lag screw extender -

C) The lag screw extender (arrowhead) is tightened (white curve arrow) on the cephalic screw to guide the plate.

D) Placement of the plate onto the screw using a lag screw extender. This is the easiest and safest mode to slide the plate onto the screw

Our case report underlines the importance of scrupulously following the steps of DHS surgical technique, particularly in the application of a lag screw extender. As a matter of fact, the use of the mallet to slide the plate on the screw should be discouraged. If the plate and the screw are not on the same plane, it is recommended to manually control the rotation of the plate until they are congruent. This should be made mandatory, especially when treating very old osteoporotic patients. Finally, in the event of such an unfortunate complication, we would suggest resorting to an extraperitoneal approach to remove the intrapelvic screw, a far safer and faster procedure.

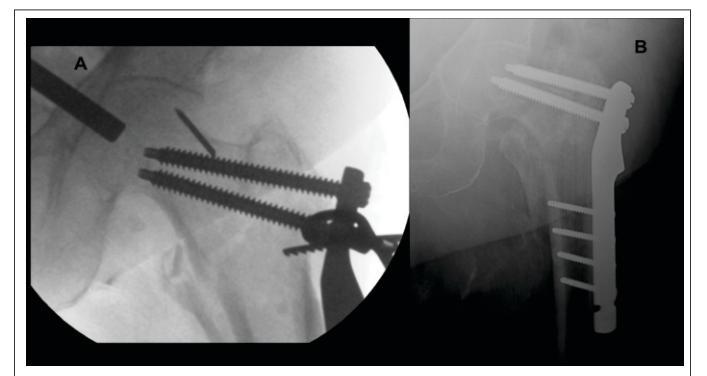
Figure 3: A) Intraoperative positioning of the condylar plate. B) X-ray examination one month after the implant

abdominal approach to remove the screw, which was finally retrieved in a few minutes without any further complications. Meanwhile, the procedure of osteosynthesis was completed using a condylar plate (Fig 3). The patient started postoperative physical reconditioning three days after, with only one day's delay compared to standard procedure.
