ORIGINAL ARTICLE

Characterization of the soil and rock hosting an aquifer with possible uses for drinking water and irrigation in SE Panama City using Geotechnical, Geophysical and Geochemical parameters

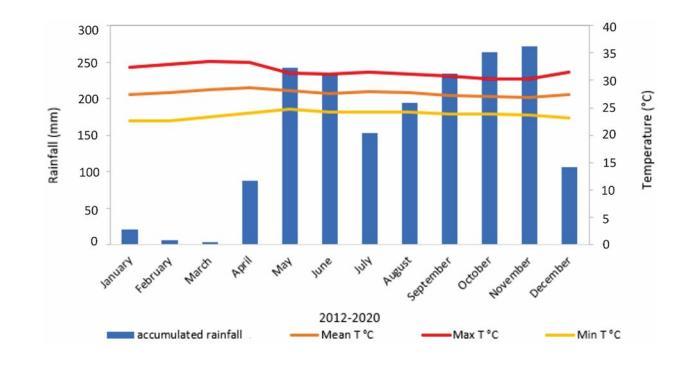
Fig. 2 Climograph: Tocumen weather station 2012–2020

The area has a characteristic tropical climate (Awi type, savanna tropical climate) according to the Köppen climate classification map, with annual rainfall > 1000 mm (Dirección de Hidrometeorología de ETESA 2007). Figure 2 shows the climograph with ETESA meteorological station data from 2012 to 2020 (Dirección de Hidrometeorología de ETESA 2021). We can see that the dry season includes the months of January to March (lowest rainfall) and the rainy season goes from April to December, when the rainiest months are October and November. Regarding the environmental temperature, the highest temperatures occur in dry months.

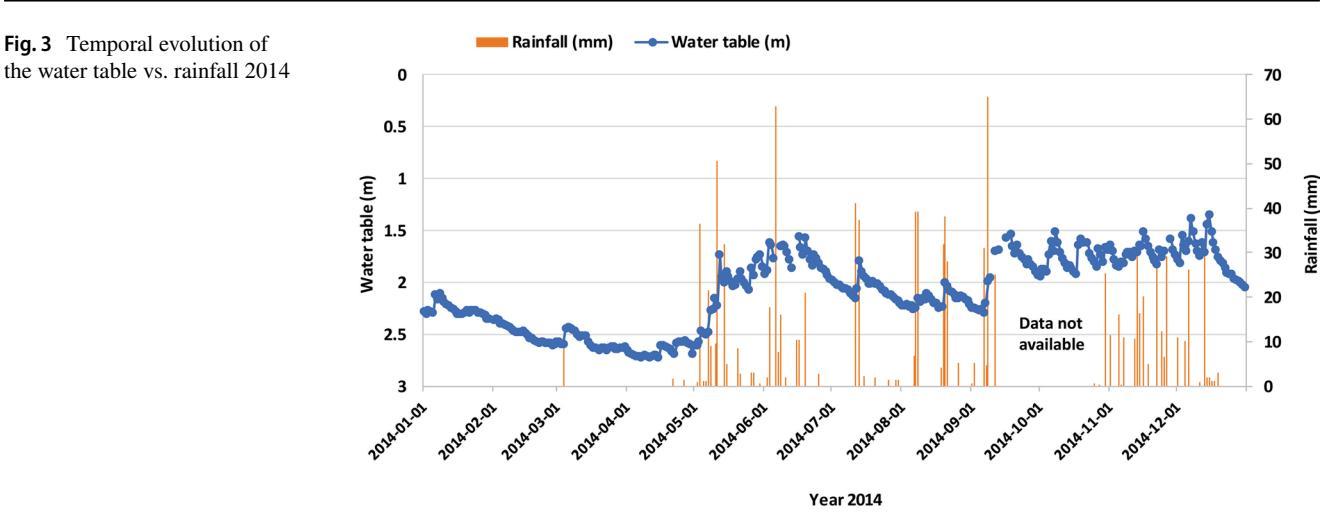
The aquifer's recharge is very important (Abiye et al. 2018; Barbera et al. 2018; Healy and Cook 2002; Martínez et al. 2017). Figure 3 shows the graph of the temporal

evolution of the watertable in the studied well (Centro de Investigaciones Hidráulicas e Hidrotécnicas 2016) vs. rainfall (Dirección de Hidrometeorología de ETESA 2021) for 2014, which shows that the rainfall in the area directly influences the watertable in the well, because in dry months, the water level lowers when rain is absent. The much higher rainfall that falls during the rainy season rapidly produces a net recharge of the water level in the well.

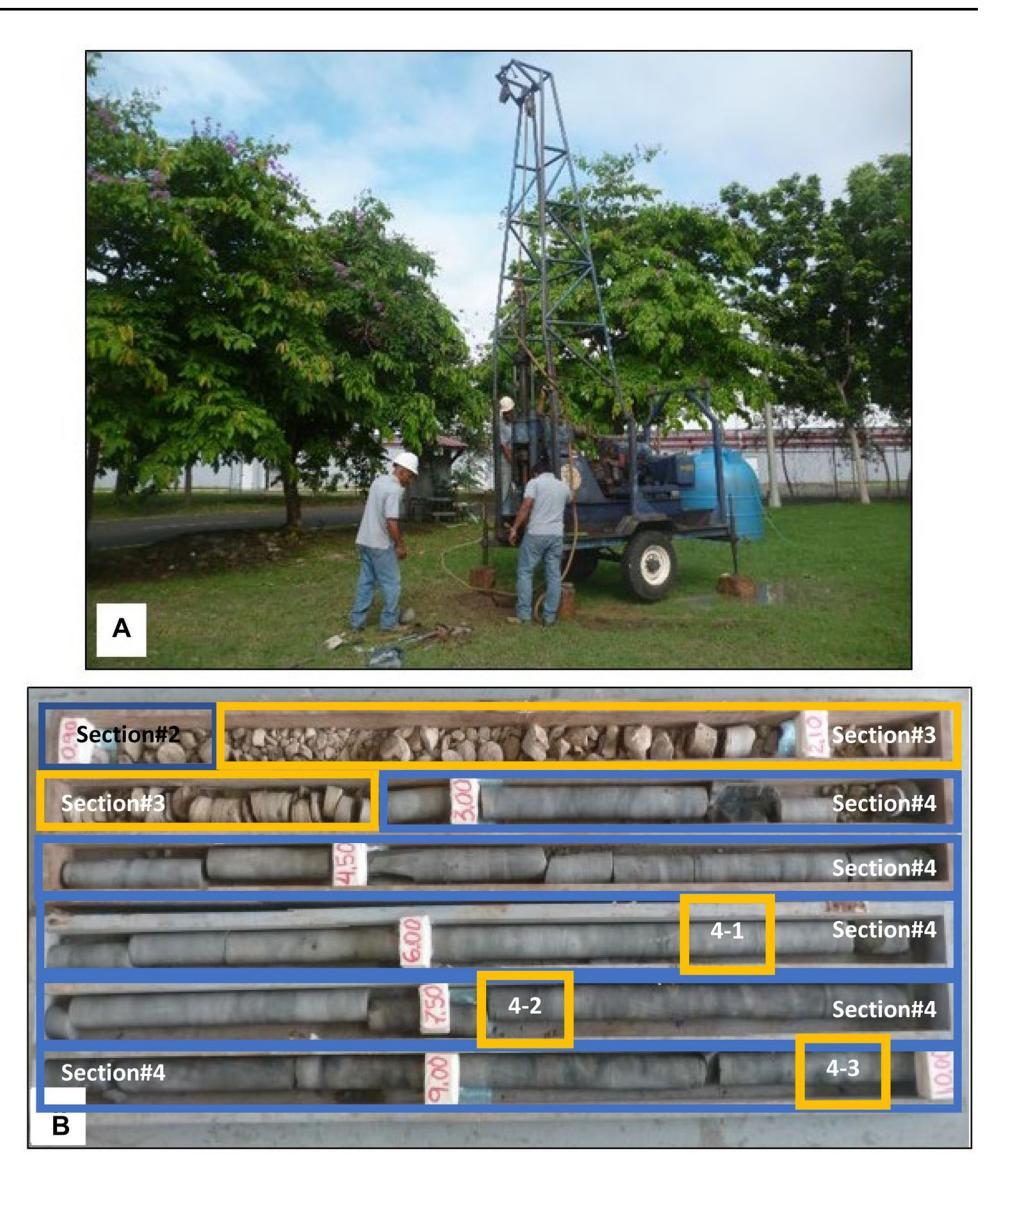
Fig. 4 Study area: (**a**) drilling of well; (**b**) lithological logs of drill cores. The different lithological sections described in the location of the three subsamples 4 are indicated

Four samples were taken from the drill's profile, corresponding to the different lithologies observed on it (Table 1; Fig. 4). The samples corresponding to complete soil and to fragments of underlying rock were taken using gloves, stored in plastic bags and kept at room temperature until analysis.

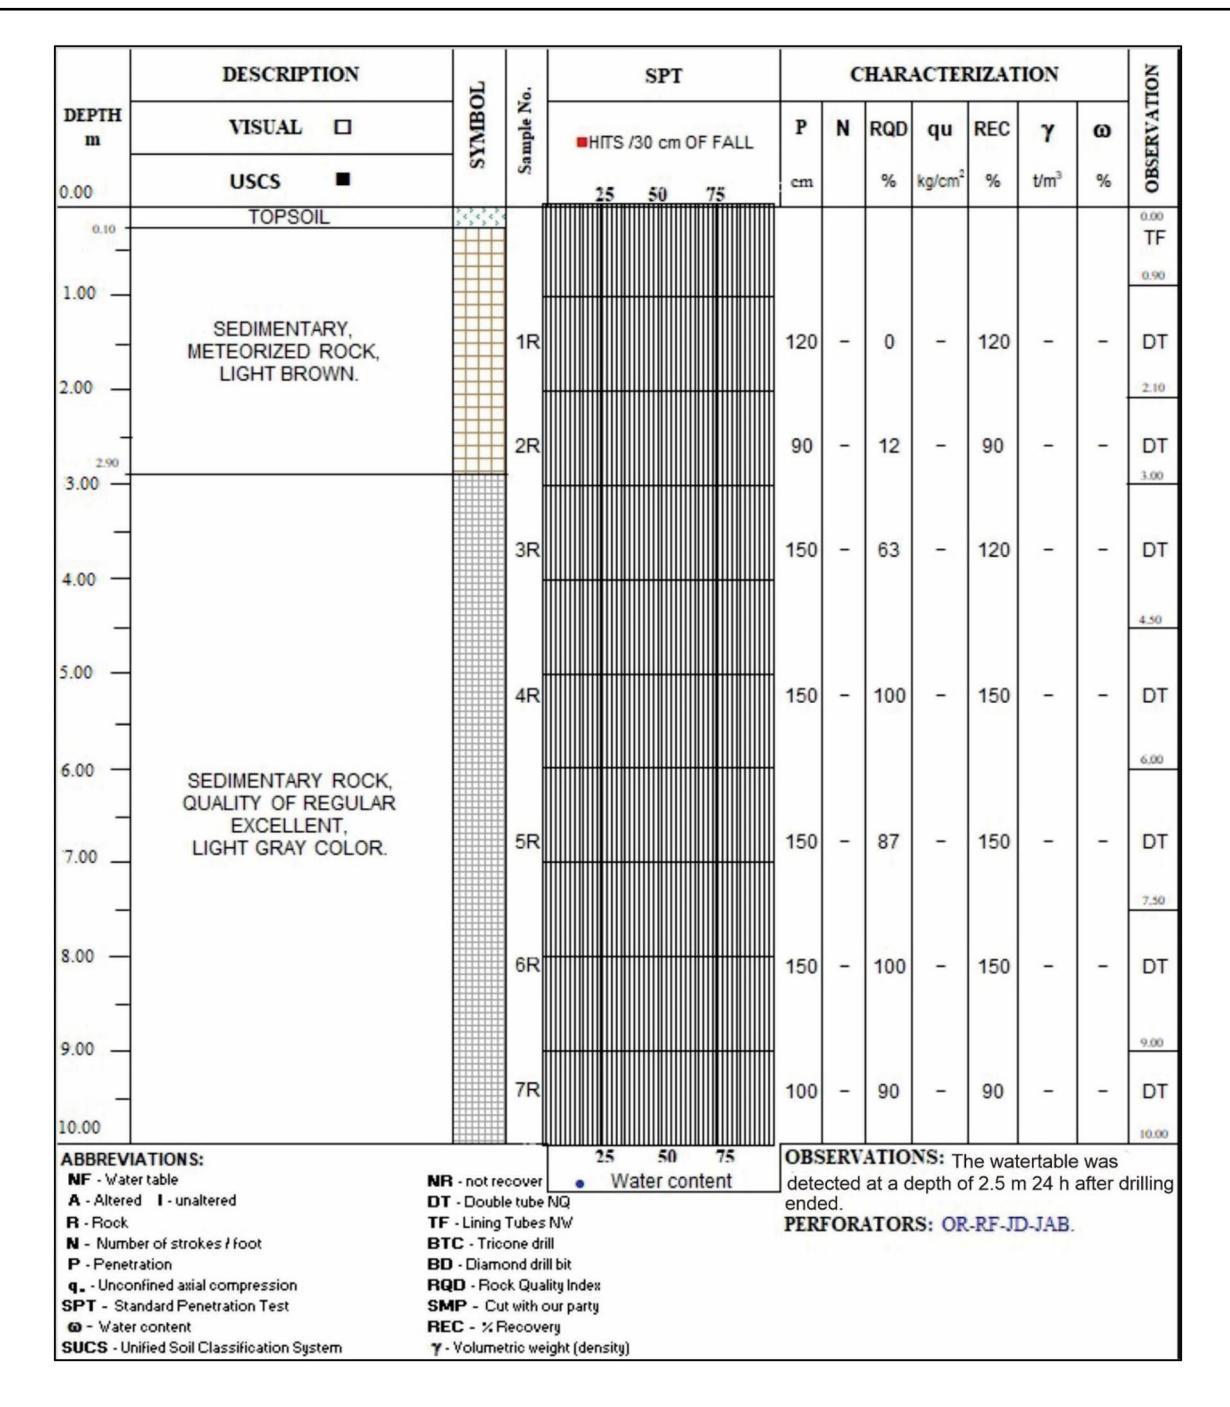
Fig. 5 Drilling profile of the drill hole

The results of the axial compression test carried out on three subsamples of sample 4 (4-1, 4-2, 4-3) are presented in Table 3. These values can be considered normal for lutitic rocks (Kiamco et al. 2004). As well, the results of the visual inspection of discontinuities observed in the rock within the interval 2.9 to 10 m (samples 3 and 4) are presented in Table 4. Figure 5 shows the drilling profile at a 10-m depth and indicates the parameters estimated by visual inspection.

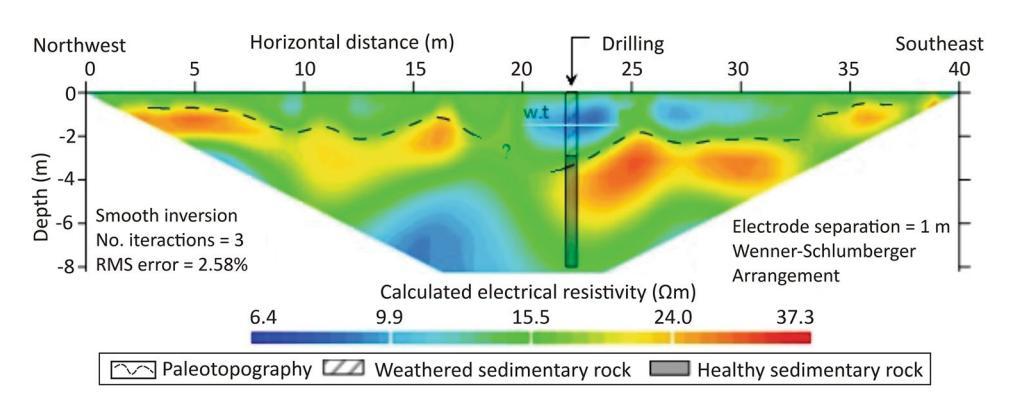
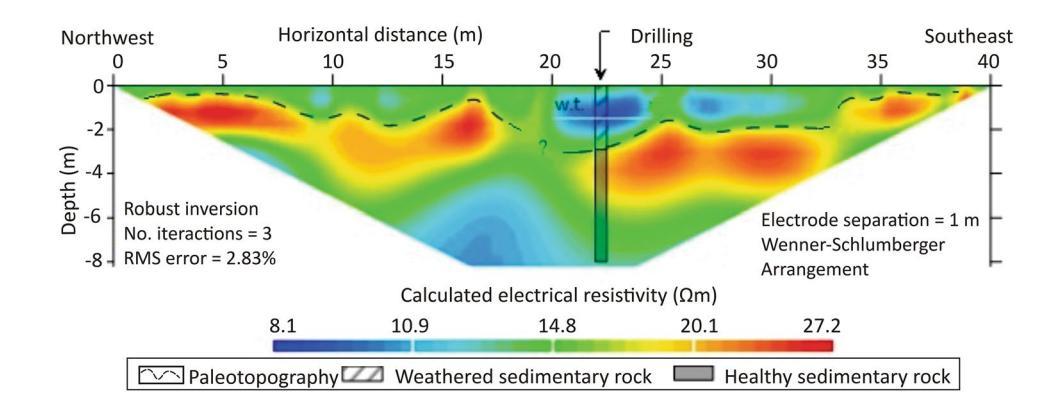
The 2D tomography study suggests the presence of groundwater, which coincided with the limit between the weathered and unweathered rocks (Mojica et al. 2012; Mojica 2018), as shown in Figs. 6 and 7. The smooth inversion method (see Fig. 6) included three iterations and an RMS calculation error of 2.58%. The robust inversion method (Fig. 7) involved three iterations and an RMS calculation error of 2.83% (Mojica 2015). Although the error in the robust inversion was slightly larger than that for the soft

one, both figures basically showed the same calculated electrical resistivity profile for the terrain. Both figures show the inversion profile in comparison to the drilling profile. The calculated electrical resistivity tomography corresponded very well with the mechanical drilling profile of the terrain. The surface layer, corresponding to topsoil and soil, is shown in green and presents intermediate resistivity values ($\approx 15 \ \Omega \ m$). The resistivity areas (depicted in blue in the profile, $\approx 10 \Omega$ m) seen in this layer indicate the presence of moisture on the ground surface as tomography was performed during the rainy season. The high resistivity layer (in yellow and red, $\approx 24 \Omega$ m), identified at greater depths, suggests fresh bedrock. Finally, at the bottom, there is an additional low resistivity area (blue, $\approx 10 \Omega$ m) that indicates a high moisture content, meaning the probable presence of groundwater in the aquifer.

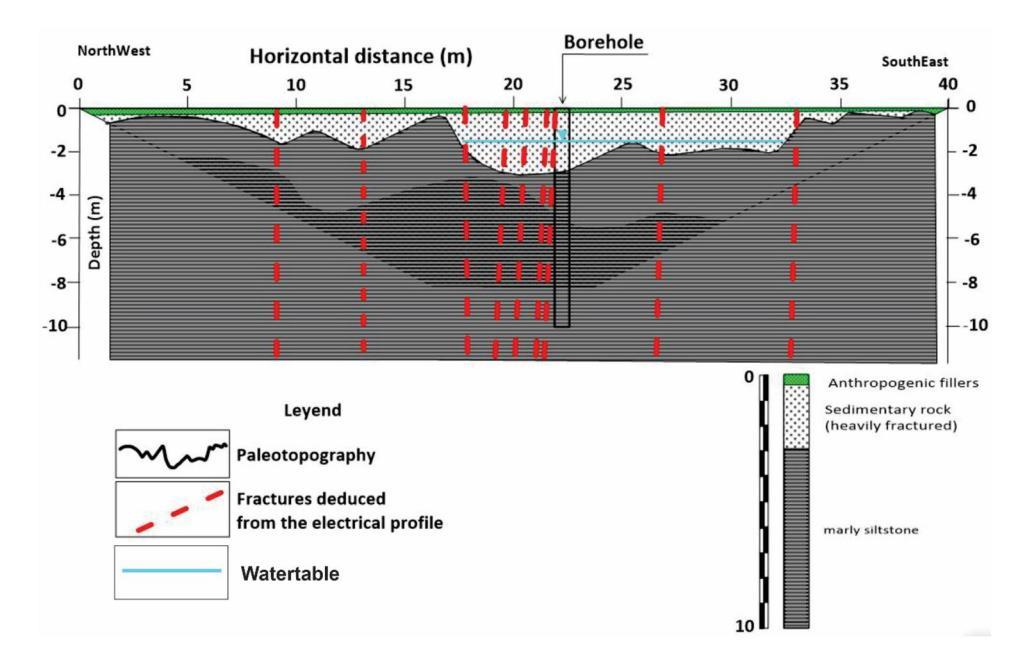
Fig. 8 Geological profile interpreted based on the lithology and fractures deduced from the electrical profile

The variations in resistivity suggest the possibility of fractures in the bedrock, locating the contact between the two areas with contrasting resistivity at different depths. The most important appears as located at about 18–19 m along the profile, and other possible fractures are shown at 9 m and 33 m along the profile (Fig. 8).

The electrical tomography profile interpretation allows us to deduce an irregular topography in contact between soil and rock substrate (Fig. 8). This topography, formed by grooves and peaks, is probably related to the fracturing observed in the test core. This character also allows us to suggest the presence of two aquifer types, both fractured. The upper aquifer, hosted in soil, corresponds to a free aquifer concentrated in areas with strongly fractured rocks and which, in turn, is delimited by some type of impermeable fracture. The lower aquifer corresponds to a semiconfined aquifer, presents less fracturing and is delimited by fractures, such as those observed in the drilling profile. It is assumed to be in contact with the upper aquifer through some of these fractures.

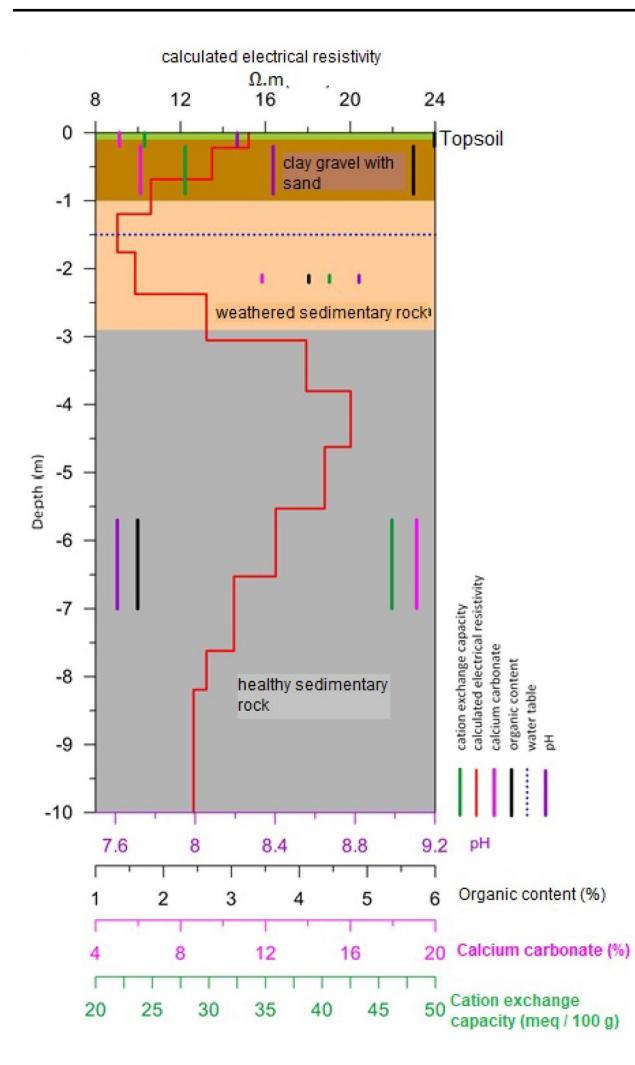
Fig.9 Graphical representation of the stratigraphy of the profile, including values for the geochemistry and the determined electrical resistivity parameters, in the borehole

Figure 9 illustrates an attempt made to correlate the results obtained from the geotechnical profile, the 2D electrical resistivity tomography and geochemistry, in the borehole. This figure presents the drilling profile at 10 m, together with variations in the calculated electrical resistivity and some geochemical parameters, such as CEC, % CaCO₃, pH and % organic content. We can see that the calculated electrical resistivity of subsoil decreases in the layer of clayey gravel and sedimentary rock to the watertable (1.5 m), and then increases at a depth of 4 m before lowering again at a depth of 8 m.
