Newson, T. and Sentenac, P. and Dong, P. (2006) *Modelling failure mechanisms of soft cliff profiles*. In: International Conference on Protection and Restoration of the Environment VIII, 2006-07-03 - 2006-07-07, Chania, Greece.

# **MODELLING FAILURE MECHANISMS OF SOFT CLIFF PROFILES**

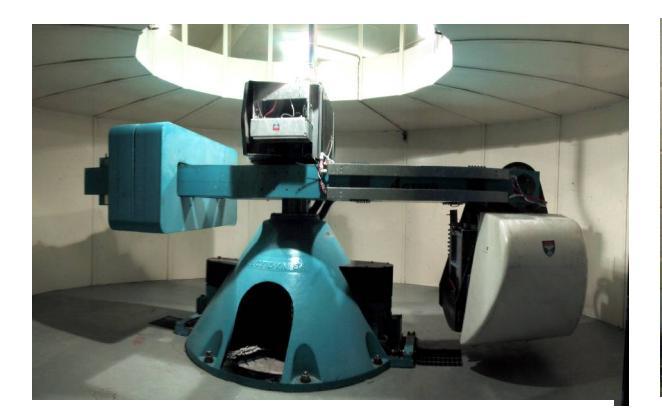
Figure 1. Dundee Geotechnical centrifuge

A number of scaled physical model tests were conducted using different cliff materials. These were simulated in the 7 m diameter (150 g-tons) Dundee centrifuge (shown in Figure 1).

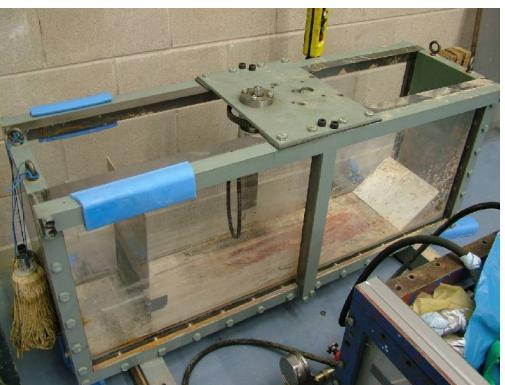
Figure 2. Wave flume container

Two dimensional plane strain soil models were tested in a specially design wave flume container of internal dimensions 1500 mm x 450 mm x 400 mm (shown in Figure 2), which formed the centrifuge strong box. The flume box has Perspex sides, so that the model may be viewed from the side during testing.

Digital video cameras (viewing the side and top of the model) were used to record soil movements (via the use of small side markers and a grid system) and provide information on the failure mechanisms.

Drainage was accomplished using a basal filter system and the internal water table in the cliff was controlled by adjusted the head of water at the base filter.

Wave loading was created using a quasi-flap paddle system that was located at the opposite end of the centrifuge box. Wave probes and pore pressure transducers were used to monitor the wave height and period. Internal pore pressures (and /or suctions) will also monitored within the slope using miniature pore pressure and tensiometer devices. In order to correctly scale the dynamic and diffusive events (Dong et al., 2001) it is required to use a more viscous fluid than water. Some of the later testing has employed metholose like Dewoolkar (1999), however the tests reported herein have used de-ionised water only.

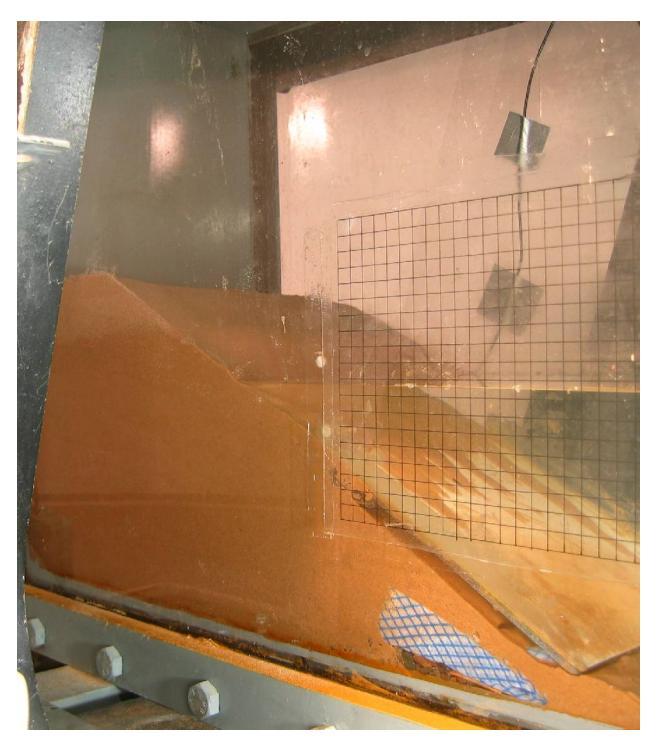
Figure 3. Example sand and cement cliff slope

Cliffs were created with model heights varying from 25-30 cm and slope angles of 30, 45, 60 and  $80^{\circ}$  (see Figure 3).

Model cliffs were made using a fine silica sand (known as Congleton sand). This material is uniformly graded with  $d_{50} = 0.3$  mm,  $G_s = 2.65$  and the particles were surrounded. The angle of repose of the loose soil was measured to be  $32^{\circ}$  and this is believed to be close to the critical state angle of friction.

The maximum and minimum densities of the sand are 1.78 and 1.39 g/cm<sup>3</sup> respectively. All of the models were mixed at 10% moisture content and placed in the flume box by hand prior to cutting to the required geometry and height.

Additional quick drying Portland cement was added to a number of the mixtures prior to placement at concentrations of 0.5, 1 and 2.5 % (weight for weight).

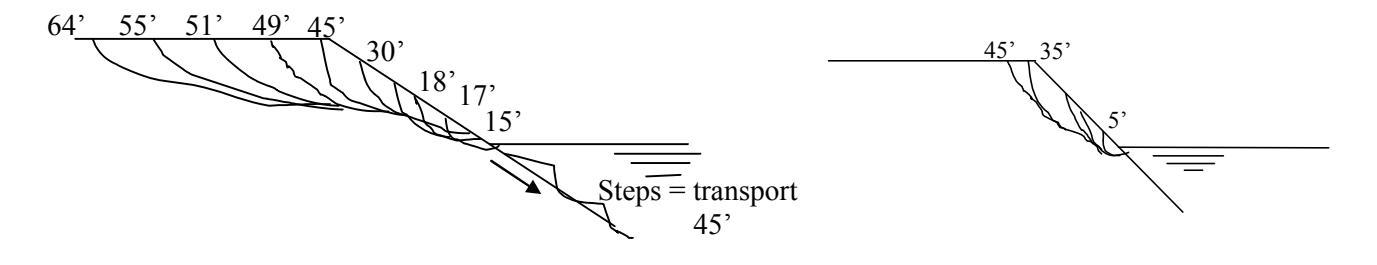
Figure 4. Sand cliff erosion evolution profile for a 30° slope and for a 45° slope versus notching time

In order to get the most efficient erosion, some 2 cm crest waves are created to attack the beach and the toe of the cliff or the joint position, tending to form a stability equilibrium profile of the beach in the angle of repose of the sand material. From this new profile only 1cm crest waves are necessary to carry on an efficient notching. Figure 4 shows the evolution of the profile for the test 1 reported in table 1 for a cliff with a  $30^{\circ}$  slope and  $45^{\circ}$  slope. The process started with the cliff face becoming steeper gradually, then, eventually the cliff was so steep that it couldn't be stable any more. A tensile fault was produced on the top of the cliff and the collapse occurred inevitably.

When the wave run-up on the beach was sufficient the debris on the back shore from the previous collapse or the cliff toe (when it was not protected by debris) was eroded. Then the eroded material was removed from the cliff toe.

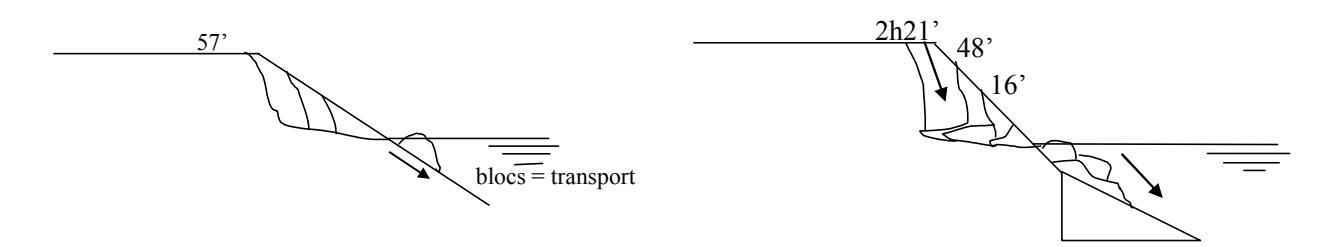
Figure 5. Cliff erosion evolution profile with sand and cement (1%) for a  $30^{\circ}$  slope and  $45^{\circ}$  slope 0

The wave action at the toe of the bluff gradually carved into the bluff material, creating a "notch". The erosion caused again an undercutting on the face of the bluff. A clear indicator of cliff erosion is the presence of a notch, a laterally extending hollow at the base of a cliff, its width being greater than its depth. Then the notch is broadened and some tensile joints located on the bluff top appeared announcing an imminent block failure. When the notch reached a threshold depth, the weight of the overhanging bluff couldn't no longer be supported which ultimately lead to a catastrophic collapse of the bluff face with large sand and cement blocks falling down to the beach. The mechanism is showed on Figure 5 in the case reported in table 3 of a cemented cliff with a 30° and a 45° slope.

It has to be noted that the tensile fault on the top of the cliff is smaller on the pure sand cliff than the one made of sand and cement.

The notch or undercutting of the toe of pure sand cliff was smaller than the one of sand with cement. The failure mode of the collapse should be a straight fall, but the pure sand cliff was eroded very quickly after the fall. The sand cliff with cement collapsed gradually, generally forming some soil blocks deposited at the toe of the cliff.
