Title: "Arc Mapping research"

Authors: Nicholas Carey PhD and Niamh Nic Daeid PhD

Abstract

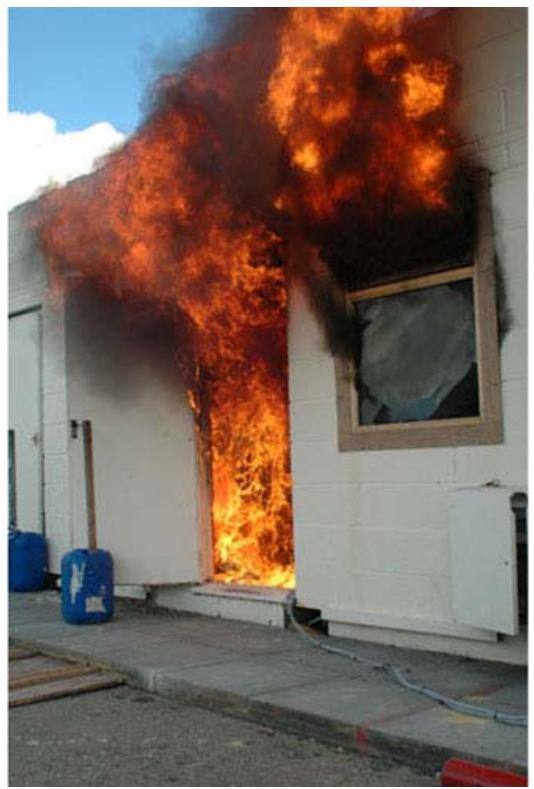
Figure 1 – a view of an experiment fire during flashover conditions.

A literature review indicated that prior to this research the reliability of arc mapping had not been established with a series of full-scale experimental fires where different compartment scenarios were repeated. Forty two fully furnished compartments (including 3 blind tests) were wired with four separate electrical circuits. This led to the generation of 141 exhibits/artefacts of electrical arcing damage to copper conductors.

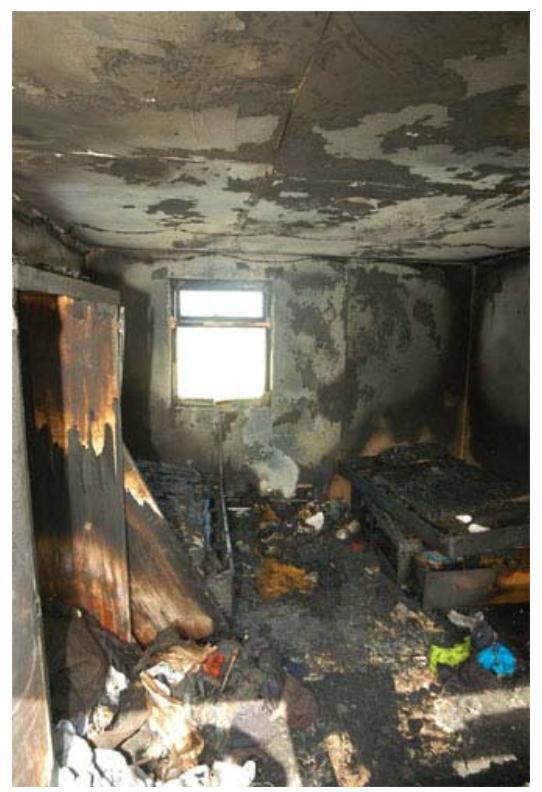
Figure2 - a post-fire scene prior to exhibit recovery.

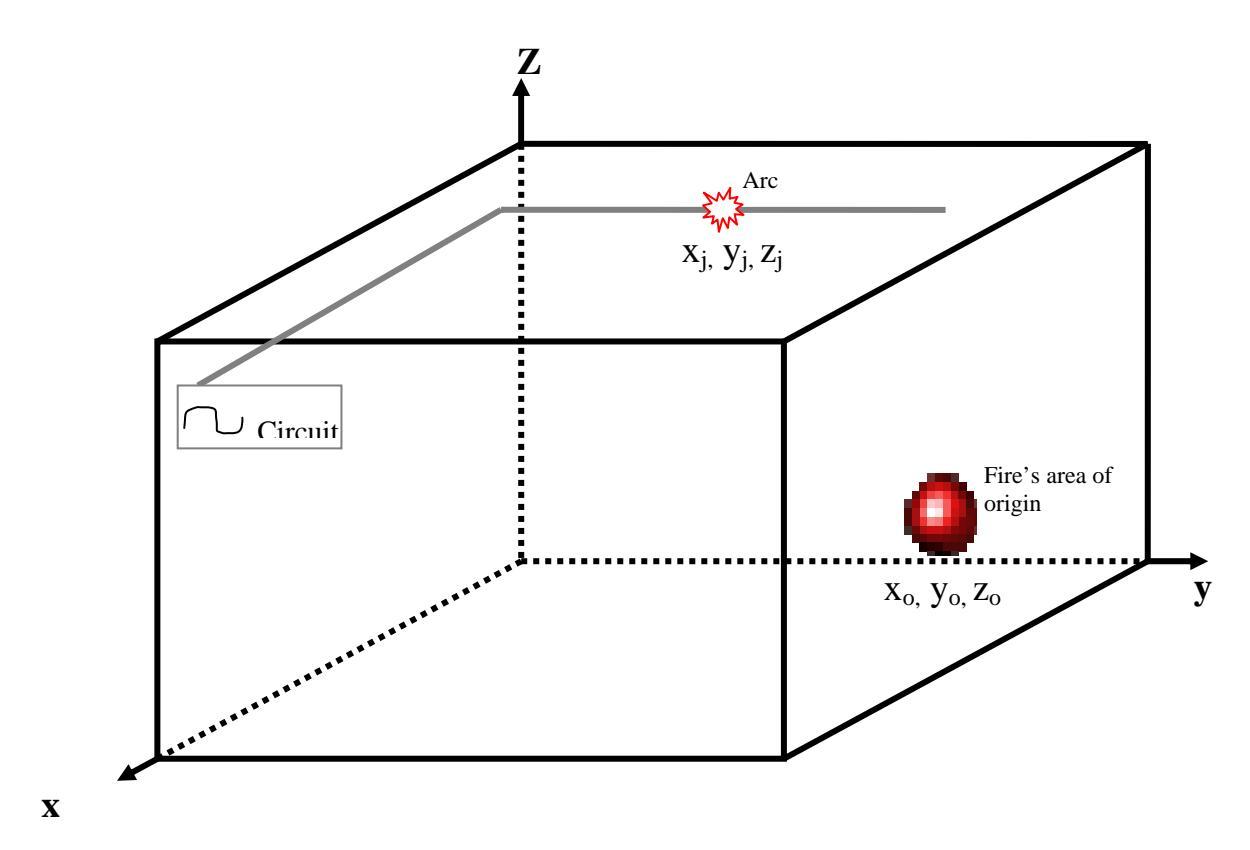
Figure 3 – Three-dimensional diagram showing the relationship between the fire's area of origin and the arcing damage on one circuit.

One of the major issues of the research was the mathematical evaluation of the three-dimensional data collected during the full-scale experimental fires. A mathematical method was used to establish the relationship between the fire's area of origin and the arcing damage locations for the experimental fires [20]. x, y and z co-ordinates were used to describe the fire's area of origin and the arcing damage for each separate electrical circuit in the compartment. Figure 3 details the x,y,z co-ordinates for one circuit within a compartment/room. Figure 4 details a cross-sectional view of a compartment, the fire's area of origin, the actual arcing location and the minimum distance between the circuit and the fire's area of origin. R_{oj} is the distance between the fire's area of origin and the arcing damage on a circuit in the experimental fires and R_{min} is the minimum distance between the fire's area of origin and the arcing damage on a circuit in the experimental fires and R_{min} is the minimum distance between the fire's area of origin and the arcing damage on a circuit in the experimental fires and R_{min} is the minimum distance between the fire's area of origin location and the circuit that sustained the arc fault.

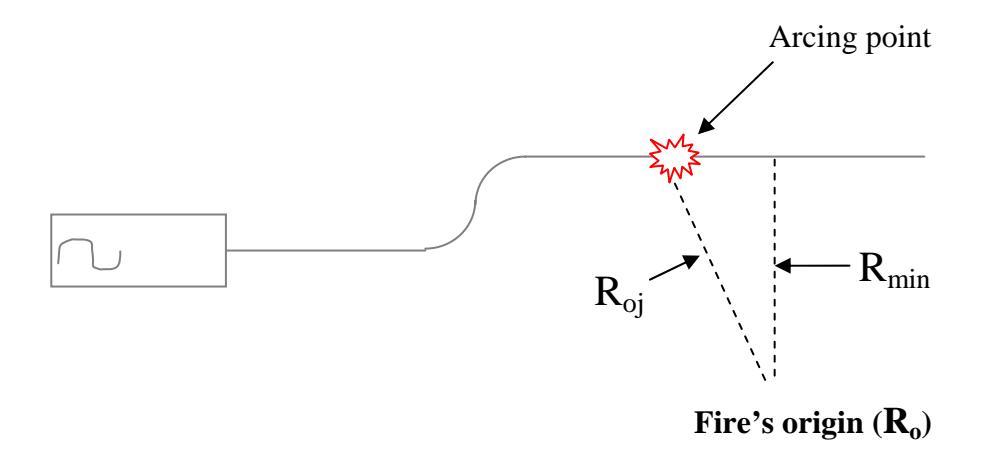
Figure 4 – A cross sectional view showing the two different distances from the fire's area of origin to the circuit's arcing point and the minimum possible distance.

The data for R_{oj} and R_{min} with each circuit and experiment was inputted into and Excel spreadsheet using the x, y, z coordinates for all locations of the area of origin for each of the experimental fires,

the actual arc locations on the circuit, and the closest possible arcing locations from the fire's area of origin and the circuit were also inputted in this format. For the purposes of the calculations, only fires which were set with one area of origin were included (22 experimental fires in total).

The formulas to calculate R_{min} / R_{oj} were inputted into the same spreadsheet. The data was analysed for each scenario and separate histograms created for the repeat tests. The three-dimensional location of the arcing damage for each circuit was compared to the closest point on that circuit to the fire's area of origin in each case.

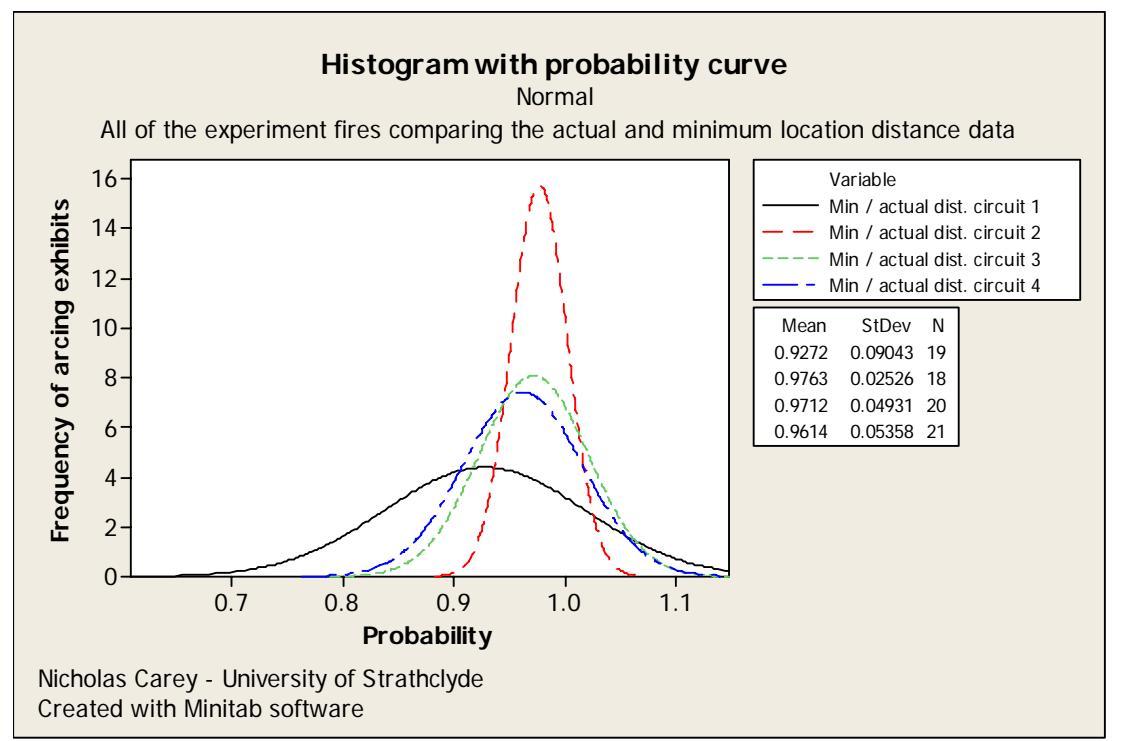
Figure 5 – Histogram detailing the probability of the arcing damage compared to the closest point on a circuit.

The spreadsheet data was imported and analysed with the statistical software package MiniTab version 15 (Minitab Inc. State College, PA. USA) and the results are detailed in figure5. This software package was able to display all four separate circuit results on to one histogram chart.

Statistical analysis suggests that the majority of the arcing events occurred on the electrical circuits within a short distance or adjacent to the closest possible points on the circuit to the fire's area of origin. The majority of the probability results were in the 0.85 to 1.0 range (at a 95% confidence level). This suggests that there is a high probability (85% or higher at the confidence level tested) that the arc occurred within a close proximity to the fires area of origin.

A reduced probability for circuit 1 was observed for almost all of the experiments. The location of the cable for circuit 1 (the power ring circuit) was consistent throughout all of the experimental fires. The cable was located at the junction of the top of the walls and the ceiling. The fire dynamics appear to have slightly delayed the exposure of the PVC insulation to the heat flux in the fire's early development resulting in arcing damage occurring further away from the area of origin in some cases and resulting in a greater spread of results.
