Judd, M.D. and Yang, L. and Bennoch, C.J. and Hunter, Ian, B.B. (2004) *UHF diagnostic monitoring techniques for power transformers.* In: EPRI Substation Equipment Diagnostics Conference XII, 2004-02-15 - 2004-02-18, New Orleans.

# UHF Diagnostic Monitoring Techniques for Power Transformers

Dr Martin D. Judd, Dr Lily Yang, Mr. Craig J. Bennoch

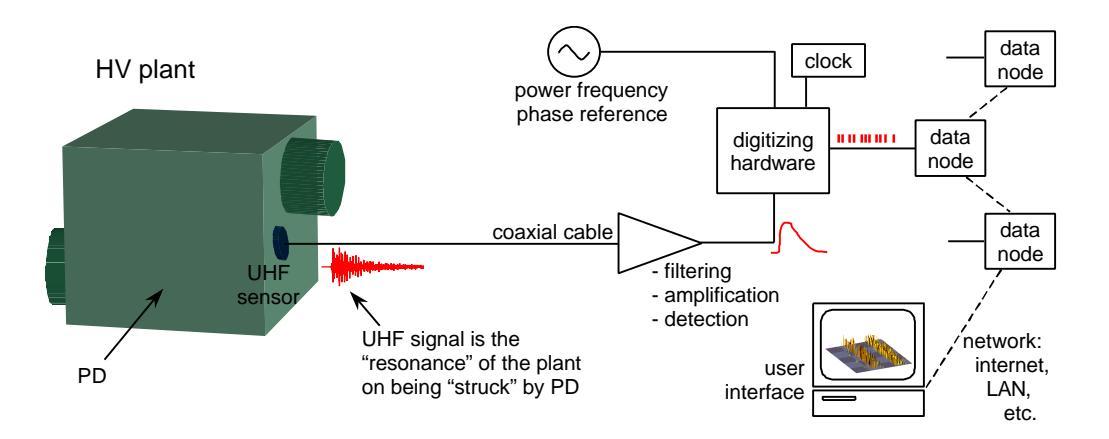
Figure 1: Basic Principles of UHF Condition Monitoring

Measurement of partial discharge (PD) activity has long been used to assess the condition of high voltage insulation in components such as bushings, capacitors, transformers and switchgear. Many methods are employed, usually based on detecting one or more of the electrical, chemical, acoustic (i.e., mechanical) and RF phenomena that are associated with PD [1,2]. The ultra-high frequency (UHF) method is essentially an RF technique that has evolved as the bandwidth of affordable test equipment and consumer electronics pushes ever upwards. The technology is now mature in its application to gas insulated substations (GIS), with over 15 years of field experience accumulated and many permanent on-line monitoring systems in use around the world. Figure 1 illustrates the basic principles of UHF PD detection.

The UHF band covers 300 – 3000 MHz. Whether or not energy from an ionizing event can be detected in this band depends on the risetime and falltime of the current pulse, the magnitude of the current and the signal-to-noise ratio of the measurement system. Roughly speaking, pulses on a nanosecond timescale are necessary for detection by UHF methods. Some of the events that can actually be detected at UHF are usually considered to be much slower than this. Often this is because they have been measured historically using equipment that was bandlimited. Furthermore, there are often superimposed on a large, slower pulse (such as an arc in oil) many small but extremely short current pulses that are associated with the energetic formation of new branches in the discharge channel. Thus, when we "see" these events using a UHF sensor, the "signature" can be quite different to conventional measurements, but just as effective in revealing the activity.

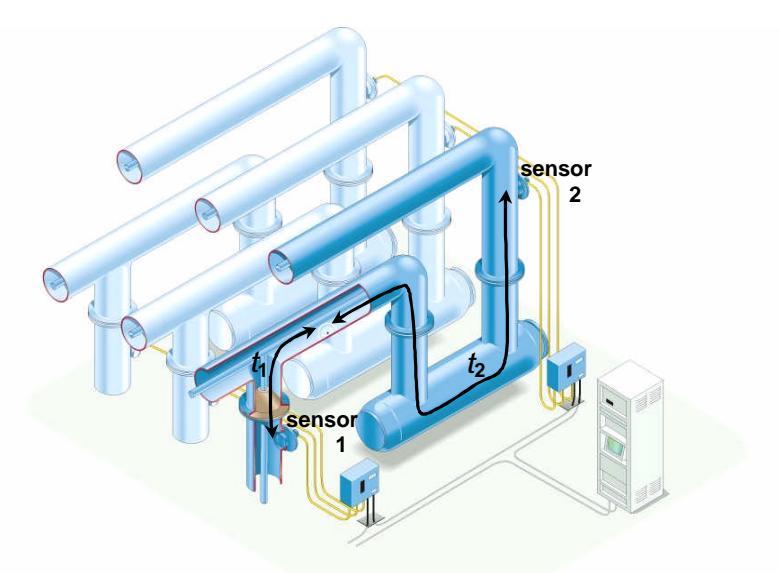
PD sources in GIS are located by time-of-flight methods, a procedure that is illustrated in Figure 2. The UHF signals are delayed by 3 ns for each meter they travel along the busbar. A 2-channel oscilloscope with a bandwidth of 500 MHz or more is connected to UHF sensors on either side of the PD source using cables of equal length. If the signals arrive simultaneously at both sensors, the source must be midway between the two sensors. In other locations, any time difference relates directly to the offset from center. By this means, PD sources can be located to within 20 cm (1% of the distance between sensors).

Figure 2: Locating a PD Source in a GIS by the Time-of-Flight Method (*Image courtesy of Diagnostic Monitoring Systems Ltd.*)

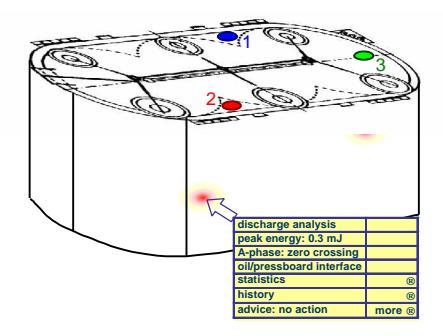
All of this data could be mapped through a remote graphical interface (an impression of which is given in Figure 3), providing a powerful tool that could reduce the frequency of site visits and would be capable of functions such as live viewing or replay of discharge activity in real time.

Figure 3: Graphical Interface for Accessing Transformer Monitoring Information

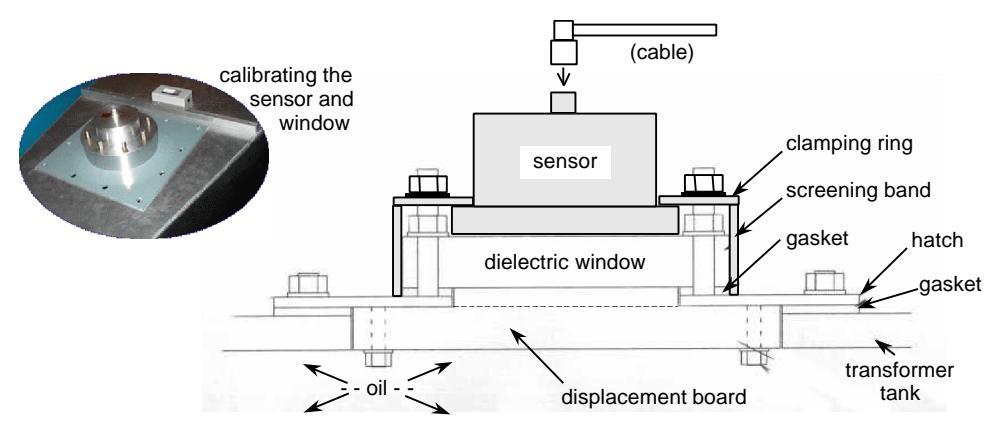
Retrofitting UHF sensors to transformers requires hatch plates on top of the tank. A new set of plates is made up which incorporate the necessary dielectric windows. Figure 4 shows the assembly and testing of one such sensor. A brief outage is required during which the transformer oil is lowered just enough to allow replacement of the hatches without exposing the windings to air.

Figure 4: UHF Sensor Assembly on a Transformer Hatch Cover

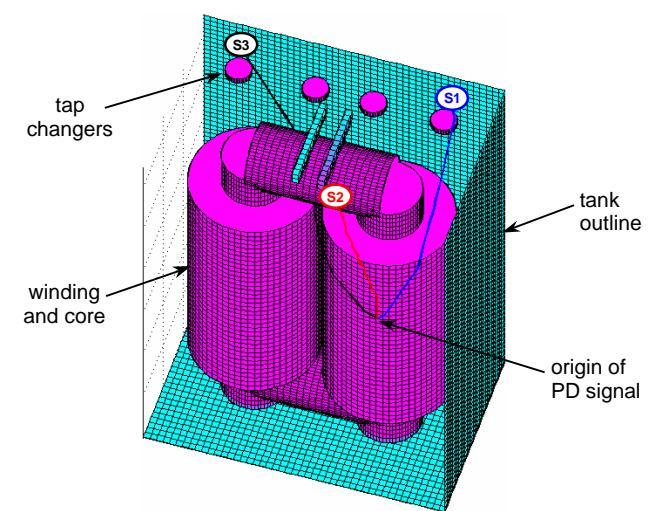
As PD data is acquired, the predefined PTMs for each sensor pair are interrogated to identify points that match the measured incoming time differences to within a specified tolerance. Points scoring a good match are highlighted on a 3D internal view of the transformer. The PTMs can also be used to trace the predicted most direct path from the PD source to each sensor so that the engineer can check that these are realistic, as shown in Figure 5.

Figure 5: Single Phase Transformer Model Indicating Shortest Signal Paths from PD Source to Sensors

To link the data acquisition stage with the location mapping display, software is being developed that recognizes clusters in the incoming data and passes the relevant parameters to the 3D display. At present, the centers of the clusters must be transferred manually to a separate program that calculates and display the point of origin (as shown in Figure 5 earlier).

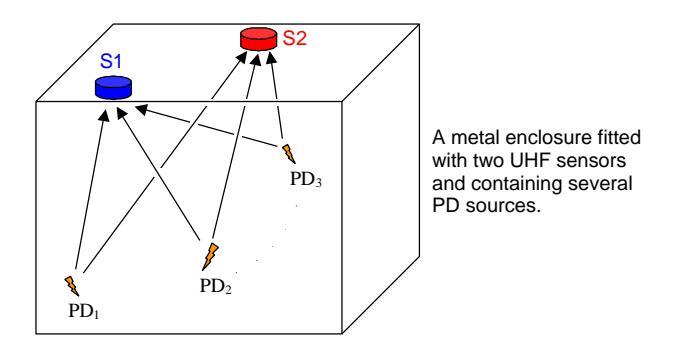
Figure 6 shows in simple form the problem to be addressed. Several sources of transient signal are located inside a metal tank. These may be PD sources, intermittent arcs, or entry points for interference from outside the tank. The different signal paths between each PD source and each of the sensors correspond to different signal transfer functions. Each exhibits a level of attenuation and a certain time delay that are reasonably consistent provided that the geometry is fixed. As long as we can detect the signal at each sensor simultaneously (that is, apart from the inherent time delay we are interested in), we can calculate two important parameters. The first is the difference in arrival time of the signal at a pair of sensors,  $\Delta t$ , which we will later use to locate the signal source. The second is the ratio of signal energies, *R*, often more usefully expressed as a logarithmic value,  $log_{10}(R)$ .

Figure 6: Recognizing Multiple Signal Sources Using Two or More UHF Sensors

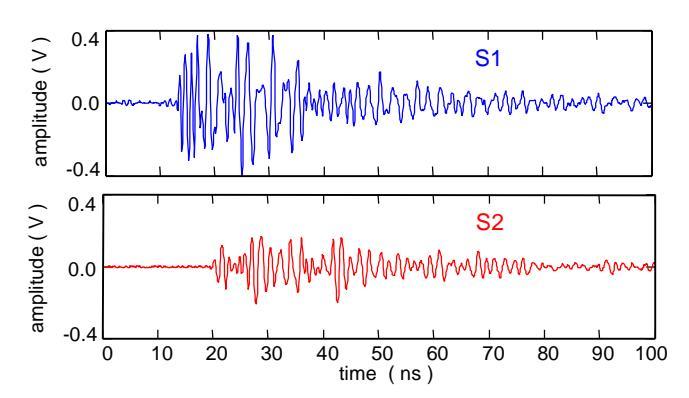
A typical pair of UHF signals is shown in Figure 7. These can be acquired using a digital sampling oscilloscope or a high speed sampling card. A bandwidth of 500 MHz is necessary to obtain the subnanosecond resolution required to locate PD sources to within 20 cm. Typically, the sampling rate of the digitizer will be 2 GHz or more. The number of raw data samples acquired for each PD pulse is consequently very high, but all of the important information can be condensed into two parameters, *time of arrival* and *signal energy*. Figure 8 shows how these values are obtained by working with the integral of the voltage waveform, which maps the accumulation of UHF energy during the burst of signal.

Figure 7: Time-Domain UHF Signals Recorded Simultaneously at Two Sensors

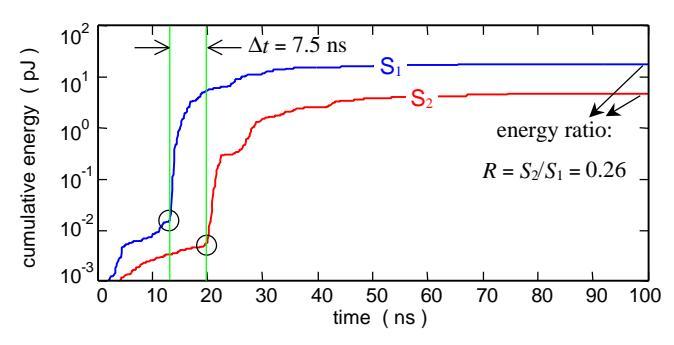
Figure 8: Cumulative Energy Plots Illustrating Parameter Extraction for a UHF Signal Pair

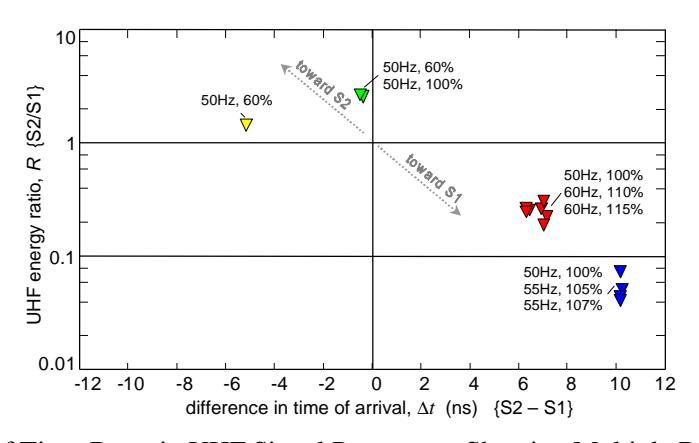
Figure 9: Map of Time-Domain UHF Signal Parameters Showing Multiple Discharge Sources (*Specific test frequency and operating voltages* [%] *are indicated beside each data cluster*)

Each incoming PD pulse can then be mapped onto a two-dimensional plane by means of its { $\Delta t$ , *R*} co-ordinates, as shown in Figure 9. This plot shows real site data from the grid transformer, which had two main discharge sources represented by the clusters at the lower right of the graph. The disadvantage of the 2D plot is that it conveys no sense of the discharge intensity. This can be rectified by using a 3D plot in which the vertical scale represents UHF signal energy. To illustrate this, the data from Figure 9 has been plotted as an energy-cluster map in Figure 10.

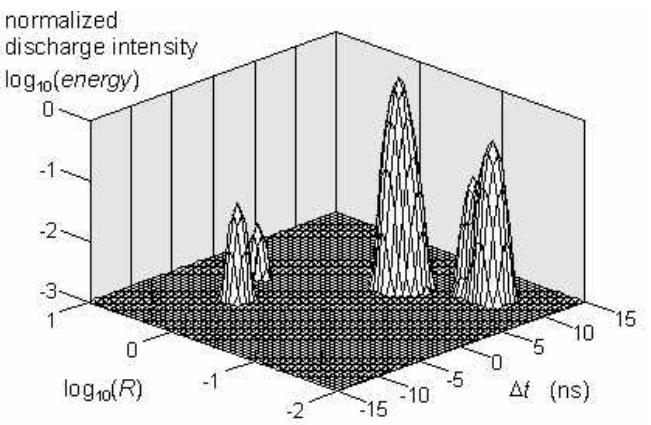
Figure 10: Three-Dimensional Energy-Cluster Map of PD Activity (Vertical scale shows the signal energy relative to the cluster with the highest energy)

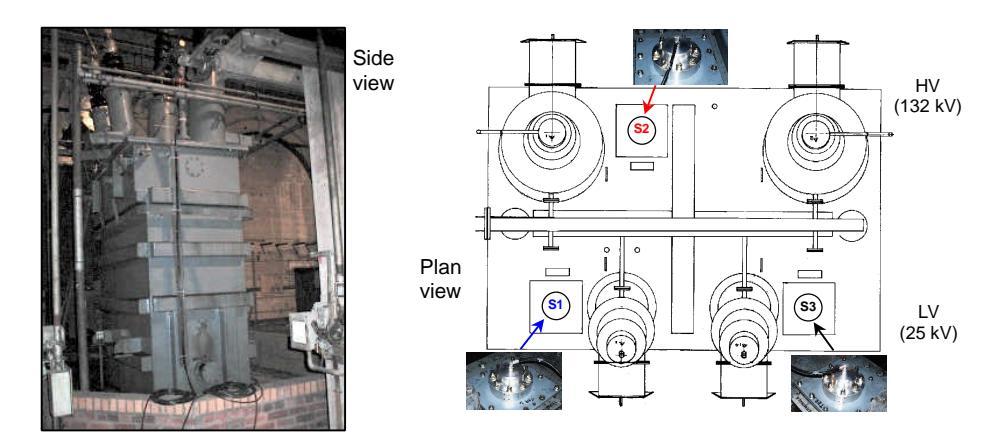
This 18 MVA single phase 132 - 25 kV unit had shown an increased rate of production of Hydrogen and Acetylene. Thorough internal inspection did not reveal any signs of discharge activity. Replacements were made for three inspection hatches located on the top of the tank. Each of these incorporated a dielectric window for mounting a UHF sensor. Figure 11 shows the transformer and UHF sensors. Coaxial cable assemblies 24 m long were prepared and their electrical length was checked using a UHF network analyzer. Cable delays were matched to within  $\pm 0.1$  ns around an average value 115.8 ns.

Figure 11: An 18 MVA Single Phase Traction Transformer Equipped for UHF Monitoring

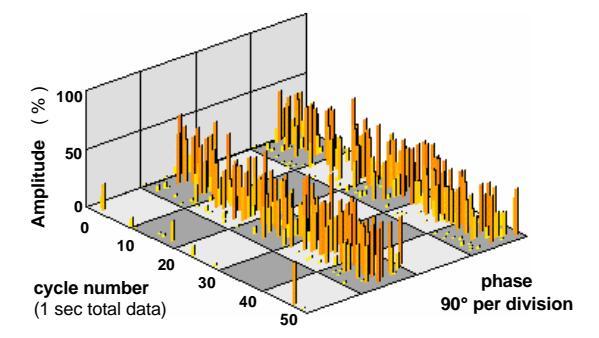
A portable UHF PD monitor (GIS type) was used to record the phase-resolved characteristics of these signals. A typical pattern is shown in Figure 12, revealing strong 180° phase symmetry. Identical patterns appeared at all three sensors, but the amplitude was consistently greater at S1. To establish whether the discharge was affected by changing operating conditions, the portable UHF monitor was left on site to record data continuously for 6 days. Over this period the PD pattern and amplitude remained remarkably stable despite loading variations from 2 to 17 MVA.

Figure 12: UHF PD Signals from Sensor S1, Phase-Resolved to the 50 Hz Power Frequency

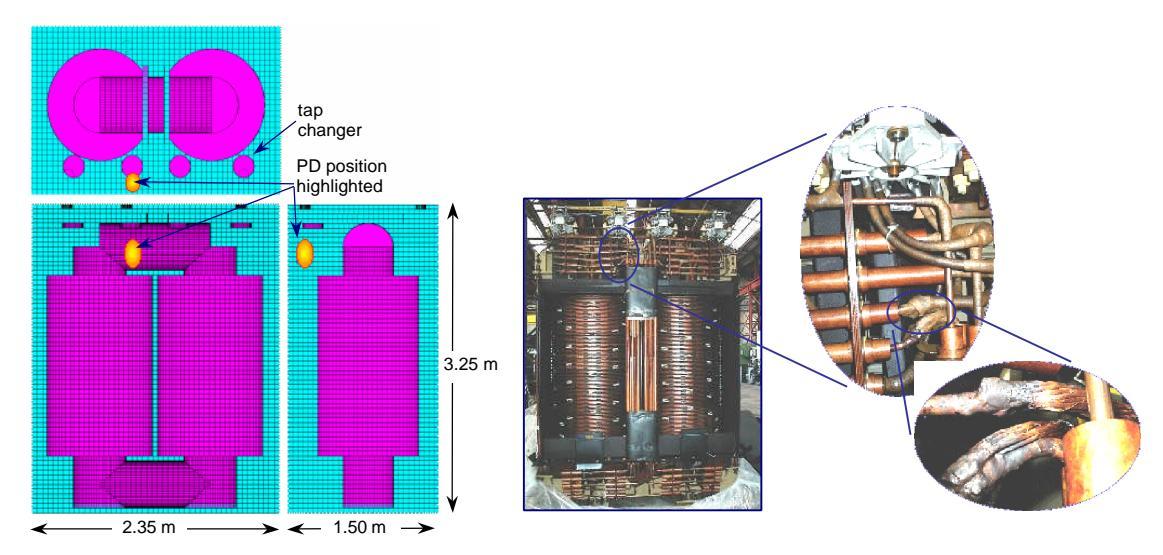
When the measured time differences were analyzed, the source was identified as being just under one of the tap changer mechanisms, as highlighted on the model at the left of Figure 13.

Figure 13: Predicted PD Location (left) and Photographs from the Forensic Investigation (right)

In the region where the electrical discharge activity was predicted, paper on the tap changer leads was burnt. Sludge from this discharge had accumulated nearby. No other signs of heating could be seen. Underneath the area of blackened paper were bulky joints between solid conductors and flexible leads. Different views of the area in question are shown at the right of Figure 13. The location of this discharge site was about 15 cm from the center of the suspect region highlighted in the computer model. The fact that neither of the tap leads involved was load-bearing during PD monitoring accords with the observation that the PD signals did not vary with load. Onset of this PD was probably brought about by cumulative mechanical distortion of the assembly.

Before an outage could be arranged to inspect this region, a through fault on the load side of the transformer was followed by rapid gas accumulation that tripped the Buchholz relay. Some weeks later, the transformer was detanked for forensic inspection. Considerable evidence of physical damage was apparent, including failure of the winding clamp.

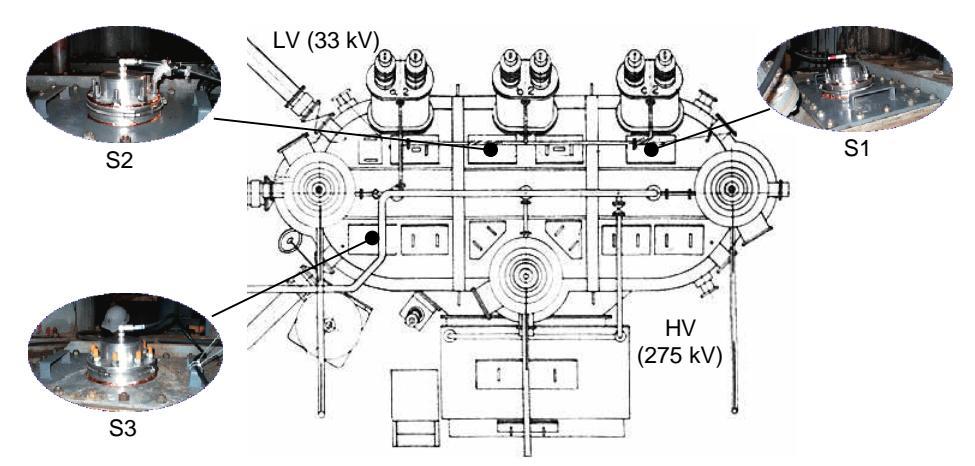
This 120 MVA, three phase 275 – 33 kV transformer supplied a large industrial complex and therefore operated under quite variable conditions. Gas production was abnormal but the cause could not be identified. Modified hatch plates were manufactured and fitted to the transformer at the locations shown in Figure 14. In this instance, the GIS-type UHF monitor was left running continuously on-site for 17 days. PD data collected was very different from the previous case. Discharge activity tended to occur in distinct blocks of several hours duration, but there was no apparent correlation with load. The UHF signals were much smaller than in the previous investigation, so preamplifiers (26 dB gain) were used throughout the monitoring period. The phase-resolved pattern of the PD signals was also quite variable, as can be seen from the examples in Figure 15, providing strong evidence of more than one PD source.

Figure 14: Top View of the 120 MVA 3-Phase Transformer Equipped for UHF Monitoring

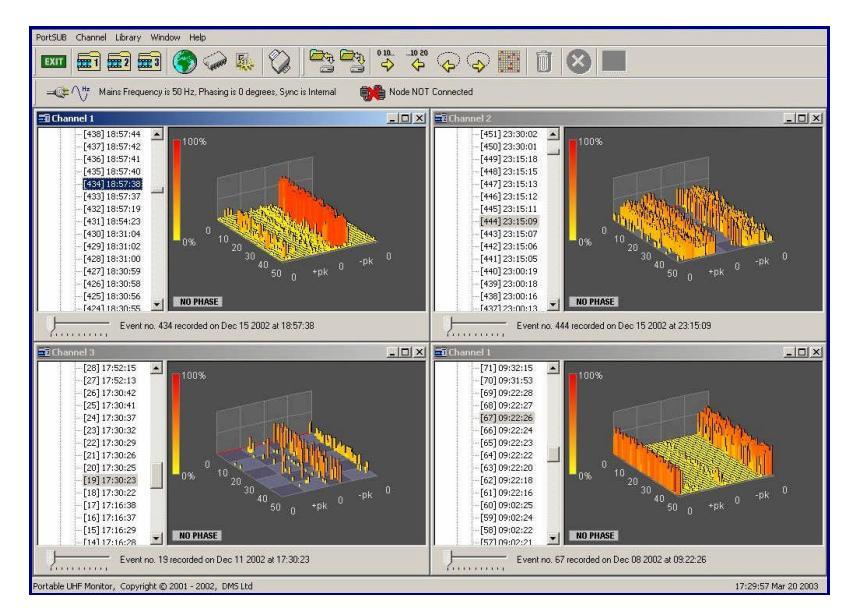
Figure 15: Examples of PD Patterns Recorded at Different Stages During the Monitoring Period

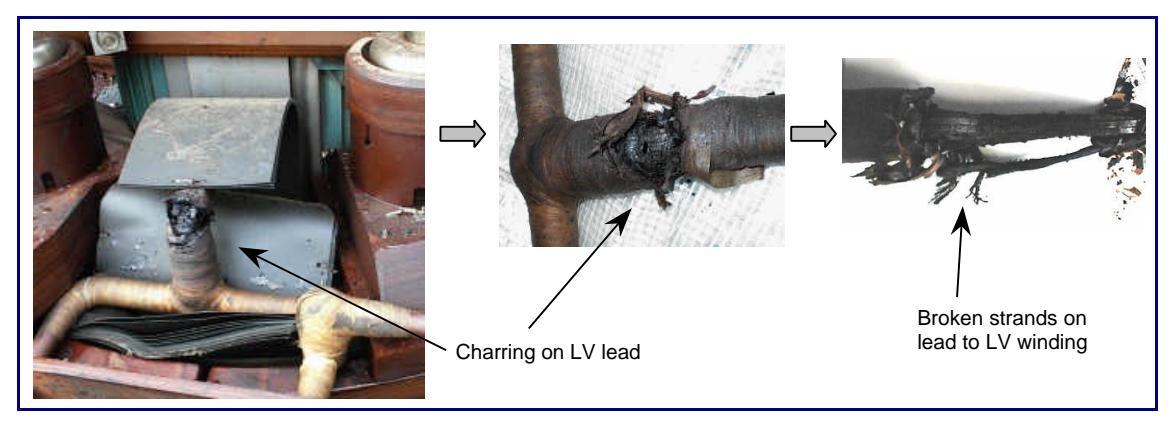
Figure 16: Damaged Joint on 33 kV Lead

Whenever we visited the site with the high-speed oscilloscope, the discharge was inactive. Consequently, we were not able to record the  $\Delta t$  values that would have allowed us to locate the signal source(s). Further testing was prevented by the timetable for replacing the unit. A gradual disassembly procedure was followed, during which a severely damaged joint between the LV winding and a solid T-piece busbar to the LV bushings was found. Heating had been so severe that several strands of the flexible lead had burnt through, as can be seen in Figure 16. Tests on this transformer highlighted the need for a continuous monitoring device that can automatically measure  $\Delta t$  values for defect location, rather than simply PD data in phase-resolved form. This will be essential if intermittent PD sources are to be located, especially when activity is infrequent.

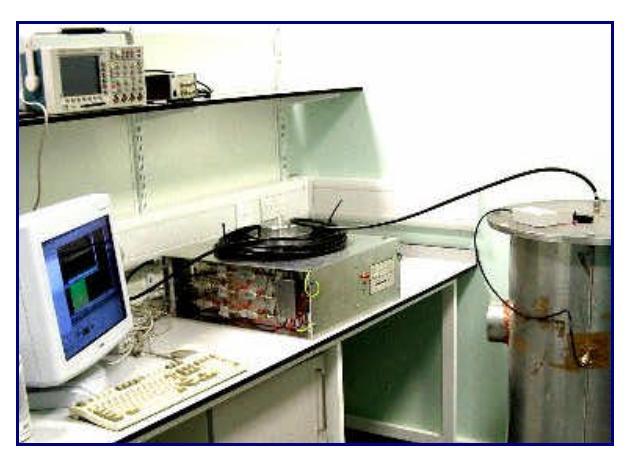
The case studies covered in this paper confirmed to us that the full potential of the UHF technique cannot be established in relation to power transformers without an automated, fully functional system that can be left on-site for periods of continuous monitoring. To this end, a PC-based system (Figure 17) is being constructed that will function as a development platform. A typical data processing display from this equipment is shown in Figure 18. The main graphs show the detected leading edges of incoming signals, the { $\Delta t$ ,  $log_{10}R$ } plot for three sensor pairs, the distribution of pulse count against  $\Delta t$  and the energy timeline for each sensor. Not yet functioning is the plot of pulse energy against power frequency phase angle, which is in the process of changeover from an analogue to a digital input stream.

Figure 17: Portable UHF Transformer Monitoring Unit in Development

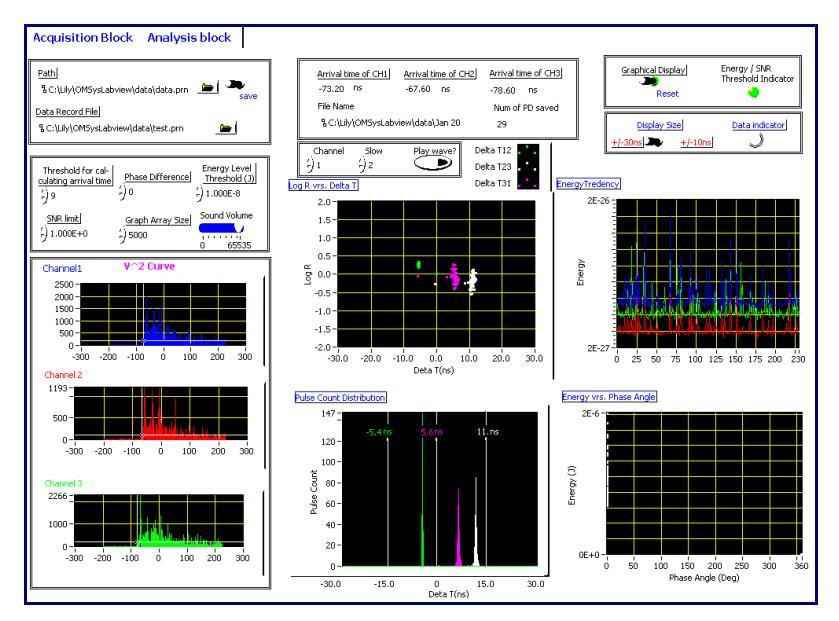
Figure 18: Screenshot of the Data Acquisition Display
