Dentomaxillofacial Radiology (2017) 46, 20170051 © 2017 The Authors. Published by the British Institute of Radiology

RESEARCH ARTICLE The effects of a common stainless steel orthodontic bracket on the diagnostic quality of cranial and cervical 3T- MR images: a prospective, case-control study

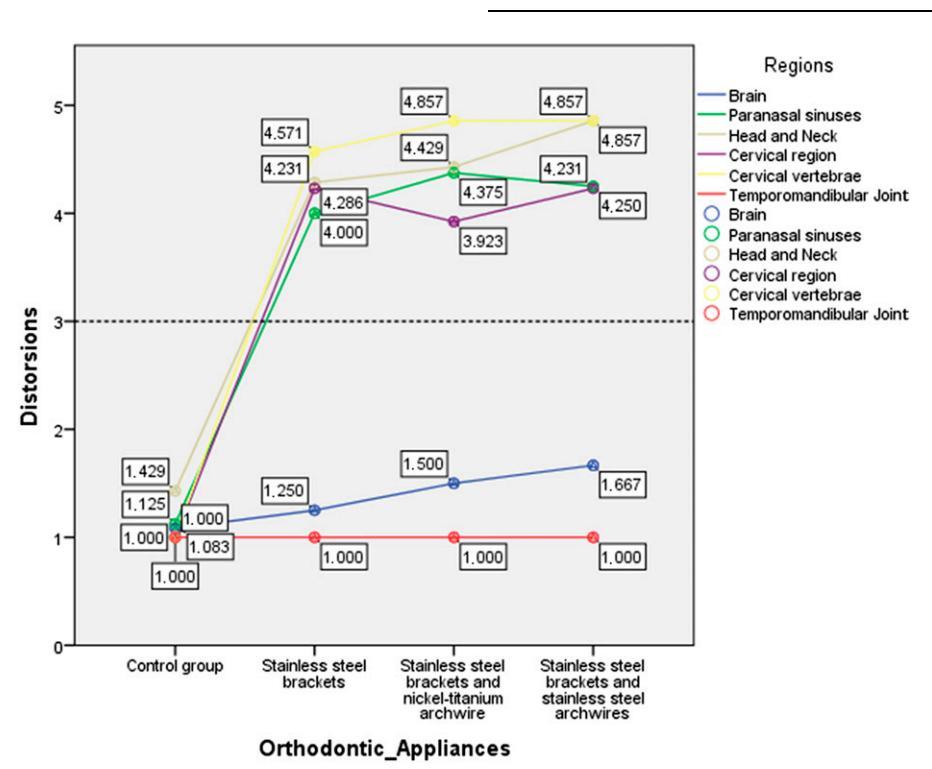
Figure 1 Mean distortion scores of MRI according to orthodontic appliance. The linear graph showed a mean score > of 3 (nondiagnostic line) in each group with different orthodontic appliances. Only two regions (brain and temporomandibular joint) were considered always diagnostic.

The results of MRI evaluation according to orthodontics appliance are summarized in Figures 1–7 and in Table 1; *post hoc* analysis results are shown in Table 2.

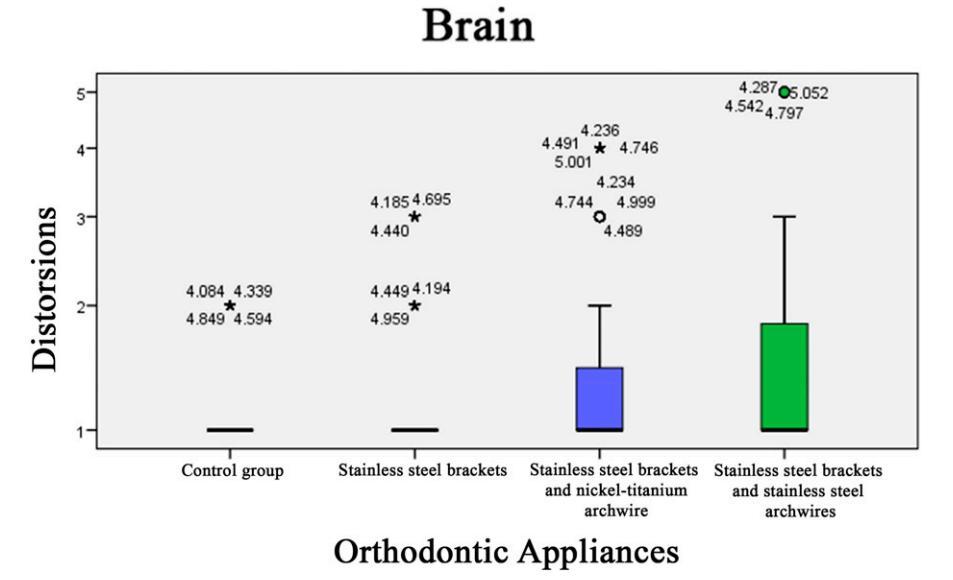
Figure 2 Box-and-whisker plots related to the distortion scores in the four groups according to orthodontics appliance in the brain region. The dark line in the middle of the boxes is the median. The box represents the interquartile (IQ) range which contains the middle 50% of the records. The whiskers are lines that extend from the upper and lower edges of the box to the highest and lowest values which are no greater than 1.5 times the IQ range. The circles are outliers. These are defined as values that do not fall within the whiskers. The asterisks or stars are extreme outliers. These represent cases that have values more than three times the height of the boxes.

In the control group (*i.e.* patients using aligners), MRI was diagnostic in each district. In patients with stainless steel brackets, without archwires, MRI was diagnostic in 91.6% of districts evaluated and moderate diagnostic

in the remaining 8.4%. In patients with stainless steel brackets and Ni-Ti archwires, MRI was diagnostic in 83.3% of districts evaluated, moderate diagnostic in 10.2% and non-diagnostic in 6.5%. In patients with stainless steel brackets and stainless steel archwires, MRI was diagnostic in 75% of districts evaluated, moderate diagnostic in 16.7% and non-diagnostic in 8.3%. There were statistically significant differences between the mean distortion scores in the four groups (p < 0.0001).

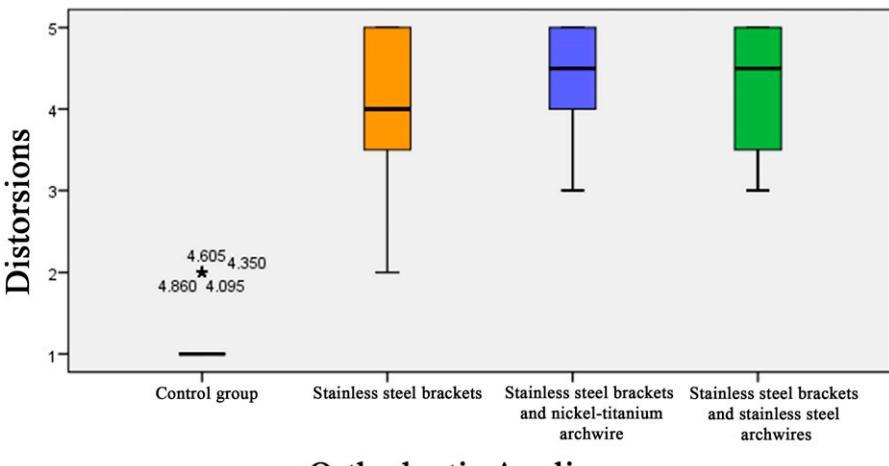
Paranasal Sinuses

Figure 3 Box-and-whisker plots related to the distortion scores in the four groups according to orthodontics appliance in the paranasal sinuses region.

In the control group, MRI was diagnostic in each district. In patients with stainless steel brackets, without archwires, the MRI was diagnostic in 12.3% of districts evaluated, moderate diagnostic in 12.7% and nondiagnostic in 75%. In patients with stainless steel brackets and Ni-Ti archwires, MRI was moderate diagnostic in 12.5% of districts evaluated and nondiagnostic in the remaining 87.5%. In patients with stainless steel brackets and stainless steel archwires, MRI was moderate diagnostic in 23.7% of districts evaluated and non-diagnostic in 76.3%. There were statistically significant differences between the mean distortion scores in the four groups (p < 0.0001).

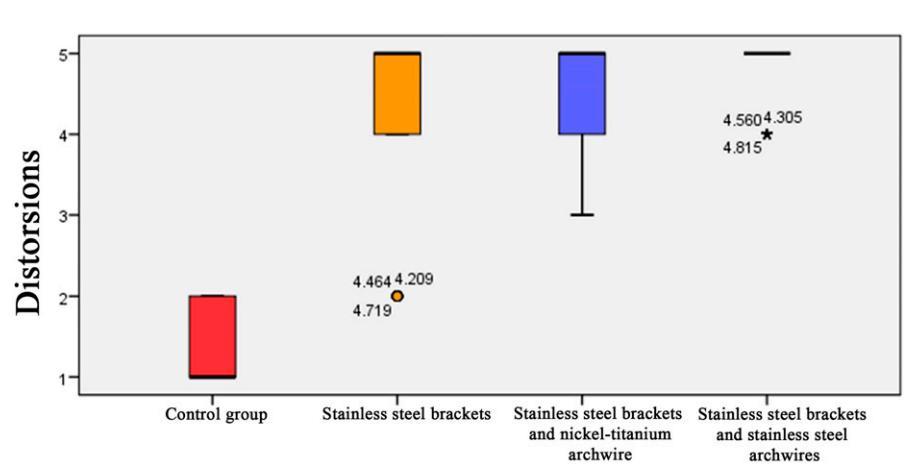
Head and Neck

Figure 4 Box-and-whisker plots related to the distortion scores in the four groups according to orthodontics appliance in the head and neck region.

In the control group, MRI was diagnostic in each district. In patients with stainless steel brackets, without archwires, MRI was diagnostic in 7.1% of districts evaluated, moderate diagnostic in 8.2% and nondiagnostic in 84.7%. In patients with stainless steel brackets and Ni-Ti archwires, MRI was moderate diagnostic in 14.3% of districts evaluated and nondiagnostic in the remaining 85.7%. In patients with stainless steel brackets and stainless steel archwires, MRI was non-diagnostic in 100% of districts evaluated. There were statistically significant differences between the mean distortion scores in the four groups (p < 0.0001).

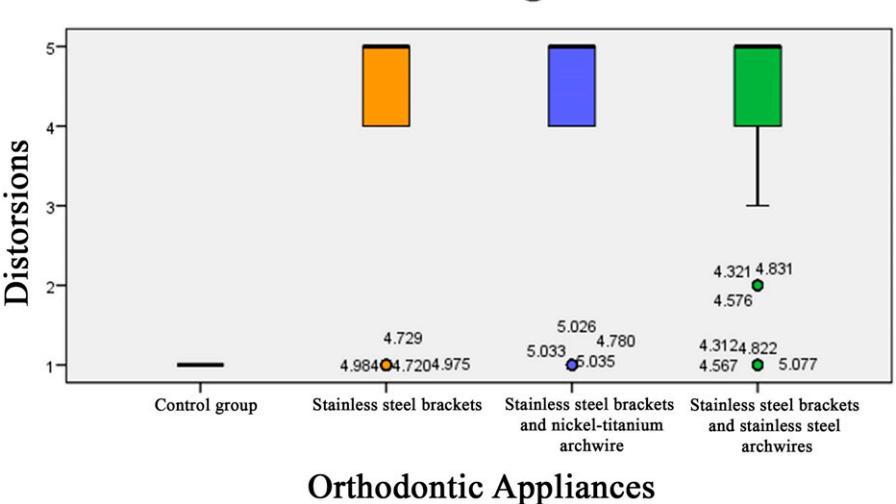
Cervical Region

Figure 5 Box-and-whisker plots related to the distortion scores in the four groups according to orthodontics appliance in the cervical region.

In the control group, MRI was diagnostic in each district. In patients with stainless steel brackets without archwires, MRI was diagnostic in 15.4% of districts evaluated and non-diagnostic in 84.6%. In patients with stainless steel brackets and Ni-Ti archwires, MRI was diagnostic in 11.3% of districts evaluated, moderate diagnostic in 11.8% and non-diagnostic in 76.9%. In patients with stainless steel brackets and stainless steel archwires, MRI was diagnostic in 7.7% of districts evaluated, moderate diagnostic in 9.8% and nondiagnostic in 82.5%. There were statistically significant differences between the mean distortion scores in the four groups (p < 0.0001).

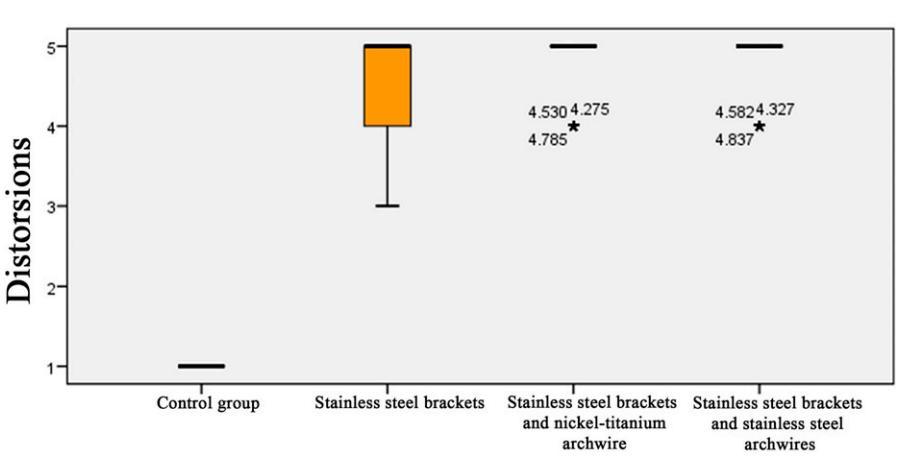
Cervical Vertebrae

Figure 6 Box-and-whisker plots related to the distortion scores in the four groups according to orthodontics appliance in the cervical vertebrae region.

In the control group, MRI was diagnostic in each district. In patients with stainless steel brackets, without archwires, MRI was moderate diagnostic in 13.7% of districts evaluated and non-diagnostic in 86.3%. In patients with stainless steel brackets and Ni-Ti archwires and with stainless steel brackets and stainless steel archwires, MRI was non-diagnostic in 100% of districts evaluated. There was a statistically significant difference between the mean distortion scores in the four groups (p < 0.0001).

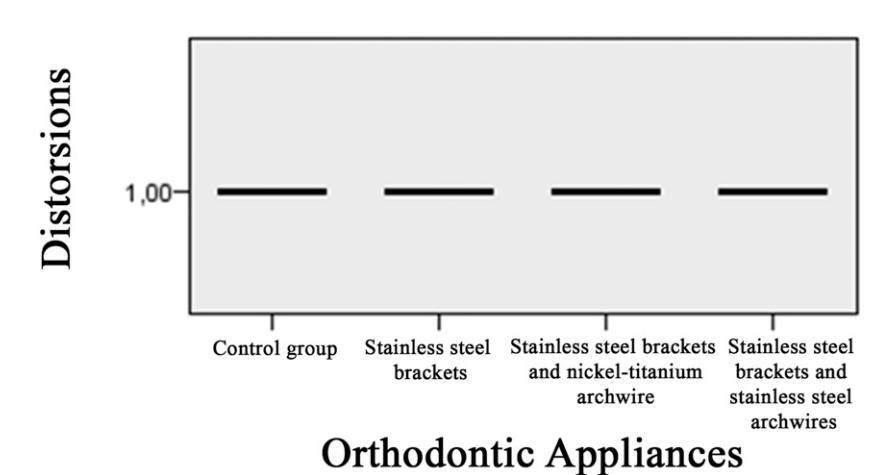
Temporomandibular Joint

Figure 7 Box-and-whisker plots related to the distortion scores in the four groups according to orthodontics appliance in the temporomandibular joint region.

In the temporomandibular joint region, MRI was diagnostic in each district of the four groups. Indeed, no difference was found between the mean distortion scores in the four groups (p = 1.000).

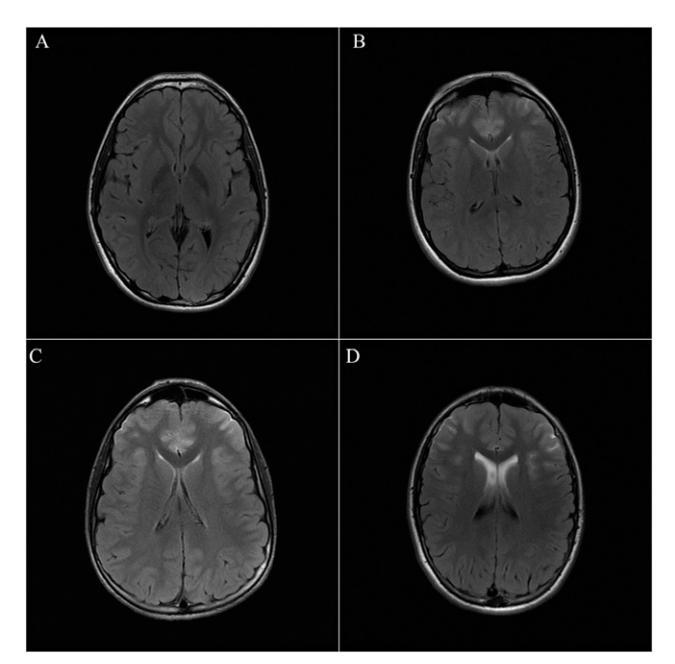
Figure 8 Axial fluid attenuated inversion recovery (FLAIR) MR images of three groups with orthodontic appliances (b–d) showed artefacts caused by stainless steel brackets and archwires corresponding to hyperattenuation of the subarachnoid spaces in the FLAIR images at the level of the frontal lobe, mainly in the straight gyra and the orbital gyra. No artefacts were reported in the control group (a).

often cause distortion in the resultant MRI. Concerning brain imaging in the patient group with stainless steel brackets, without archwires, the main artefact was the hyperattenuation of the subarachnoid spaces in the fluid attenuated inversion recovery images at the level of the frontal lobe, mainly in the straight gyra and the orbital gyra (Figure 8). This artefact could mimic pathology or interfere with the diagnosis of subarachnoid haemorrhage, meningitis and leptomeningeal carcinomatosis. In the group with stainless steel brackets and Ni-Ti archwires, the artefacts involve the frontal horn of the lateral ventricles. Lastly, in the group of patients with stainless steel brackets and stainless steel archwires, there was a complete loss of signal of the frontal lobe, making it impossible to evaluate the area for pathological or normal findings. The various regions of the brain parenchyma, aside from the frontal lobe, were almost always well displayed for diagnostic use. For the cervical and head and neck evaluation, the quality of the images was poor in all the groups with metallic orthodontic appliances. In particular, the paranasal sinus was completely non-visible (Figure 9) because, in this area, the metal artefact added to the issue of the loss of signal due to the natural presence of air. The cervical region displayed artefacts at the level of the spinal cord that appeared hyperintense in the T_2 images, mimicking pathology. The artefacts were also severe on the bone marrow of the spine, whereas the effect on the

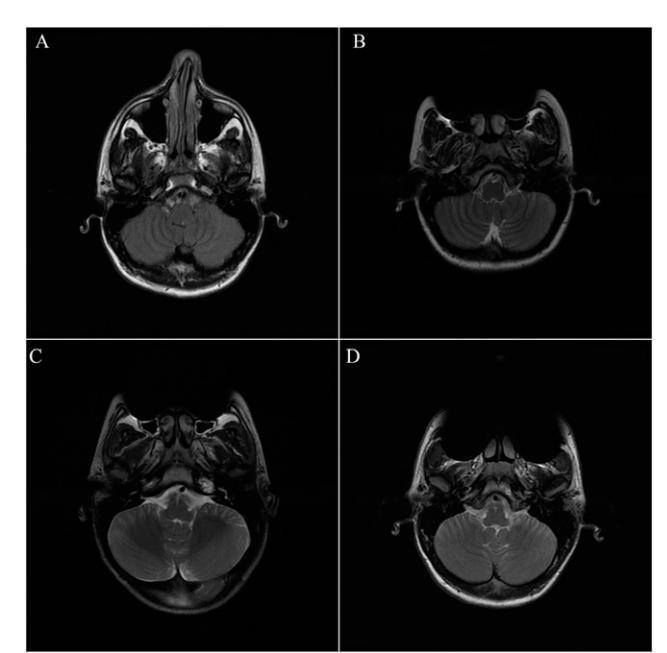
Figure 9 Axial oblique double echo proton density and weighted/turbo spin echo T_2 weighted MR images of three groups with orthodontic appliances (b–d) showed severe artefacts caused by stainless steel brackets and archwires corresponding to a complete or partial obliteration of the cervical area, paranasal sinuses and head and neck regions. No artefacts were reported in the control group (a).

that a great number of head and neck studies are performed due to lumps in the area generally caused by tumours or infections, a result which does not allow for a thorough evaluation should be considered diagnostically unacceptable (Figure 9). The only results which were diagnostically valid were those of the temporomandibular joint; the results could be due to the posterior and lateral position of the joint to the orthodontic appliance and may also be due to the high contrast signal between the articular components of the disc, bone and ligament (Figure 11). Though minor, the MR scan distortion recorded in the present study compromises the integrity of the scan and could make diagnosis of a particular condition difficult or impossible (i.e. epilepsy, searching for metastases etc). A compromised scan cannot be used for diagnosis and must be repeated.

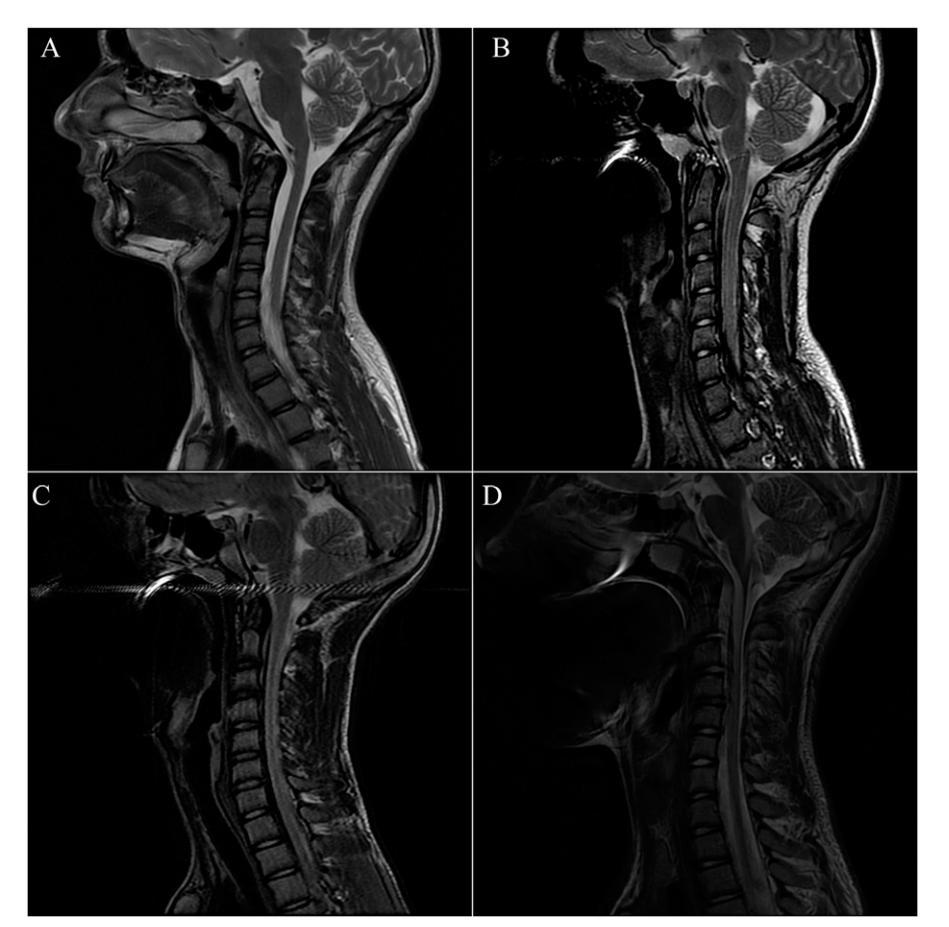
Figure 10 Sagittal turbo spin echo T_2 weighted MR images of three groups with orthodontic appliances (b–d) showed severe artefacts caused by stainless steel brackets and archwires corresponding to an hyperintense signal of the spinal cord in the T_2 images and a severe distortion on the bone marrow of the spine. No artefacts were reported in the control group (a).

hypointense spinal disc was not as great. On the basis of this observation, the examination of the spine was not diagnostic for the majority of patients (Figure 10). Head and neck structures in all three groups with metallic orthodontic appliances nearby resulted in images which were either wholly or partially indecipherable. Given

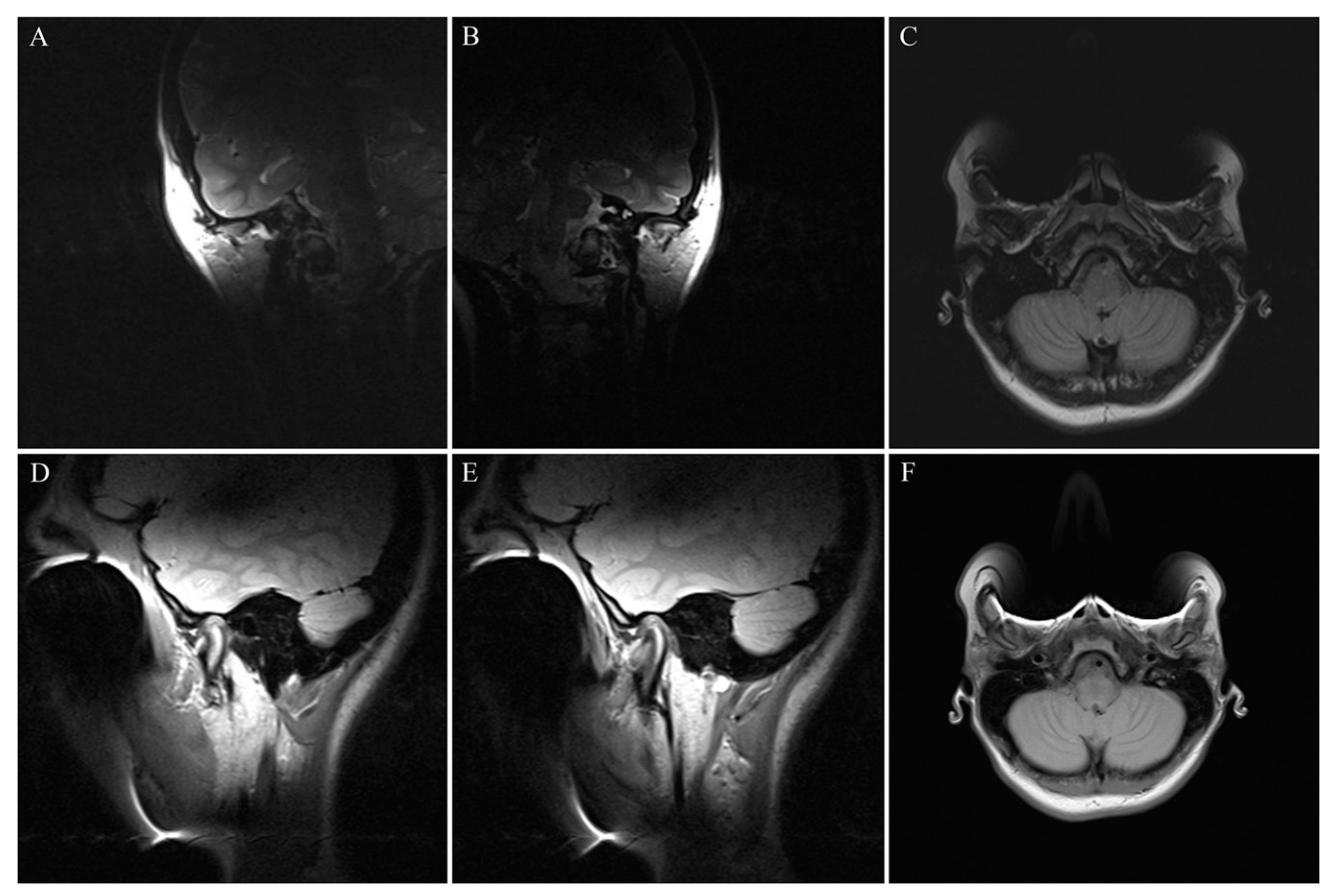
Figure 11 Sagittal, axial and coronal double echo proton density (a–c) and weighted/turbo spin echo T_2 weighted (d–f) sequences performed in a 23-year-old female patient with stainless steel brackets and stainless steel archwires, obtained at closed-mouthed position, showed diagnostic MR images of the temporomandibular joint region with a high quality. The contours of the articular disc, mandibular condyle, articular eminence, lateral pterygoid muscle and cortical bone are better displayed.
