CF6 ENGINE DIAGNOSTICS

Ron Stricklin General Electric Company

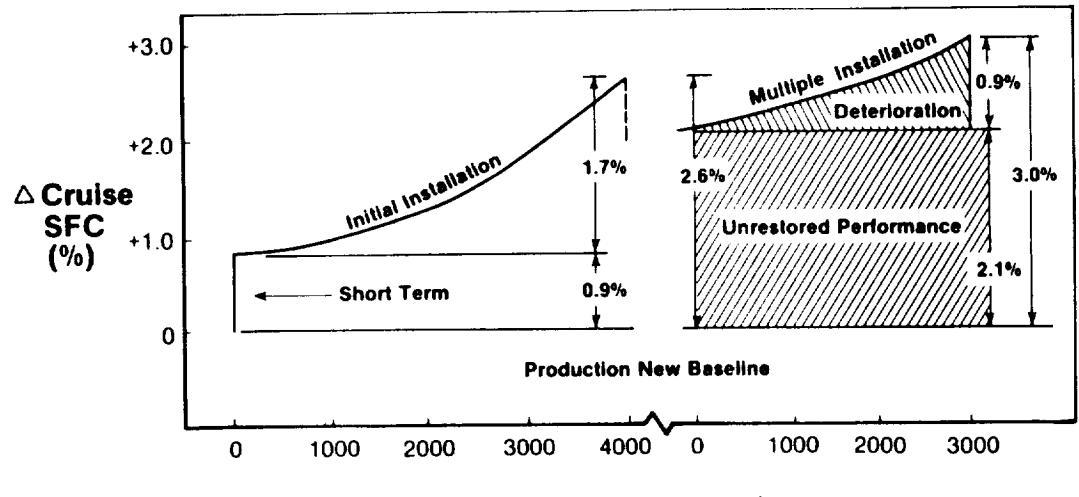
FIGURE 2

Hours Since Installation

Figure 2 shows the resulting assessment of CF6-6D performance deterioration characteristics for the typical engine thru its initial installation and experience in review service and for the same typical engine after several multiple installations. Each of the elements of deterioration is presented in Figure 2 for the CF6-6D engine. This Figure shows equivalent cruise specific fuel consumption increases relative to a production new engine. The initial installation is shown on the left. Engines incur an average Short-Term loss of 0.9 percent prior to revenue service. During their initial installation, SFC increases an average of 1.7 percent based on the 4000-hour family of engines. The total increased SFC of the deteriorated engine is thus 2.6 percent from production new. Insufficient data is available to determine the amount of performance restoration during the first shop visit.

During the "nth" installation, the serviceable engine re-enters revenue service after a shop visit with an average unrestored cruise SFC loss of 2.1 percent. During revenue service, the cruise SFC of this multiple-build engine increases 0.9 percent for the 3000-hour engine. The total increased SFC of this deteriorated engine at 3000 hours was 3.0 percent from new. On the average, 0.9 percent cruise SFC is restored during the shop visit. During the next installation, an average revenue service deterioration of 0.9 percent is incurred. This amount is restored on the average during maintenance and the cycle is repeated.

The deterioration rates shown on Figures 2 and 3 are presented as a function of flight hours since installation. An analysis was conducted as part of the CF6-50 program, to understand the variability in deterioration rates which resulted from analysis of DC-10, 747 and A300B data. The conclusion was that deterioration rates for the data surveyed was most strongly influenced by average flight length per cycle and the amount of derate or reduced power being used by the individual operators. Table 1 shows the data from Figure 3 translated into the deterioration rate per 1000 cycles basis. The conclusion is that while the DC-10 and 747 data are reasonably consistent and show approximately the same deterioration rate per 1000 cycles, the A300B data shows a much lower deterioration rate per 1000 cycles. Since the A300B data studied as part of this program were consistent with flight cycle lengths of approximately 1.9 hours, the lower deterioration rate per 1000 cycles but also time at temperature.

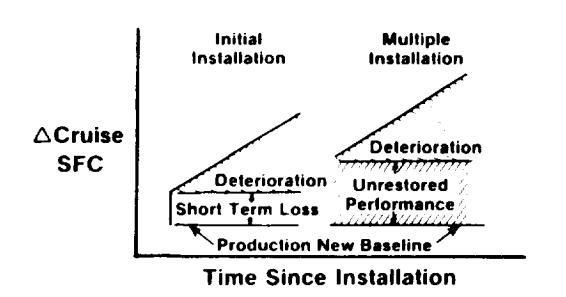
FIGURE 3

CF6-50 Deterioration Characteristics

DC- 10	B747	A300
	1	
3000	4000	2000
1.5	1.6	1.1
3000	3850	2000
0.79	0.95	0.79
1.8	1.8	1.8
	DC- 10 0.7 3000 1.5 3000 0.79 1.8	DC- 10 B747 0.7 0.7 3000 4000 1.5 1.6 3000 3850 0.79 0.95 1.8 1.8

Figure 3 shows the deterioration characteristics resulting from cruise data analysis of data obtained for the CF6-50 engine on various aircraft. General findings of the program were that the Short-Term losses which occurred during the airframer checkout of the aircraft tended to be the same for operation on all three aircraft. Also, the unrestored performance level of the multiple-build engine as refurbished by the various airlines was essentially the same. It can be noted from Figure 3 that the deterioration rate shown during typical 747 operation was lower than observed with DC-10 and A300 operations. The same relationship holds for both the initial and multiple installations. The unrestored SFC of the typical engine re-entering revenue service after airline shop visits is 1.8 percent poorer than the new engine baseline for the CF6-50 engine as compared with the 2.1 percent determined in CF6-6D analysis.

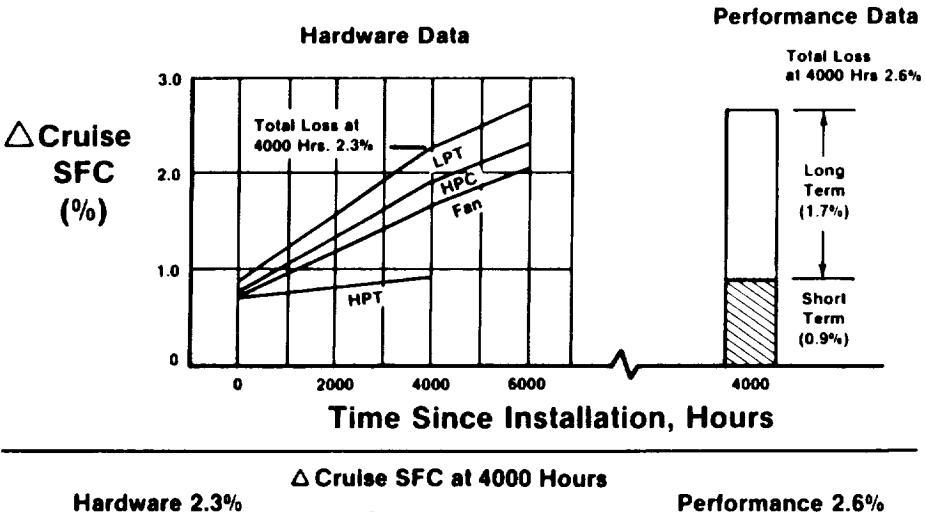
FIGURE 4

CF6-6D Initial Installation **Performance Deterioration**

Good Agreement!

Performance 2.6%

Figure 4 illustrates the results of the hardware inspection analyses and the resulting deterioration model compared to the performance-data-derived deterioration level for the CF6-6D initial installation. It shows that the largest portion of the 0.9 percent Short-Term SFC loss resulted from High Pressure Turbine (HPT) performance losses. This loss was due largely to HPT clearance increases during the initial checkout phases of the airplane. During initial operation of the aircraft by the aircraft manufacturer, there is little attendant loss in fan, high pressure compressor and low pressure turbine. It is also to be noted that the combined performance deterioration level created by the stackup of the individual component deterioration losses at 4000 hours shows 2.3 percent total performance degradation from the "as new" condition compared to the 2.6 percent level which resulted from performance data analysis.

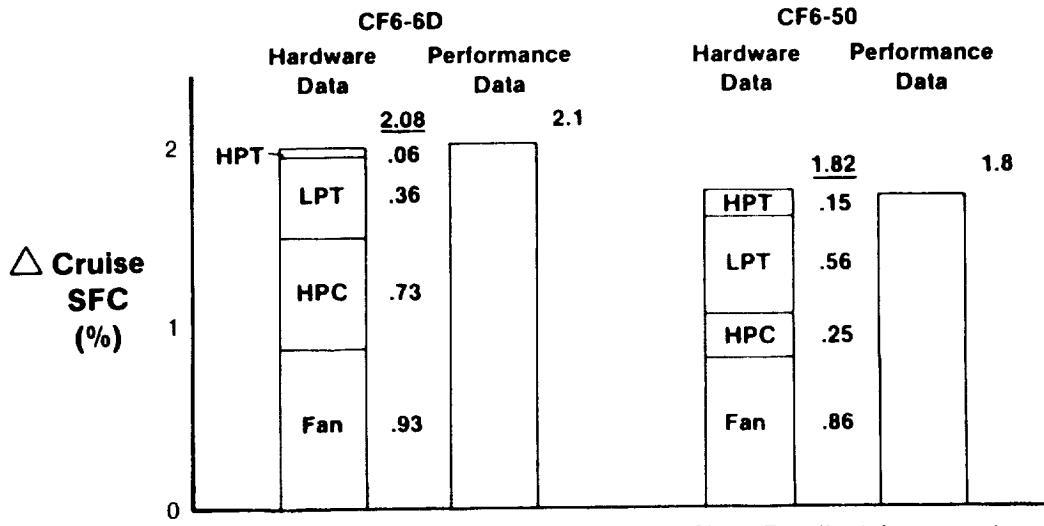
FIGURE 6

Unrestored Performance

Hardware Inspection Summary Compared to Performance Summary

• Hardware Inspections and Performance Data Analysis Show Excellent Agreement

Of prime importance to the program was the finding that the unrestored loss for the typical engine out of the overhaul shop, based on hardware inspections, was 2.08 percent in terms of cruise SFC compared to the 2.1 percent unrestored performance level as identified by performance data analysis. Figure 6 describes the component breakdown for both CF6-6D and CF6-50 engine models as shipped from the airline overhaul facilities compared to the new engine performance levels. It shows that, of the 2.1 percent unrestored performance for the CF6-6D engine and 1.8 percent unrestored performance for the CF6-50 engine, a large portion of these performance losses are due to lack of performance restoration in the fan area with lesser amounts of the performance loss associated with the high pressure compressor and the LP turbines. Note that there is very little performance left to restore in the HPT area for typical outbound engines, again, this is due to the fact that HP turbines are typically completely refurbished during shop visit. Again, the hardware inspection data and the performance data show excellent agreement.

The unrestored performance identified in Figure 6 represents a potential gold mine in terms of fuel and dollars savings to the airlines, if it can be reduced on a cost effective basis. The presence of large amounts of unrestored performance associated with performance degradation of the fan module, HPC module and the LPT module, relative to new modular performance levels, is due to early workscope definitions. These airline shop overhaul work scope definitions were primarily aimed at maintaining reduced EGT levels and at restoring the condition of the hardware primarily from a reliability standpoint. The engine modules, which have the most direct impact on EGT margin and direct impact on reliability, are primarily associated with the hot section of the engine. the combustor and high pressure turbine area. Larger efforts (dollars and manhours) are required to achieve the same amount of EGT margin restoration in the LP system components than in the HP system components. In the early 1970's, it was concluded that it was not cost effective to do significant performance restoration in the fan and LPT areas with fuel prices at a 30 cents per gallon level. With current and projected fuel prices, the cost effectiveness of doing performance restoration work in all of the engines' major components must be re-examined.
