RADIATION MONITORING USING IMAGING PLATE TECHNOLOGY: A CASE STUDY OF LEAVES AFFECTED BY THE CHERNOBYL NUCLEAR POWER PLANT AND JCO CRITICALITY ACCIDENTS

Key words: CNPP accident, JCO criticality accident, imaging plate technique

Scientific paper UDC: 539.1.074/.075:614.876 BIBLID: 1451-3994, 21 (2006), 1, pp. 41-47

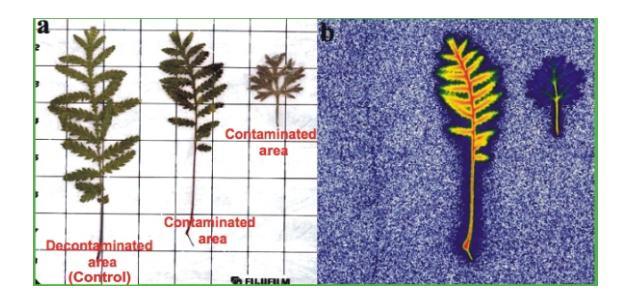
Figure 1. IP analysis of fern leaves (a) photograph of fern before exposure to IP (b) photograpgh after exposure to IP (exposure time was 24 h)

⁴⁰K, which exists as a naturally occurring background radioactive source, was distinguished by checking the image in real time (data not shown). In order to investigate the distribution state of ¹³⁷Cs and ⁹⁰Sr, ¹³⁷Cs was separated using various shield materials, for example, since it was found that ⁹⁰Sr had reached radiation parallel with ⁹⁰Y, a radiation shield was used for ⁹⁰Y. Results presented in fig. 1 show ferns from Masany (both decontaminated and contaminated areas) exposed to the IP plate. It can be clearly seen that the leaves of the ferns from the contaminated areas show very high radioactivity, particularly in the veins (dark red color), strongly suggesting that these radionuclides had moved into the plants from the soil. In total contrast, control plants from the decontaminated area did not reveal any radioactivity. These initial data indicate the usefulness of IP in visually determining radioactivity.

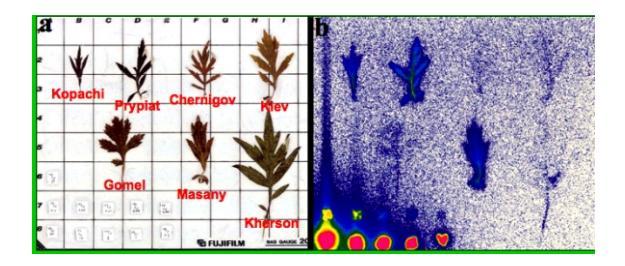
Figure 2. IP analysis of wormwood leaves (a) photograph before exposure to IP (b) photograph after exposure to IP (exposure time was 72 h)

We examined the leaves of both wormwood and ferns from various locations around Chernobyl (figs. 2 and 3). The leaves of wormwood plants from Kopachi, Prypiat and Masany show presence of radioactivity. On the other hand, the ferns were strongly radioactive in comparison with the wormwood plants, and the leaves from the Red Forest, Kopachi and Masany showed high levels of contamination. Surprisingly, the leaves from the decontaminated area of Prypiat also showed radioactive contamination, though not at levels detected in the still-contaminated areas. These results, while clearly showing the efficiency of the IP technique, disturbingly reveal that some of the decontaminated areas have a certain amount of radio-contamination still left in the plants, which is most likely to originate from the soil. This makes us very anxious about in-the-body contamination, *i. e.* the shifting of the radioactive nuclide from contaminated soil to agricultural products.

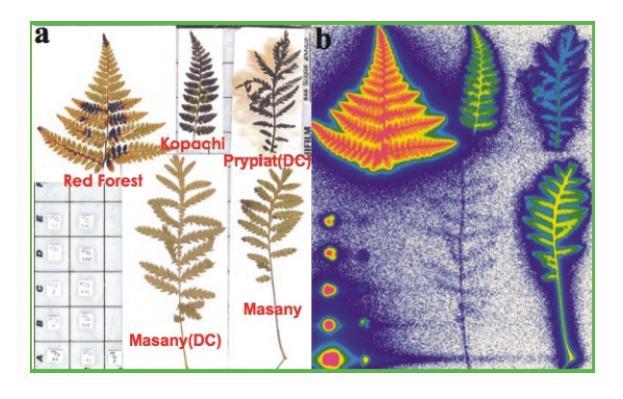
Figure 3. IP analysis of fern leaves from the Chernobyl exclusion zone
(a) photograph of wormwood before exposure to IP (DC, decontaminated area)
(b) photograph after exposure to IP (exposure time was 12 h)

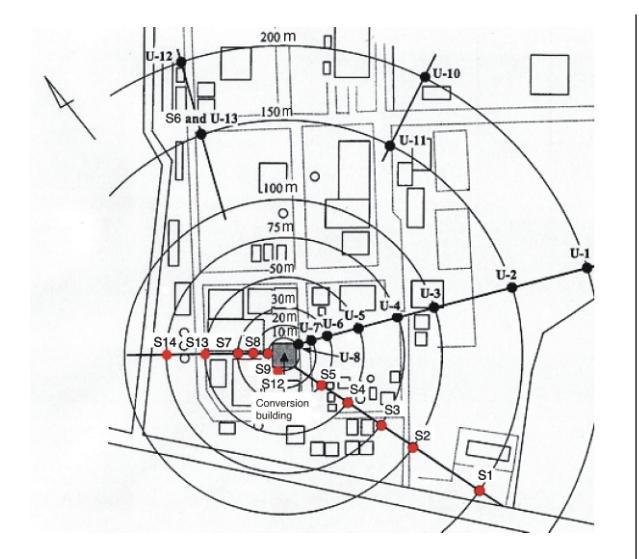
Figure 4. Sampling point of the Tokaimura JCO site Distance from the uranium conversion building was 2.1 m (S9), 23.8 m (S8), 37.1 m (S7), 49.1 m (S13), and 63.5 m (S14)

plants from the Tokaimura accident site in Japan (JCO criticality accident site). At first, in order to select an IP index plant around the JCO site, ivy, wormwood, mulberry and fern plants were collected and examined. The sampling points are shown in fig. 4 (S1-S14). Consequently, wormwood, whose detection sensitivity of the radioactivity by IP was good (fig. 5), was adopted as the index plant. This was based on its presence at almost every point where it was easy to form a plant community, and a suitable height from the ground in the range of 10 to 30 cm. This result further provided support to the use of the IP technique for measuring radioactivity in plants. However, as seen in fig. 5, S7 and S8 samples showed higher radioactivity than S9, which is closest to the precipitation tank (conversion building), fig. 6). Hence, these initial results revealed that it was not advisable to depend on the distances of the wormwood plants from the precipitation tank, the main generating source of neutrons. Moreover, in order to investigate the contribution of surface contamination by the radioactive noble gas as another cause of the contamination, the distance of a sampling point was measured from the surface of a wall near the exhaust duct. As a result,

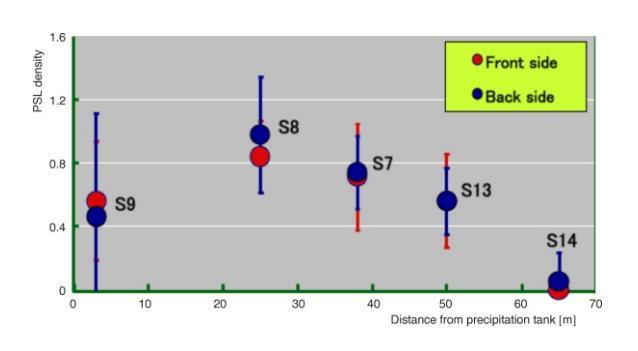
Figure 7. Relation between sampling point and the photo-stimulated luminescence (PSL) density by IP

S9 (23.7 m), S8 (12.1 m), S7 (18.0 m), S13 (28.9m), and S14 (41.8 m) sampling points were selected, which proved to be in good agreement with the photo stimulated luminescence (PSL) density of IP (fig. 7). We also checked the PSL density of the same samples (S9-S14) in a time-dependent manner. It can be clearly seen that the PSL density decreased with time (day), fig. 8. Therefore, it can be suggested that the PSL density was strongly influenced by the neutron-induced fission product,

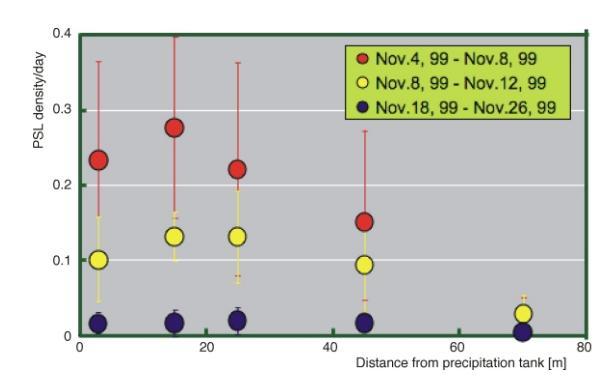
Figure 8. Decrease of radioactivity in collected wormwood samples during the progress of time (days) after the JCO criticality accident

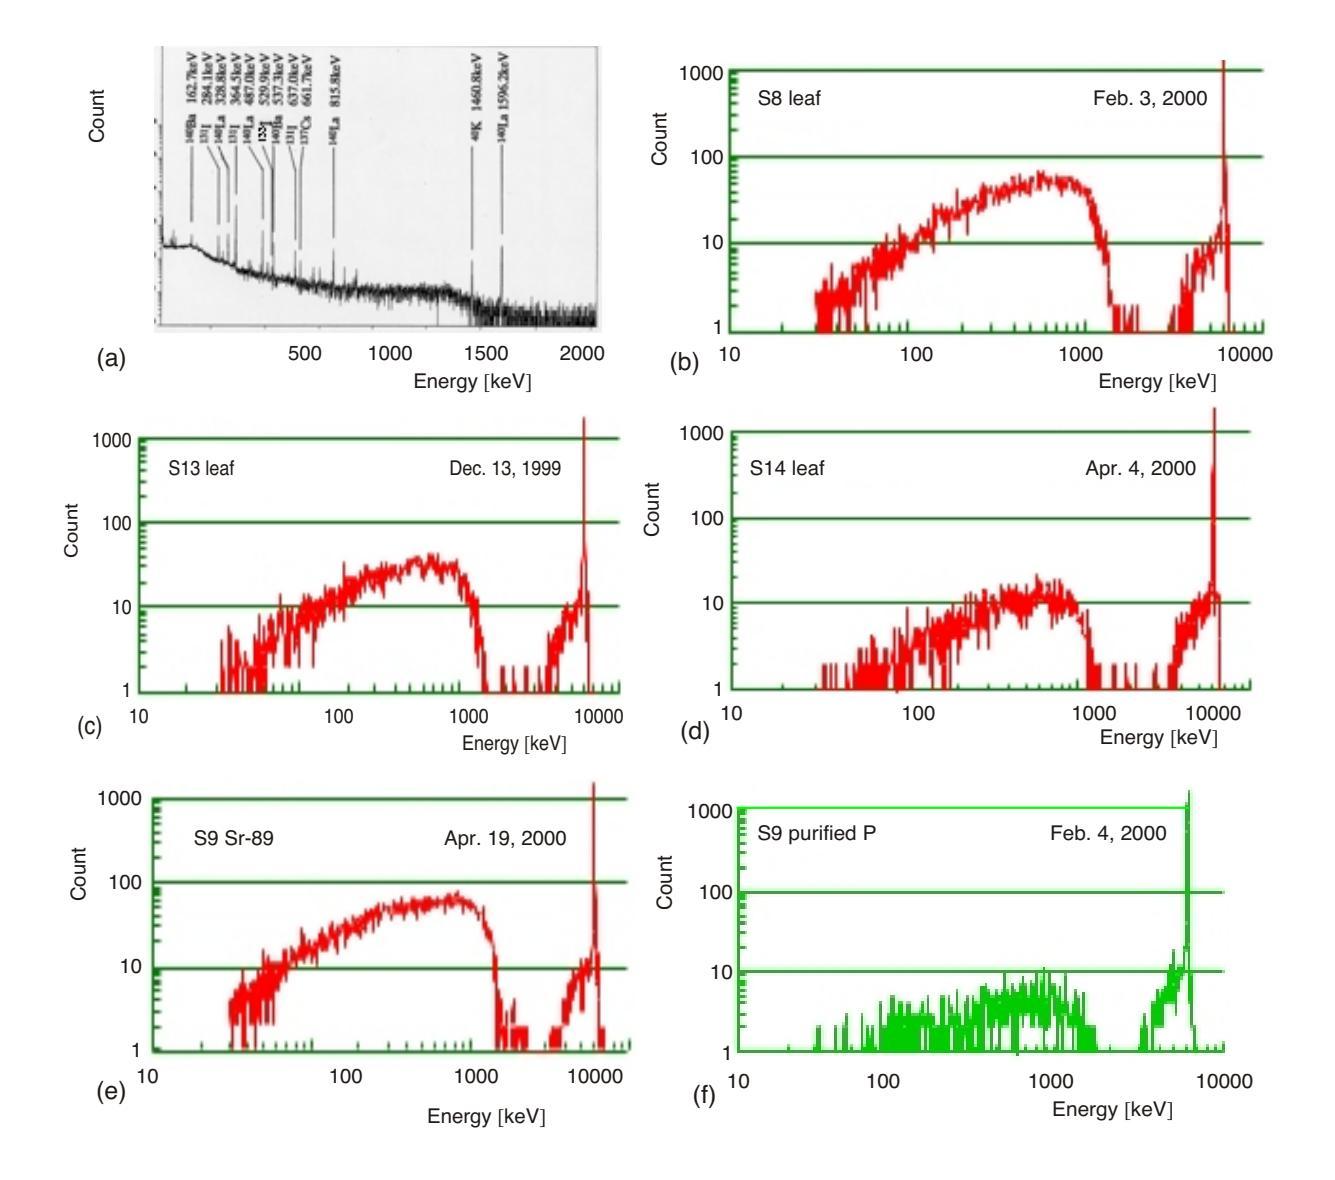
Figure 9. Gamma ray and beta ray spectrum from wormwood collected within the JCO site (a) gamma ray spectrum from wormwood,

(b-d) beta ray spectrum from wormwood leaves,

(e-f) identification of the beta ray emission nuclide by the beta ray spectrometer after the purification of Sr (e), and of P (f)

In order to prove this, an identification of the radionuclide was attempted by using a Ge-detector and a low background beta ray spectrometer. Radionuclides such as ¹⁴⁰Ba (0.537 MeV), ¹⁴⁰La (1.349 MeV), ¹³⁷Cs (0.662 MeV), ¹³¹I (0.365 MeV) and ¹³³I (0.529 MeV) were detected by a Ge-detector (fig. 9a). According to the report of Ban-nai et al. [5], the level of ¹³¹I was about 120 Bq/kg at the JCO site. This was less than the index (pine leaf: 2000 Bq/kg) ingestion restrictions imposed on food and beverages for ¹³¹I. As an identification of the -ray nuclide by low background beta ray spectrometer, the existence of ⁸⁹Sr (1.497 MeV) from the fission product origin ⁸⁹Kr was found in the leaves [6] (fig. 9b-d) and confirmed by purifying Sr from the S9 leaf sample (fig. 9e). The detection of ⁸⁹Sr, which is a beta ray emitter, is a new observation, clarified due to the emission into the environment. These results were also in good accord with the PSL intensity of IP (fig. 9).

We further examined whether other radionuclides, like the beta ray emitters ³²P, ³⁵S, and ⁴⁵Ca, neutron-induced, were present in the leaves. We therefore selected the S9 leaf sample, and consequently, ³²P, which is the neutron-induced radionuclide of phosphorus, identifying a sulfurous origin (fig. 9f). In general, based on all these results, it can be suggested that, in the JCO criticality accident, the influence of fission products was more pronounced than the effect of the
