SPACECRAFT CONTAMINATION ISSUES FROM LDEF: ISSUES FOR DESIGN*

Gary Pippin and Russ Crutcher Boeing Defense & Space Group P.O. Box 3999 Seattle, WA 98124–2499 Telephone: (206) 773–2846

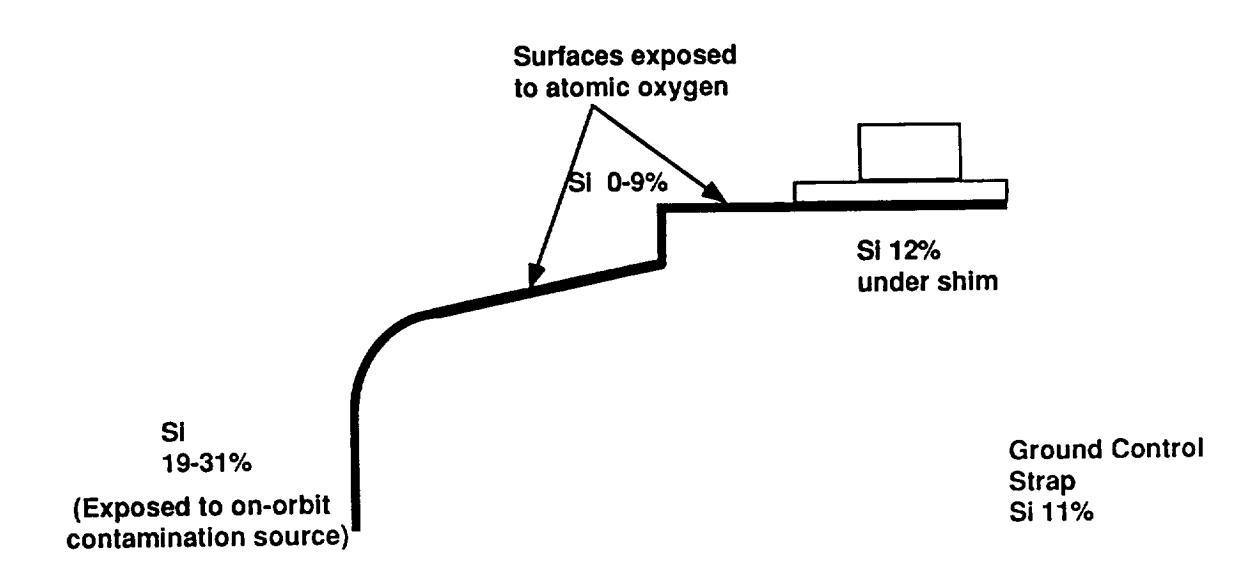
Figure 1. Cross section view of copper grounding strap, Tray D11, showing Mol% silicon on surface in different areas. (The value for the ground control strap is shown for comparison.)

Thin film deposition on LDEF can be explained by line-of-sight deposition from many individual sources and with a smaller contribution from material reflecting from one surface to another. The grounding strap for blanket D11 shows a variety of contamination and environmentally induced changes. The adhesive release paper had a siloxane coating which left silicon-containing species on the copper. The silicone room temperature vulcanized (RTV) adhesive used to bond Velcro[™] strips to the underside of thermal control blankets and to tray frames outgassed through vent holes at the edge of the blanket materials onto the portions of the copper grounding strap tucked down along the tray edge. Figure 1 shows a schematic of the strap with key areas of differing silicone deposition intensity shown. Areas of the copper strap exposed to significant AO show levels of silicone decreased from the levels on shielded areas and ground control specimens.
