DAMAGE TO METALLIC SAMPLES PRODUCED BY MEASURED LIGHTNING CURRENTS

Richard J. Fisher and George H. Schnetzer Sandia National Laboratories Albuquergue, NM 87185

ABSTRACT

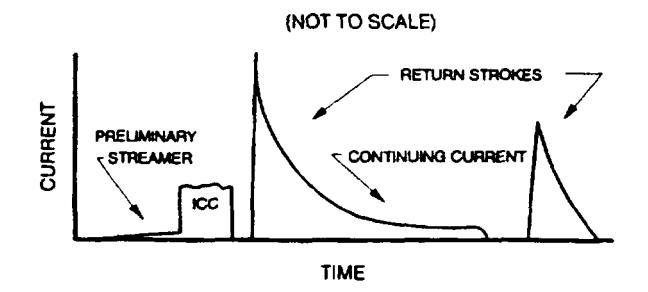
Figure 1. Typical Rocket-Triggered Lightning (RTL) Flash Current

For these experiments, the rocket and wire dispensing assemblies developed by the Centre D'Etudes Nucleaires de Grenoble (CENG) in France were employed [6]. There are several variations of these systems. The one employed here, called LRSG (for lightning rocket system, grounded), incorporates a 2100-ft length of wire that is tied to earth ground at the bottom of its launch tube. The typical flash current that results from this system is illustrated schematically in Figure 1.

There are certain features of this current that depart from those of a naturally initiated flash, most notably the presence of the few hundred milliseconds of low-level initial continuous current (ICC) that precedes the first return stroke. A second, more subtle difference is that the first return stroke of the triggered flash is thought to be most often initiated by a dart, rather than stepped. leader and is otherwise typical of a subsequent return stroke of a purely natural flash [7]. From the viewpoint of the objectives of the present experiment, however, this latter issue is of no practical consequence. This is so because, in a metal of any appreciable thickness, virtually all penetration is due to the intermediate and continuing-current components of the flash current, which in triggered flashes fall well within the statistical envelopes of their counterparts in purely natural flashes.²

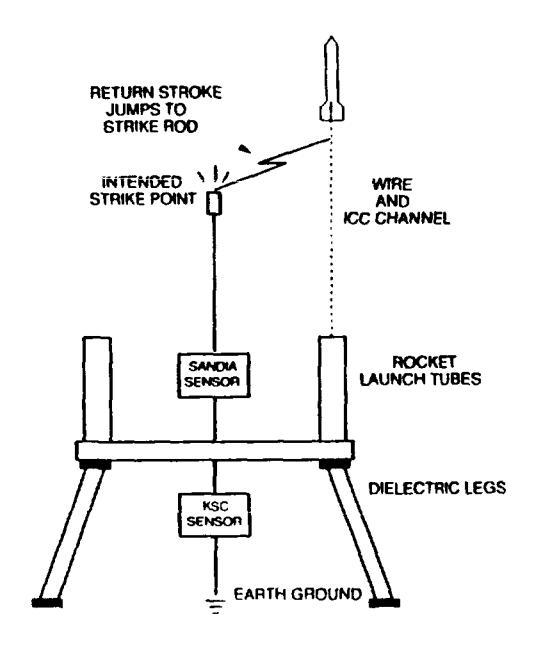
Figure 2. RTL Materials Damage Experiment Configuration

The ICC flows in the channel prepared by the vaporized wire that terminates on the launcher tube. The tube is grounded to earth potential via an array of stranded steel wire cables. As indicated in Figure 2, it was arranged that this portion of the current would not be intercepted by the test specimens so that interpretational complications associated with this component of the triggered lightning flash were avoided. The typical sequence following cessation of the ICC was that one or more return strokes, often with intervening continuing currents, would jump from the ICC channel and attach to the top of the sample, evidently because this path to ground presented a lower impedance than the decayed original channel. In this way the desired data spots created by individual return strokes and returnstroke/continuing-current combinations were acquired.

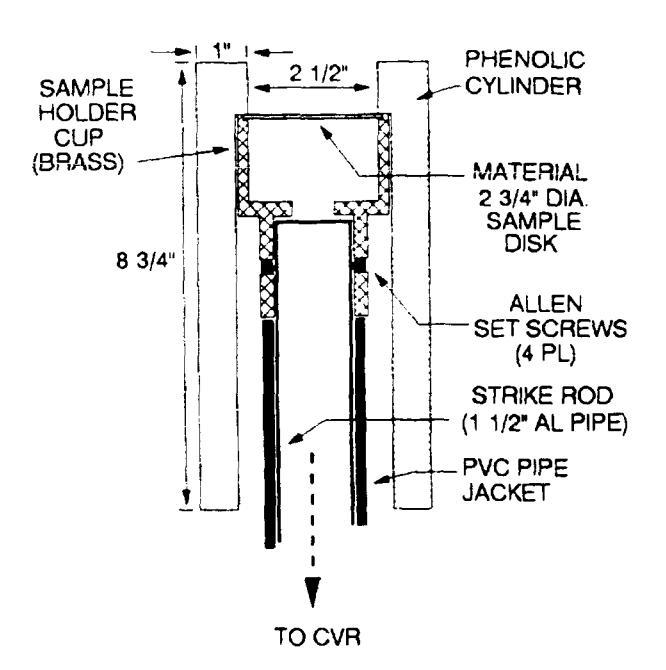
Figure 3. RTL Materials Damage Specimen Fixture

Figure 3 shows the fixture in which the individual samples were held. The development of upward streamers from the edge of the brass fixture cup, which would lead to undesired attachments there, were suppressed by the presence of the dielectric sleeve of woven phenolic material. Two 0.5-in holes were provided in the dielectric shield to prevent the build-up of rain water

over the surface of the sample. The entire arrangement was mounted on a 10-ft hollow aluminum pole, the bottom of which was tied by a 1.5-in braided ground strap to the input of a coaxial $0.5-m\Omega$ current viewing resistor (CVR). In order to discourage the attachment of return strokes along its length, the pole was encased in PVC pipe of ~0.2-in wall thickness from just below the fixture cup to the bottom of the pole.

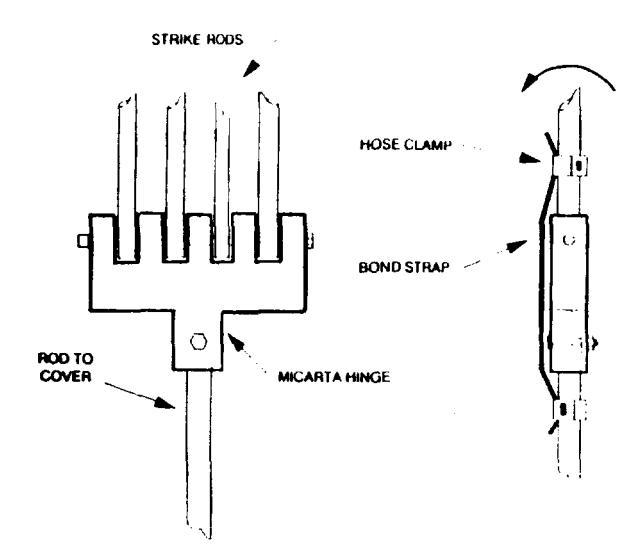
Figure 4. Hinging Mechanism for Raising and Lowering Test Specimens

The potential data return during any triggering session was increased by arranging four identical poles and fixtures on a hinging mechanism so that they could be remotely raised and lowered sequentially during the course of a given storm. Figure 4 shows the hinging mechanism that was employed. A network of plastic ropes and metal pulleys led back to the instrumentation van to allow the raising and lowering of the samples. For safety reasons, two of the sets of pulleys over which the ropes passed were tied together and led to local grounds via braided strap. The eyebolts through which the ropes passed just outside the door of the instrumentation van were also electrically tied together and to the structure of the steel van so that the ends of the ropes were held at the same potential as the structure. The ropes were only operated between rocket launches, and only then after clearance from the rocket launch controller was received.

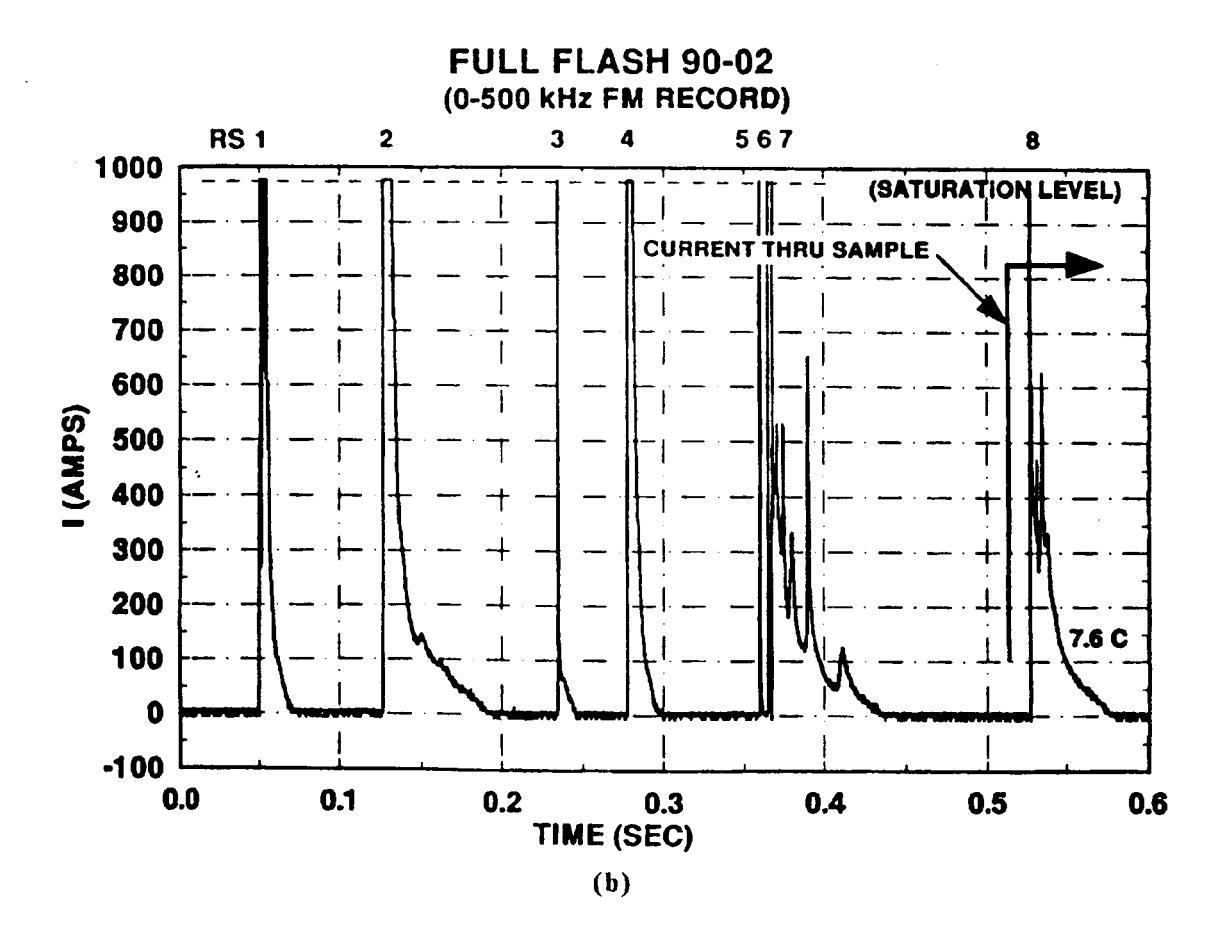
Figure 5. a) 80-mil-Thick Al Specimen Exposed on Flash 90-02 and b) Current Recorded on Same Flash

Figure 5 shows a photograph of the aluminum sample exposed to Flash 90-02 and a plot of the corresponding flash current recorded by the 500-kHz Dymec channel. These data illustrate the importance of the cinematic films. The sample exhibits numerous small surface marks clustered near These correspond to upwardthe center. going streamers, which were recorded during several events by the close-up video system. Aside from those, there is a single significant spot, identified as RS#8 in Figure 5a. In this case, the cinematic film clearly revealed that the wind carried the ICC channel across the fronts of three samples that were lying horizontal prior to being raised for exposure. As a result, the first seven strokes attached to one of the horizontal samples, while only the last stroke attached to the erected one, thereby creating the data spot shown in the figure.

The stroke that hit this sample had a peak current of 13 kA. A charge of 7.6 C was transferred by the continuing current, which lasted approximately 50 ms. The spot is a raised mound of crystalline material of 0.16-in diameter and 0.002-in height above the flat surface. There is a pinhole in the center of the mound with a depth of approximately 0.002 in below the flat surface. Such an isolated spot, caused by an unambiguously known current, represents precisely the sort of data that was sought.

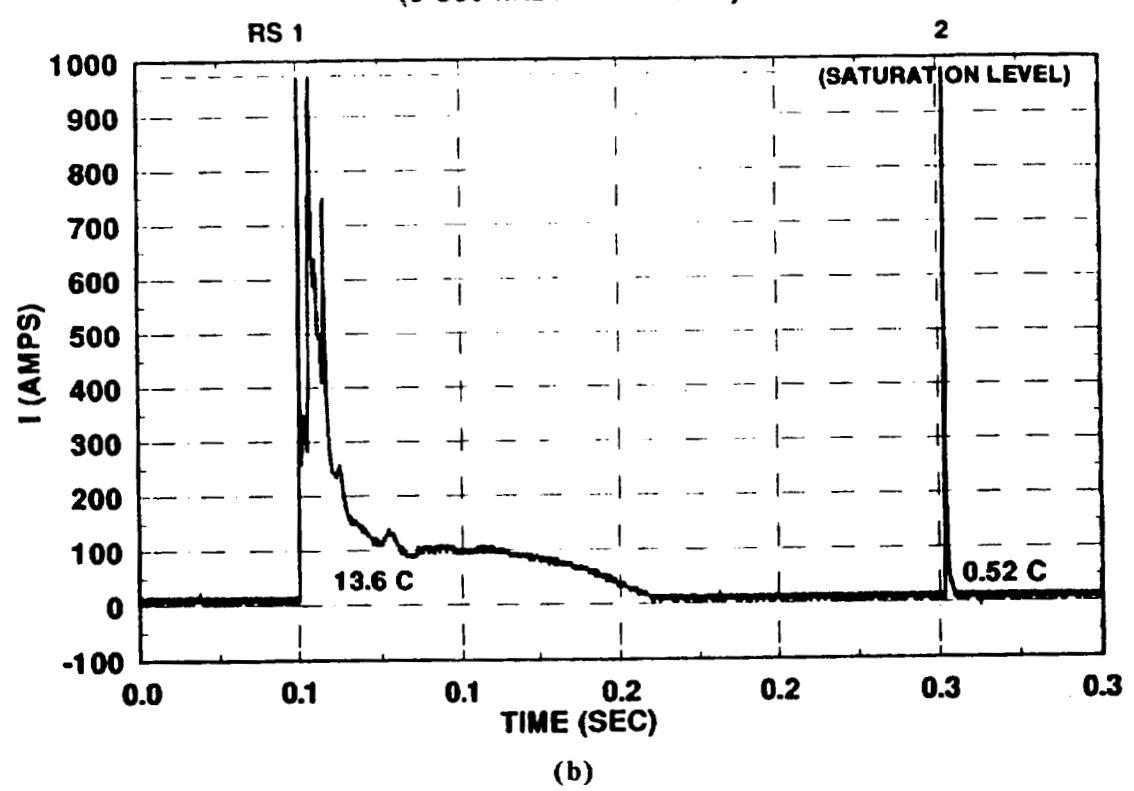
Figure 6. a) 80-mil-Thick Al Specimen Exposed of Flash 90-03 and b) Current Recorded on Same Flash

The two most dramatic results are indicated in Figures 6 and 7. Flash 90-03 consisted of two strokes, both of which were confirmed photographically to have hit the top of the sample. The first stroke $(I_p=13$ kA) was followed by a continuing current that transferred ~13.6 C of charge at a sustained level of 100 A. The corresponding spot is evidently the large one (#1 in Figure 6a), which has a diameter of 0.3 in. Inside the spot is a 0.19-in-diameter raised mound of crystalline material of ~0.04-in height. This bead is surrounded by a crater of maximum depth of 0.001 in. There is no significant discoloration on the back side of the spot, but there is a 0.06-in-diameter round dot, very much like a single braille dot. Precise correlation of the other two major spots (#2 and #3) appearing in the photograph is more tenuous due to the clear photographic evidence that only two return strokes attached to the erected sample. Nevertheless, tentative correlation has been established based on a detailed examination of all the data and a rationale that is discussed in Reference 9.

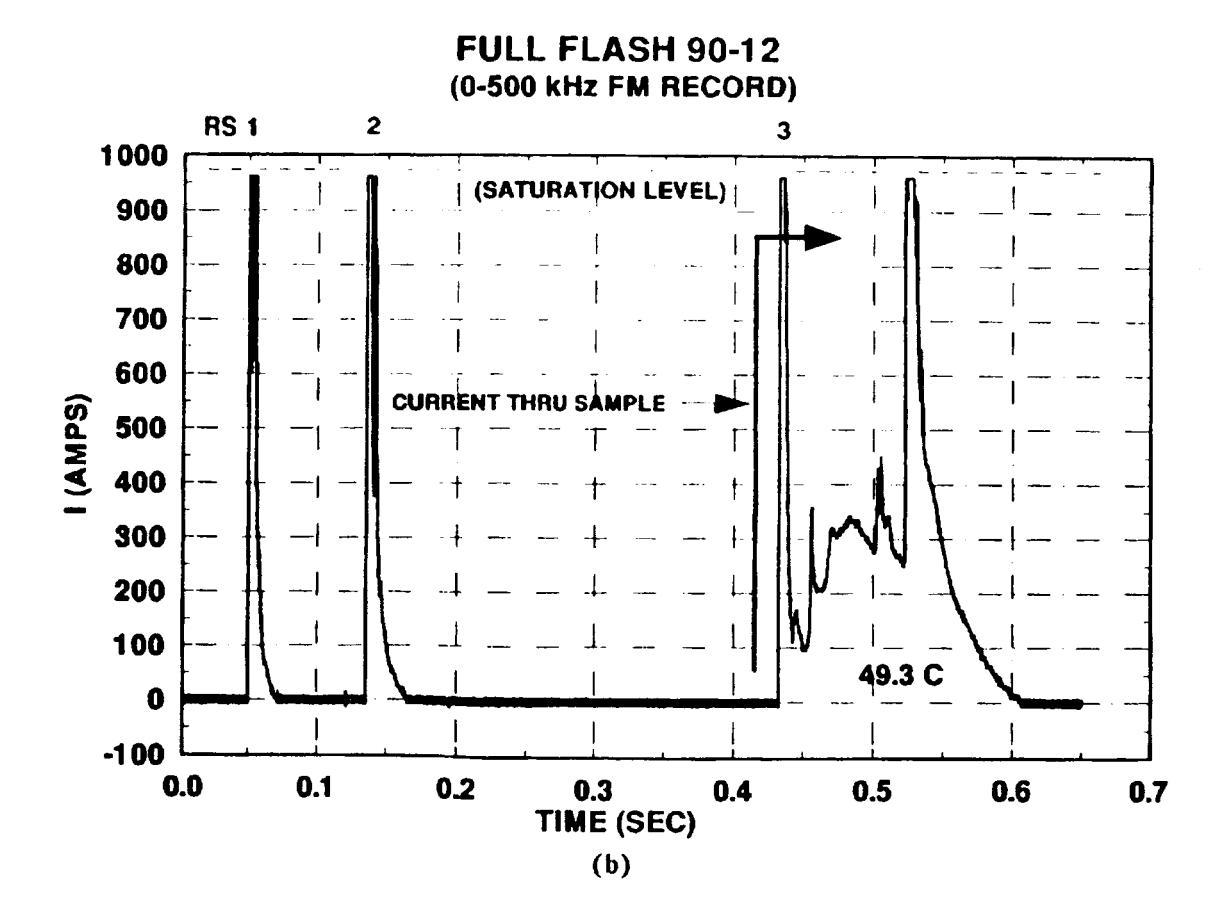
Figure 7. a) 35-mil-Thick Steel Specimen Exposed on Flash 90-12 and b) Current Recorded on Same Flash

Figure 7 corresponds to a 0.035-in thick steel sample. The three distinct overlapping spots have diameters of 0.33, 0.39, and 0.28 in, respectively, and the sample was fully penetrated at the center spot. Again, as confirmed by the film record, the first two strokes indicated in Figure 7b terminated on one of the horizontal samples. Only the current to the right of the indicated line attached to the top of the sample. The current consisted of a single return stroke and a rather severe continuing current. The large peak occurring at ~540 ms represents a large surge (peak of ~1500 A) riding on the established continuing current. Figure 8 shows the back side of the sample. The appearance of the melted material is different from that of the aluminum. It is not crystalline, and seems to have flowed smoothly. In several instances, the residue is silver and shiny, indicating some sort of chemical separation process of the alloy constituents.

Aside from their immediate utility in the process of quantifying simulation fidelity, the data offer additional points of interest. Consider Figure 7. The continuing current following the initial return stroke in Flash 90-03 had a duration of ~120 ms, a sustained current level of ~100 A, and a total charge transfer of 13.6 C. According, for example, to Cianos and Pierce [10], this amplitude and duration fall at approximately the thirtieth percentile points on their respective frequency distributions. The 13-C charge transfer falls at the twelfth percentile. That is, only the stated percentage of all continuing currents have smaller corresponding values. Thus, by any measure,

The 49-C charge transfer represented by the final stroke and continuing current indicated in Figure 7b corresponds to approximately the eightieth percentile level, according to the Cianos and Pierce model. It therefore ranks as a relatively severe, but by no means extreme, flash.
