NASA Contractor Report 158969

ASSESSMENT OF STATE-OF-THE-ART OF IN-SERVICE INSPECTION METHODS FOR GRAPHITE EPOXY COMPOSITE STRUCTURES ON COMMERCIAL TRANSPORT AIRCRAFT

Boeing Commercial Airplane Company Seattle, Washington

Contract NAS 1-15304 January 1979

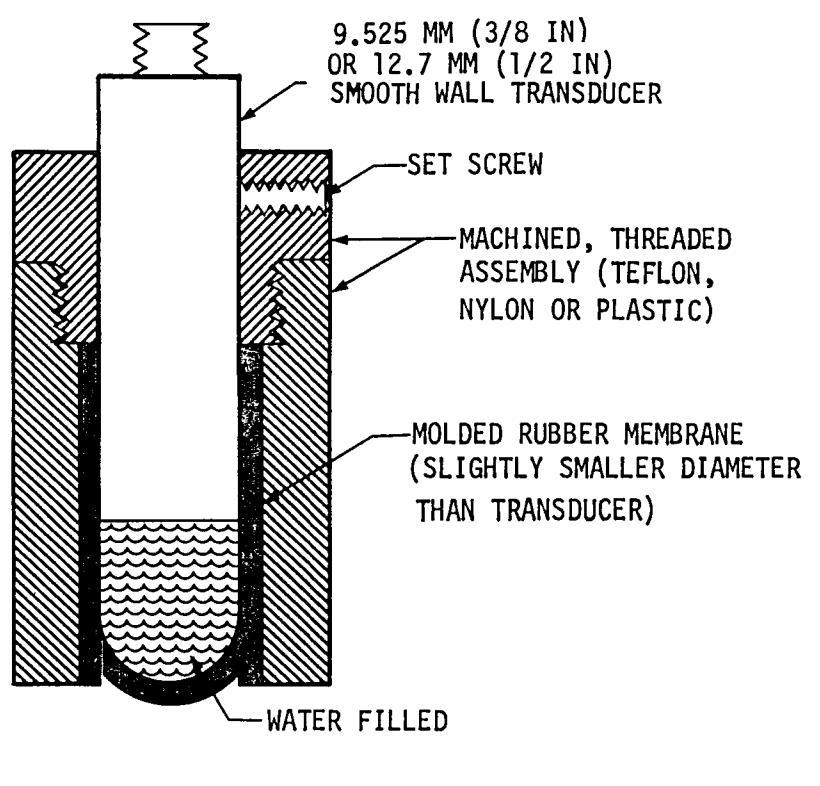
FIGURE 1. STAND-OFF SEARCH UNIT

- o Standard ultrasonic test instrument equipped with a high-resolution pulser-receiver unit for 5, 10, and 15 MHz transducers.
- o One each 5, 10, and 15 MHz high-resolution contact search units.
- o One each 5, 10, and 15 MHz transducers adaptable to angle beam shoes.
- o Angle beam shoes.
- o Couplant: oil, grease, commercial couplant. Also, water bubblers, squirters, and encapsulated water standoffs have been used. The latter is illustrated in figure 1.

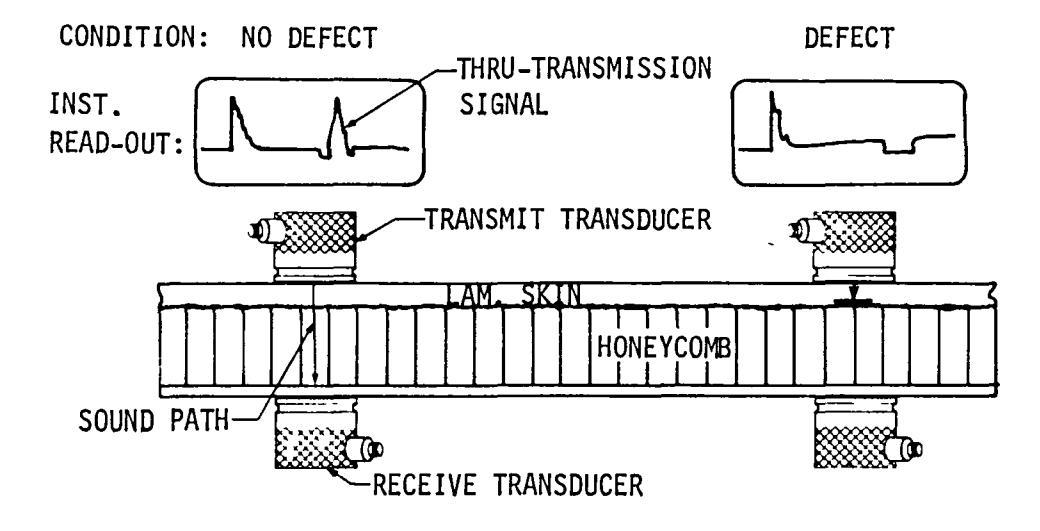
FIGURE 4. THRU-TRANSMISSION TECHNIQUE

One of these is to manually place one of the transducers in direct contact with the part (using a couplant) and position the other transducer over the opposite surface to obtain a maximum through-transmission signal. This is repeated until the area of interest has been covered. The other method uses a yoke assembly to hold both transducers in constant alignment while scanning the transducers over the area of interest. These methods have been used to inspect limited areas of a given part.

Set up instrument per applicable instructions, place transducers on reference standard, and identify through-transmission signal. Verify signal and sensitivity by positioning over defect location and observing signal loss. Select best frequency and transducers for sound transmission through the part and optimum defect sensitivity. The lowest frequency is usually best for high-attenuation materials. Defect resolution is best at the higher frequencies.

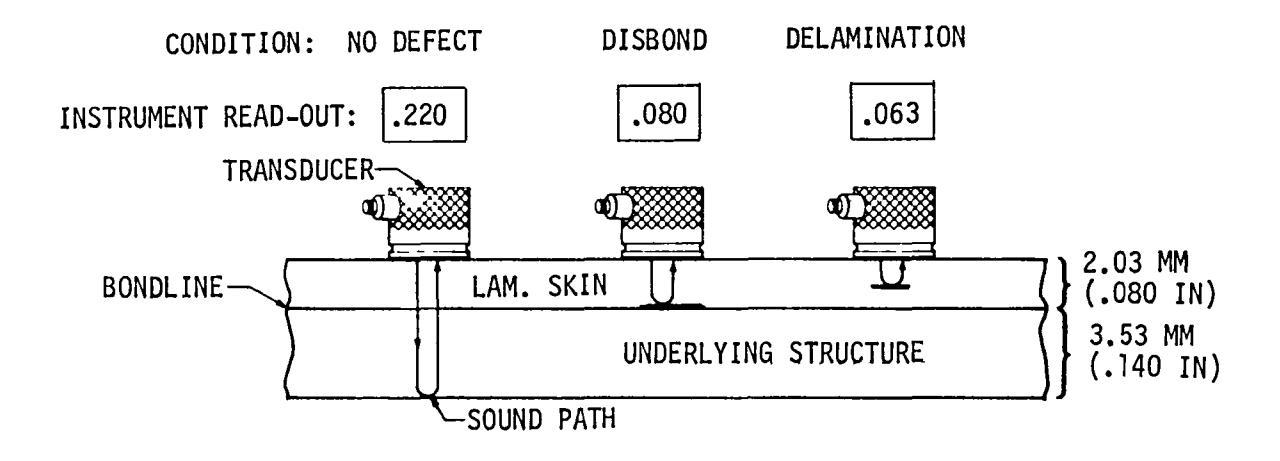
This method uses the pulse-echo principle wherein a transducer in contact, through a couplant, with the part surface generates a pulse that travels to the opposite surface of the laminated skin, echoes from this surface, and returns to the transducer. The time interval from pulse initiation to its return to the transducer is measured electronically and presented as the part thickness on a digital readout. This method detects delaminations in a laminate and may detect disbonds if the skin-to-underlying structure bond permits the pulse to pass into the underlying structure. It is illustrated in figure 6.

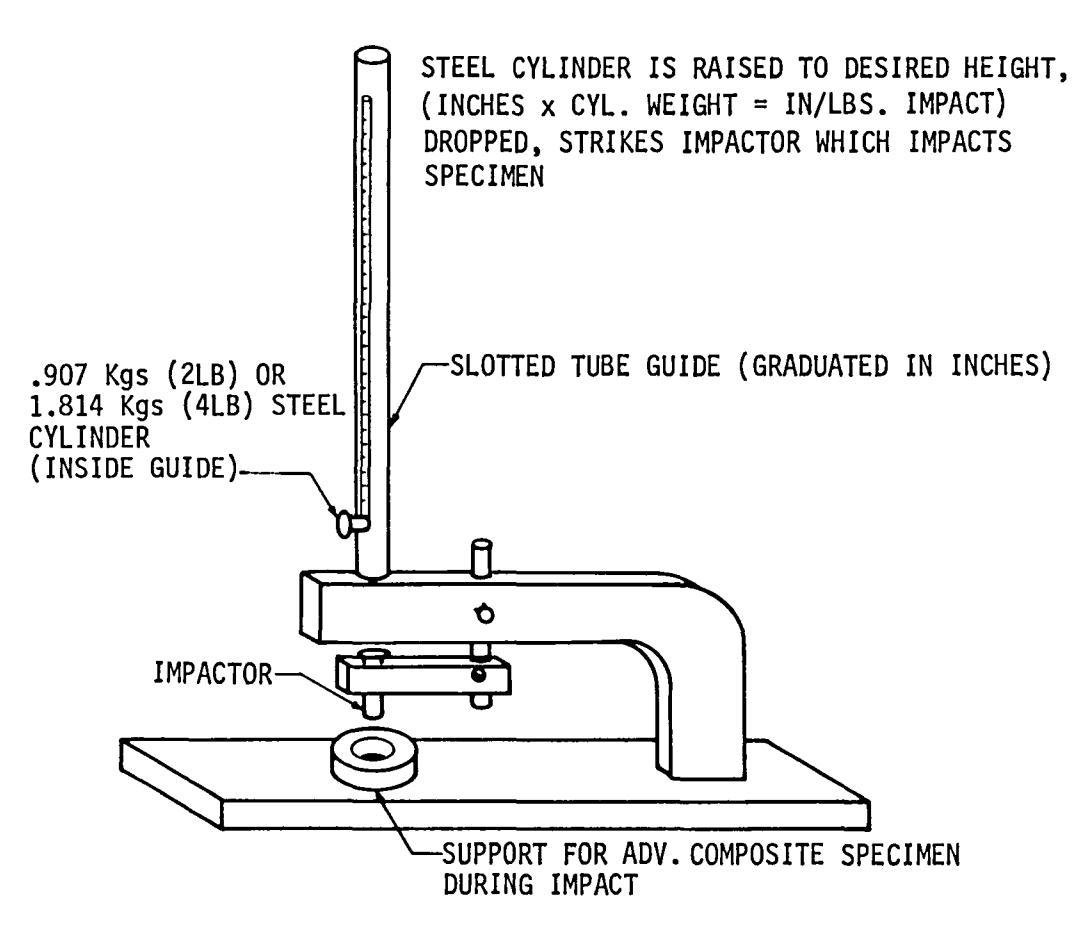
Impact Damage: This is created in the laminated skin member by impact of a blunt object with the test standard surface. A typical method is illustrated in figure 9. Impact defects in the reference specimen should range in severity up to visible damage. The nonvisible defects are used to verify sensitivity of ultrasonic, bond tester, and tap test methods.
