Testing Tensile and Shear Epoxy Strength at Cryogenic Temperatures

S J Alberts^{1,2}, C J Doehne^{1,3}, and W L Johnson¹ ¹Glenn Research Center, Cleveland, OH, 44135 USA ²Present address: Purdue University, West Lafayette, IN 47907 USA ³Present address: University of Akron, Akron, OH, 44325 USA

2017 Cryogenic Engineering Conference July 10–13, 2017 Madison WI

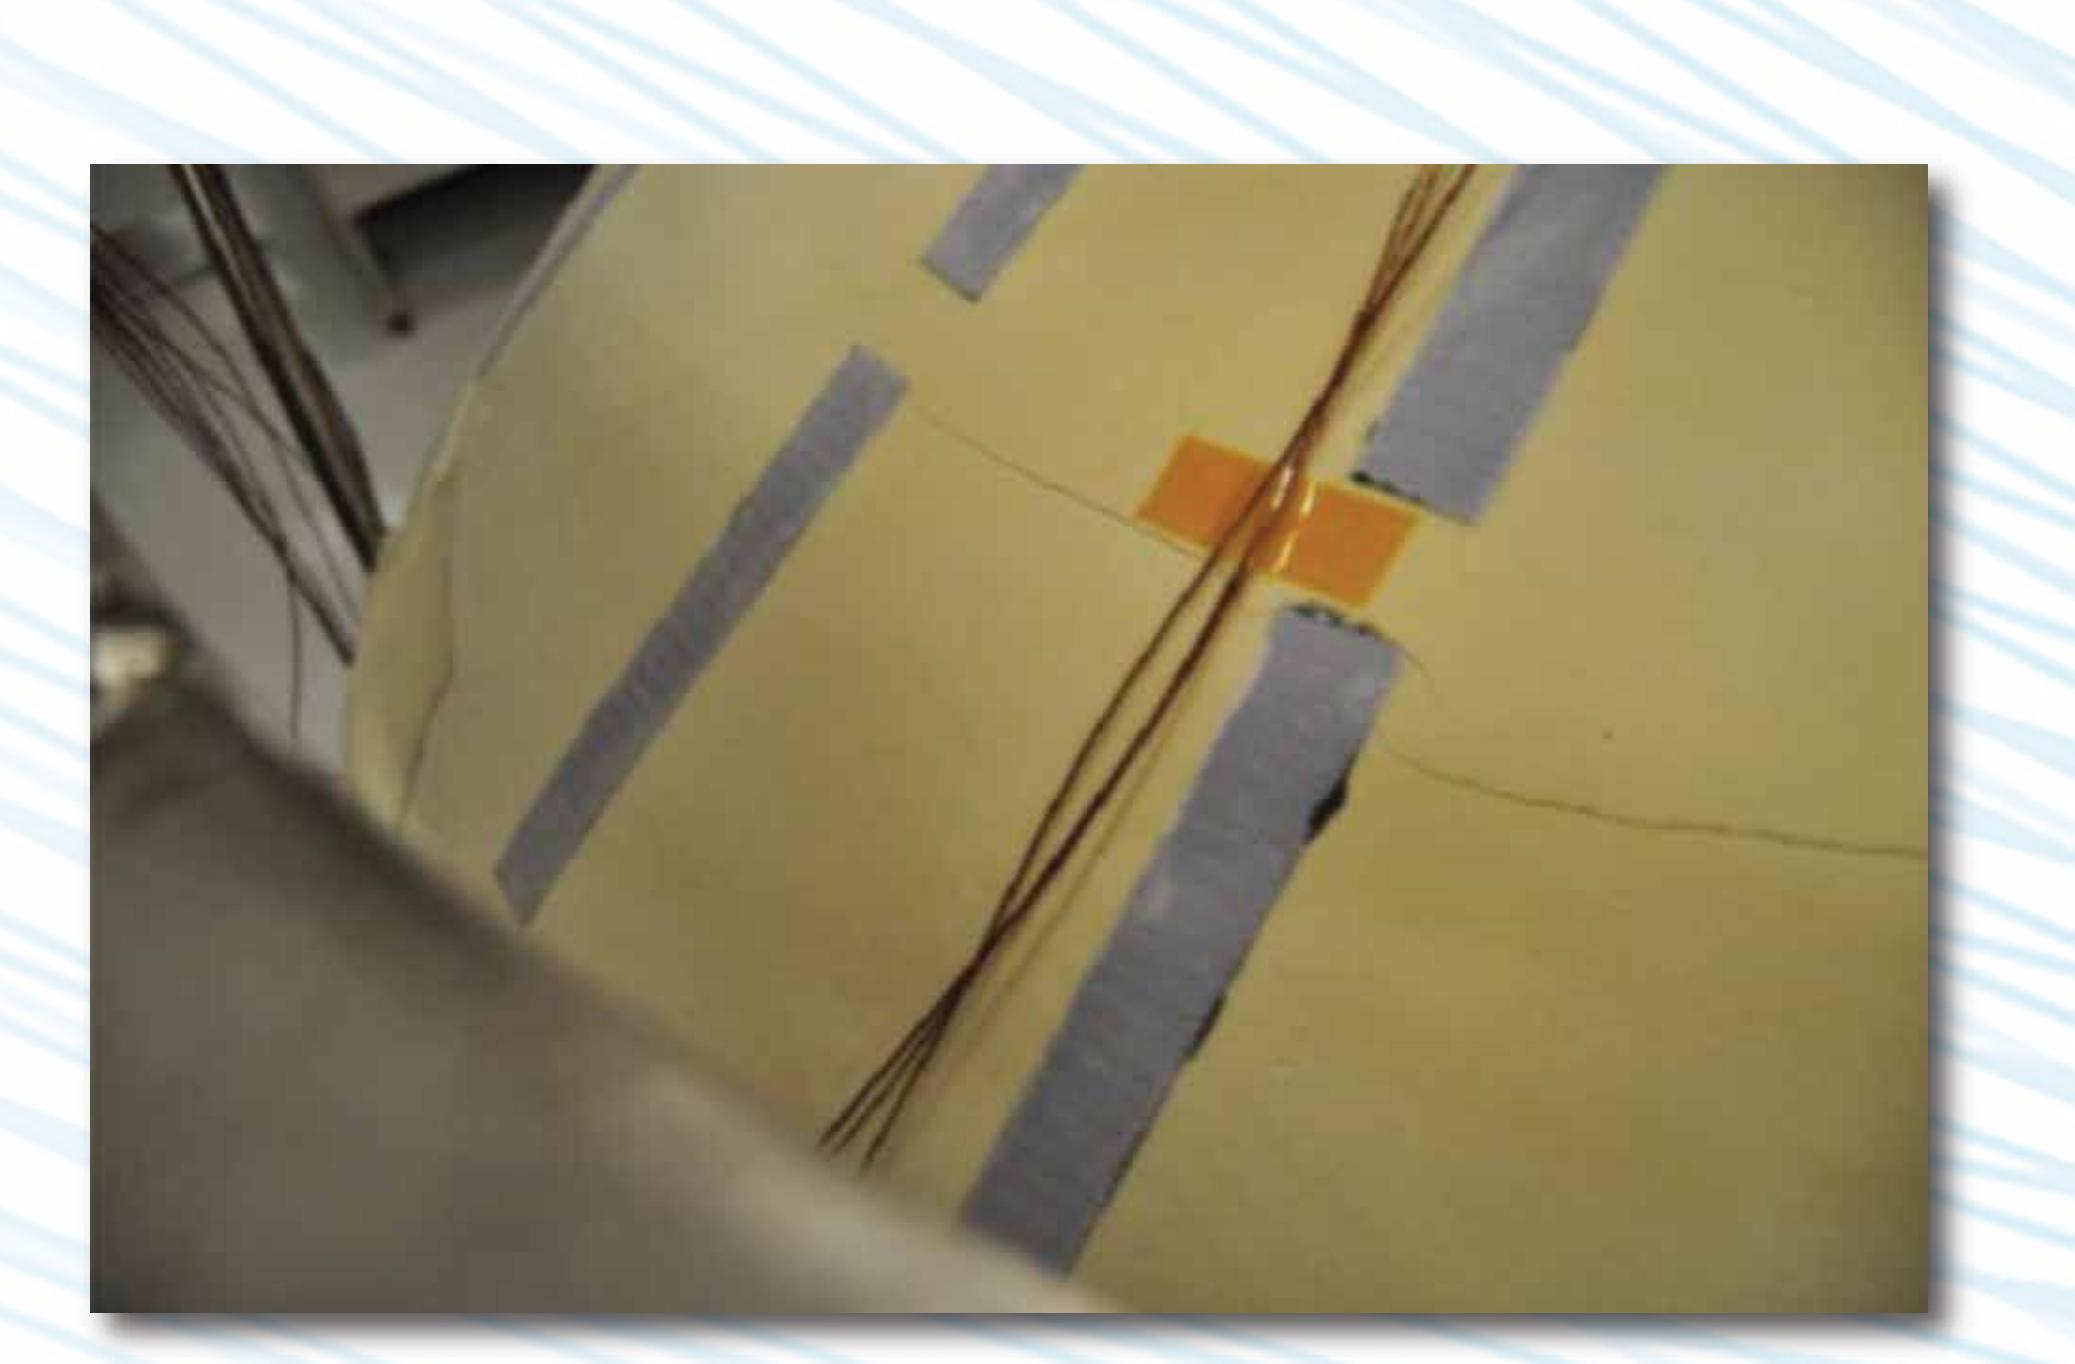
Figure 1. SOFI after MLI was directly attached to the surface.

A typical insulation system for a cryogenic upper stage would include spray-of foam insulation (SOFI) underneath the MLI blankets to prevent air liquefaction. The polyetherimide standoffs would be attached to the tank and protrude through the SOFI to provide points of attachment for the MLI blankets. Previous attempts to attach the MLI directly to SOFI has induced cracking in the SOFI as shown in • Figure 1 [5].

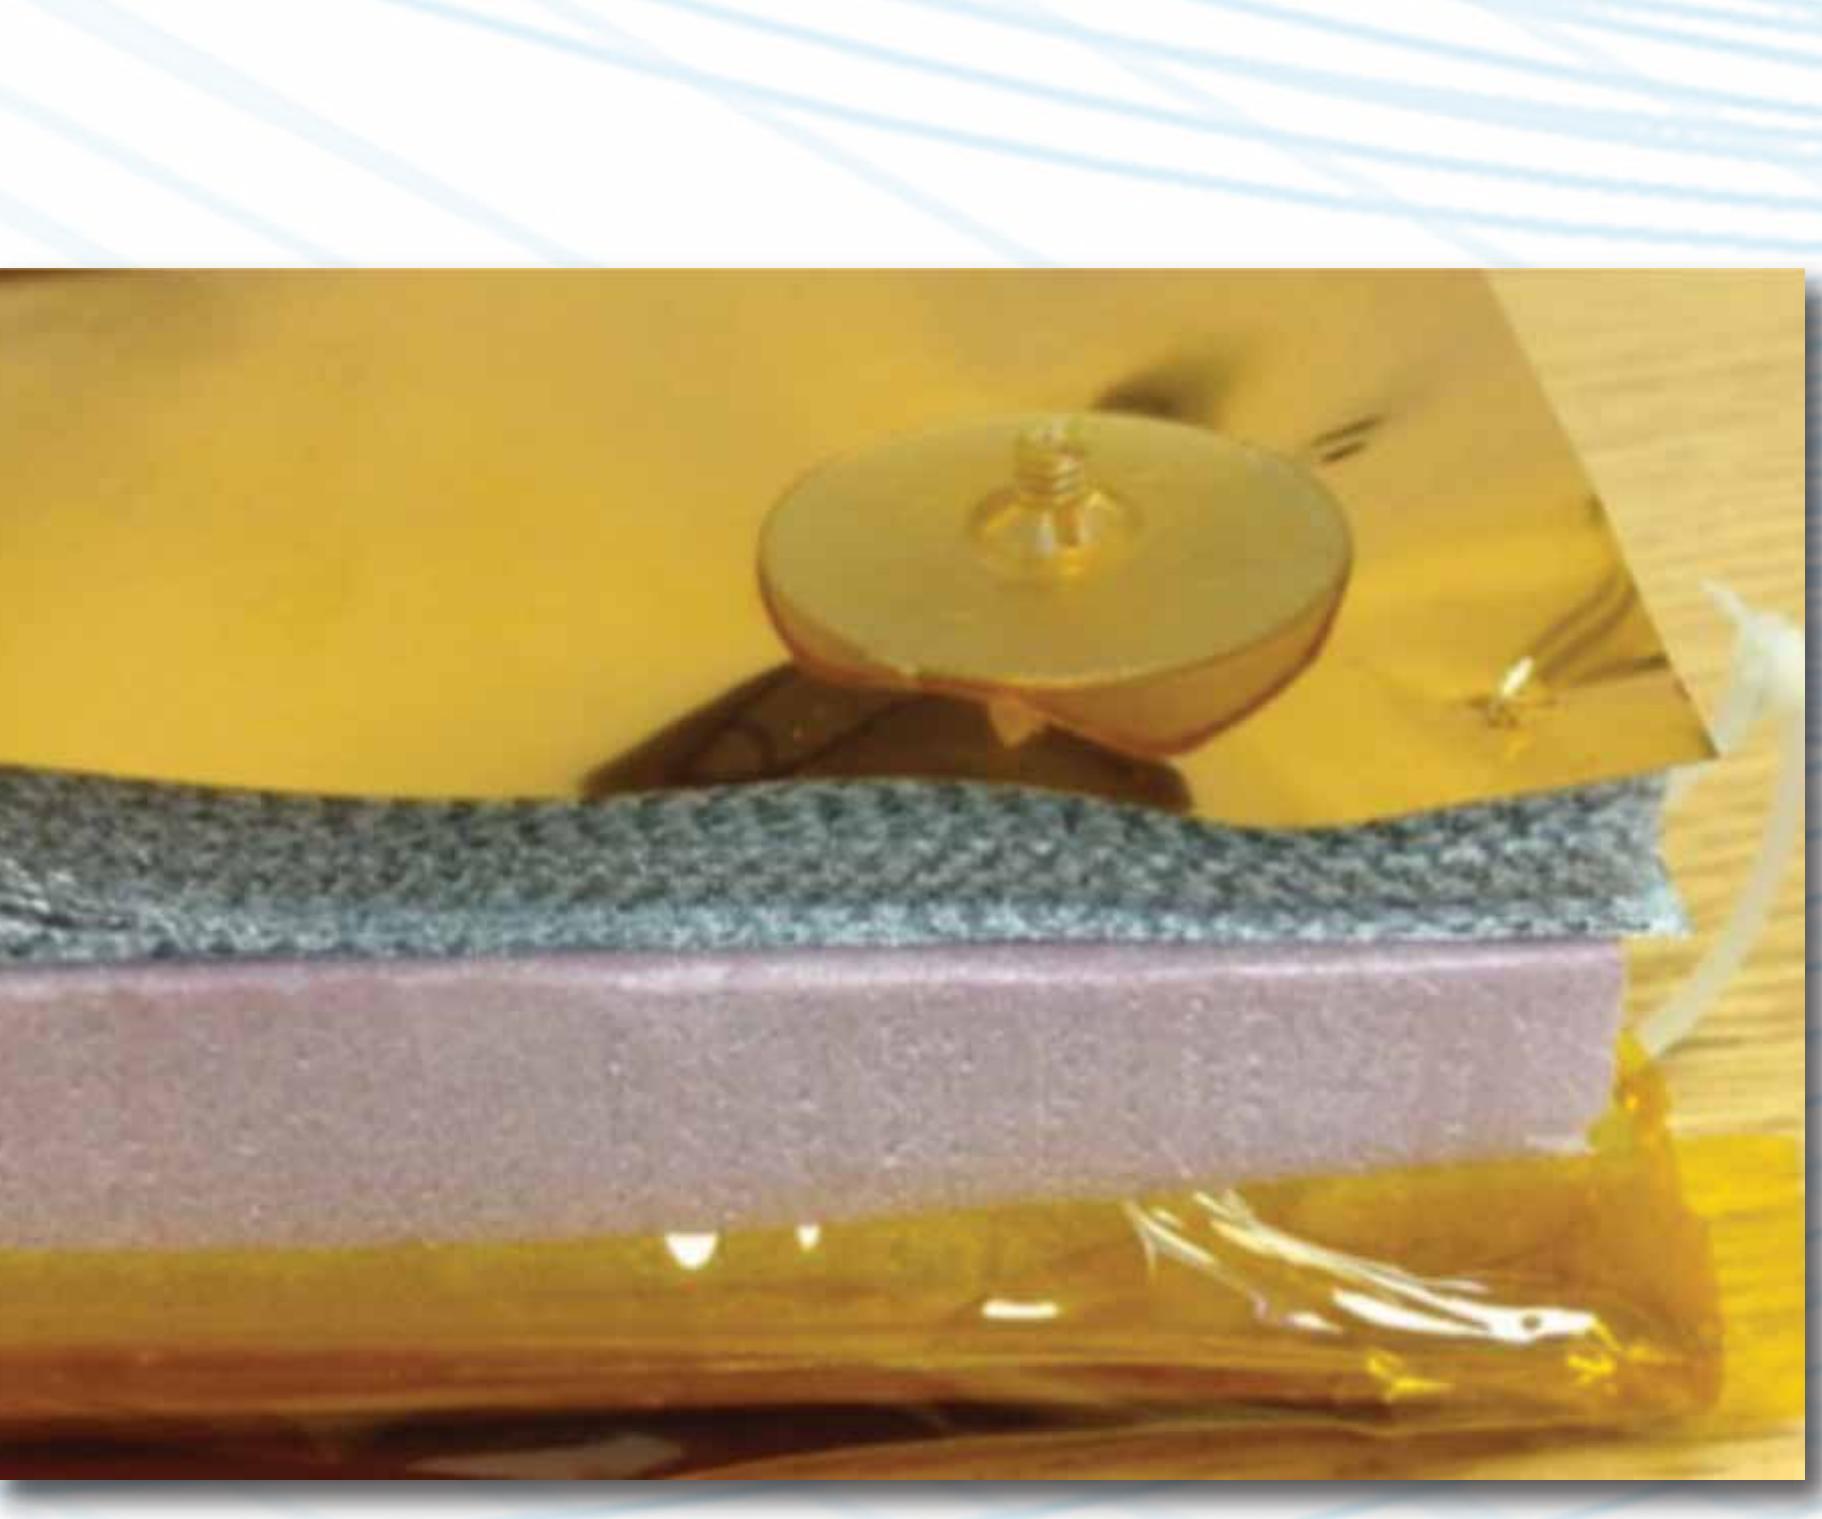
Figure 2. An MLI standoff holding the MLI blanket and foam insulation to the metal surface.

• For reference, Figure 2 shows a possible configuration of a standoff with an MLI blanket. The flat, disk portion of the standoff is bonded to the tank wall with epoxy. The strength of that epoxy bond at cryogenic temperatures is important since failure of that bond would cause the MLI to separate from the tank and increased the boil-off of cryogenic propellants. Therefore tests were conducted to assess the tensile and shear epoxy strength to aluminium, primed aluminium, and stainless steel samples at cryogenic temperatures.

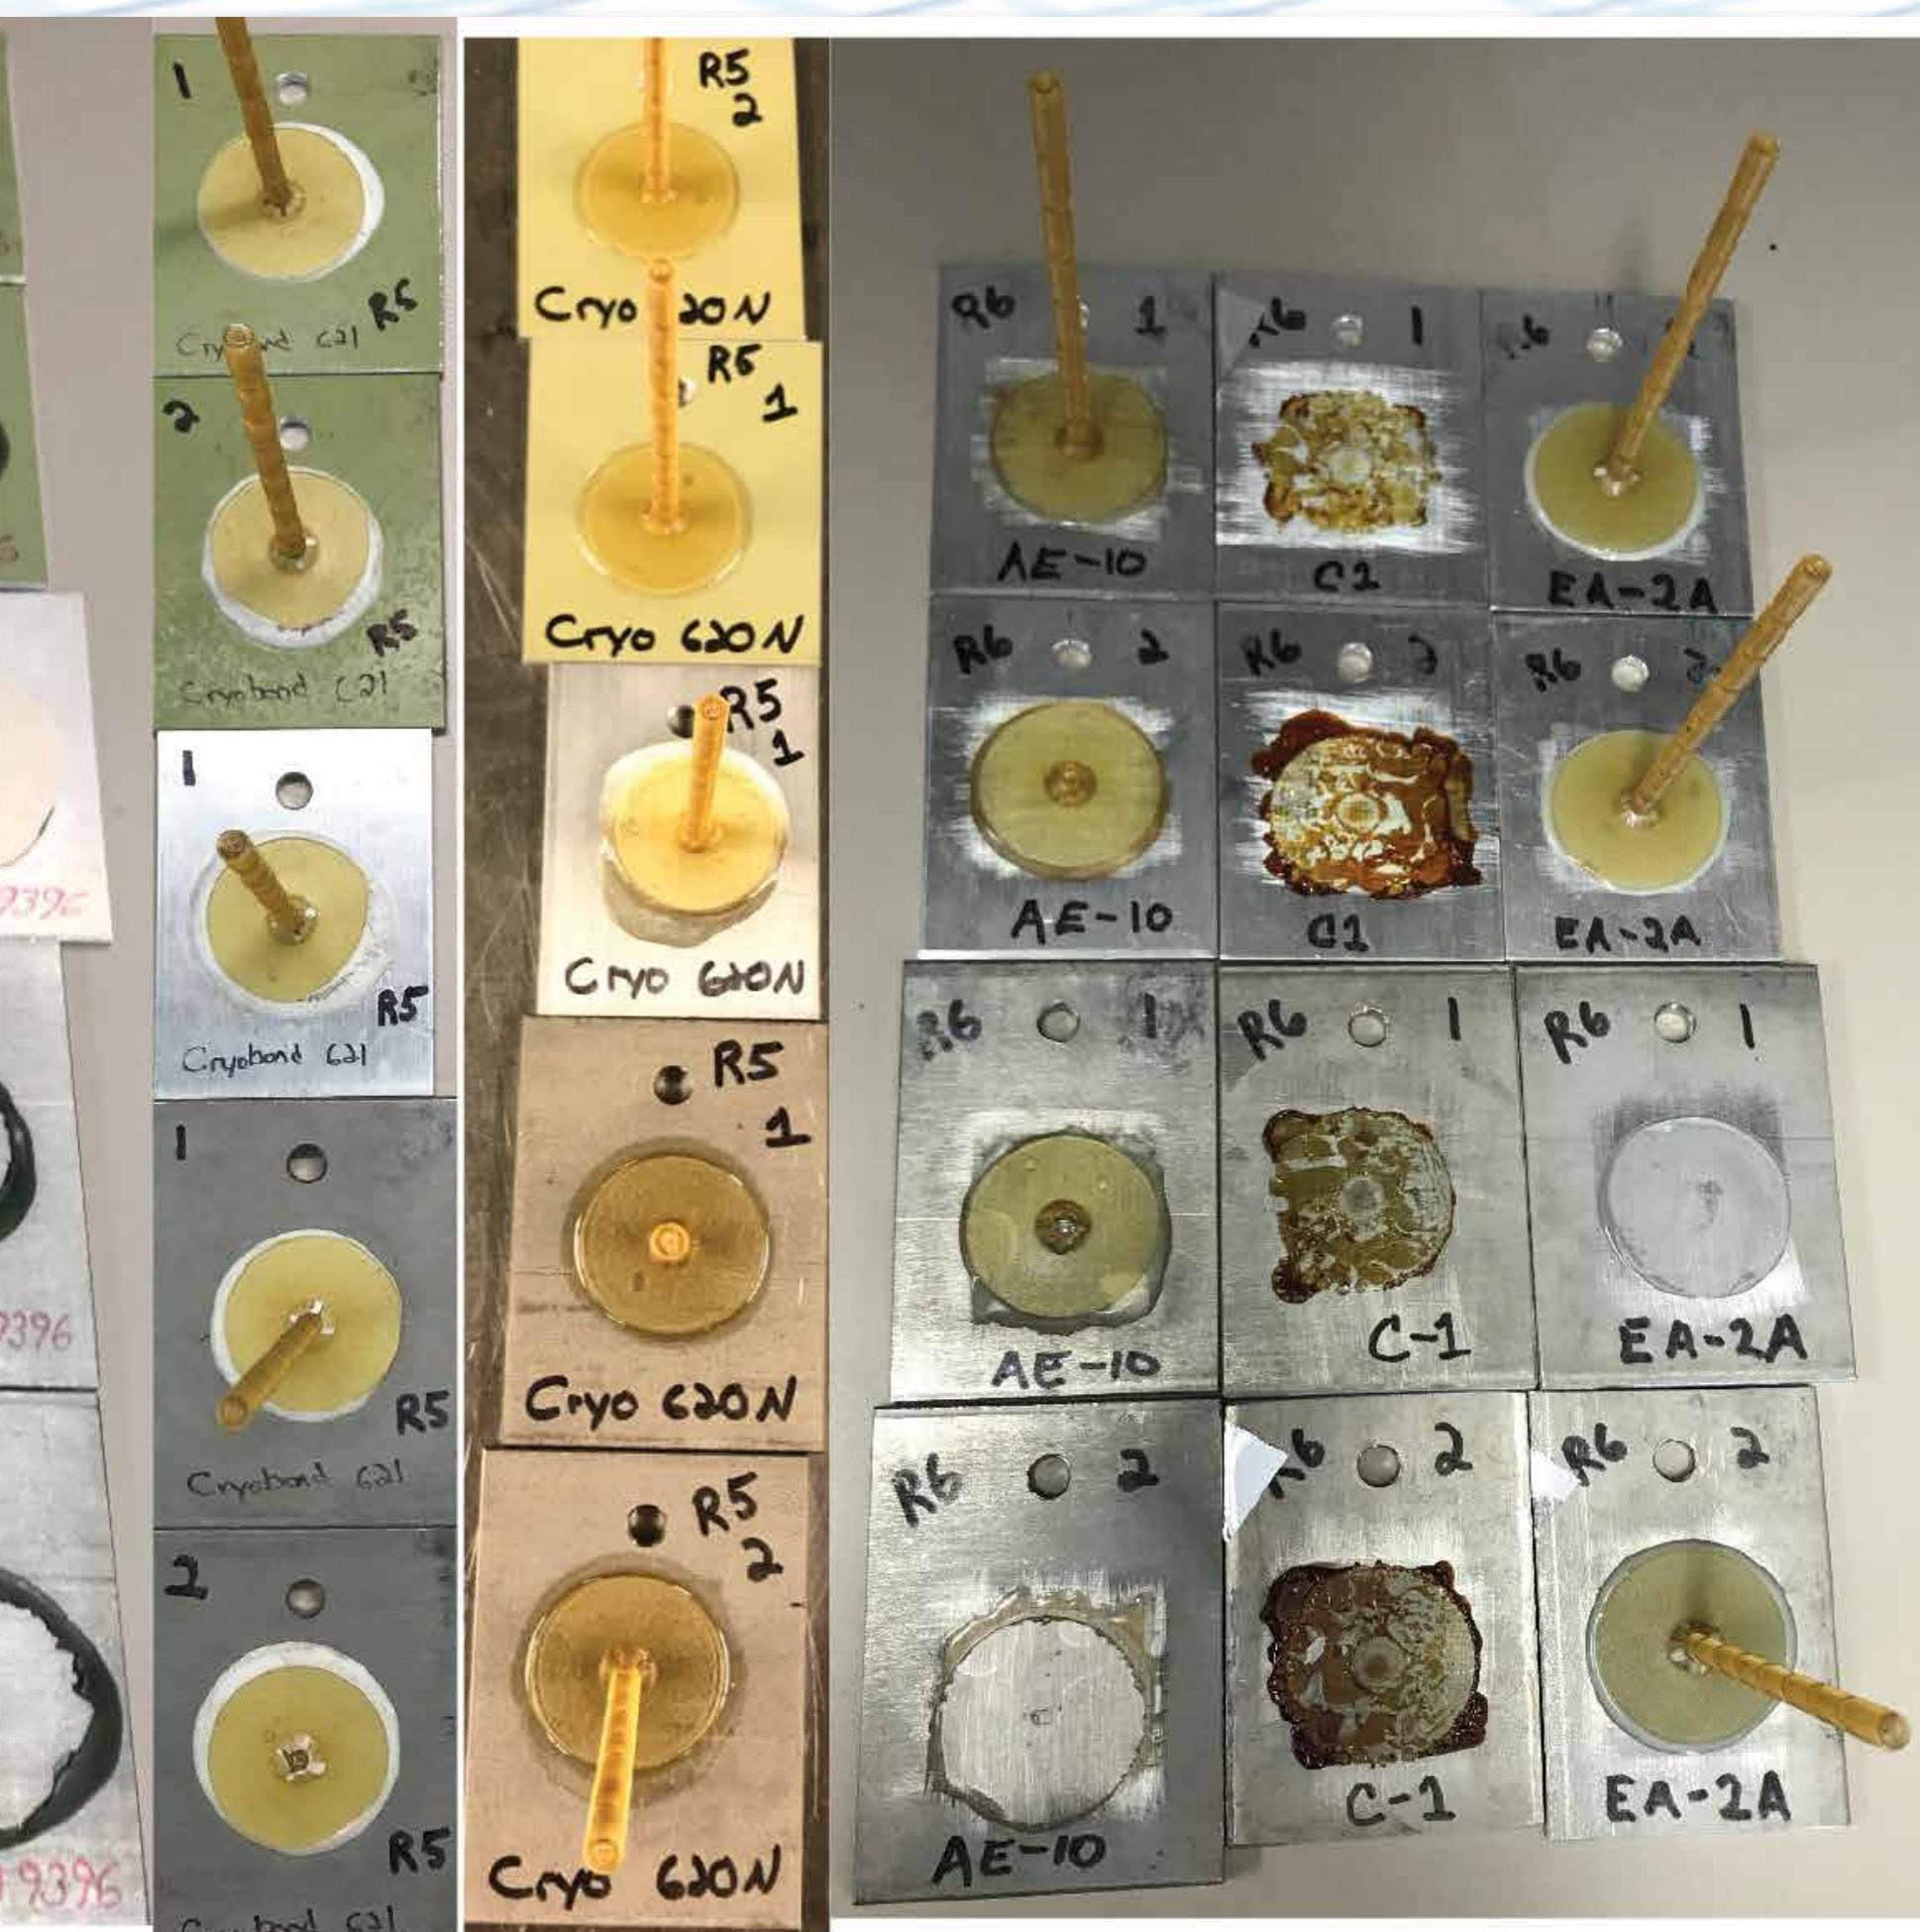
Round 3, 5, and 6 coupons after
