[Dhanasekar, Manicka](#) & Haider, Waheed (2011) Effect of spacing of reinforcement on the behaviour of partially grouted masonry shear walls. *Advances in Structural Engineering*, 14(2), pp. 281-294.

# **EFFECT OF SPACING OF REINFORCEMENT ON THE BEHAVIOUR OF PARTIALLY GROUTED MASONRY SHEAR WALLS**

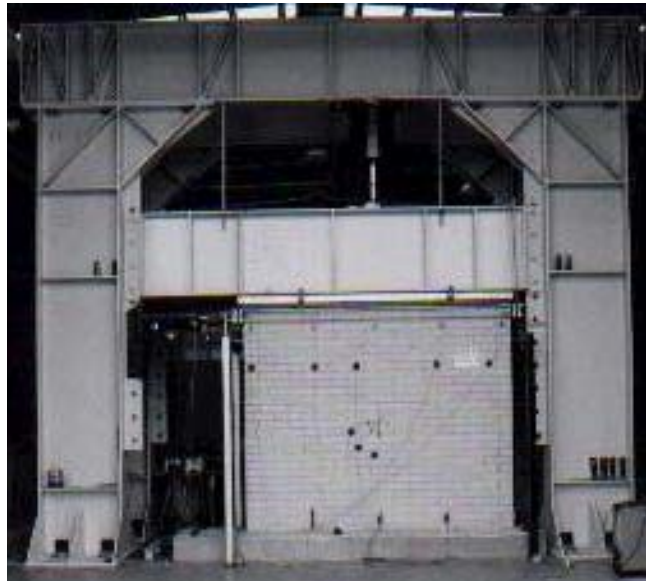
Figure 3 - Test Rig

All walls were tested under a portal-frame testing rig as shown in Figure 3. The footing of each wall was bolted onto the strong floor to provide maximum fixity. A chain of rollers was placed on top of the bond beam along the full length of wall to allow its top surface to freely drift laterally under the load application. A spreader beam was then positioned on the top of the roller and a servo-controlled actuator of capacity 2000 kN was used to maintain the vertical load at constant level (0.5MPa) throughout the horizontal loading history at the top of the wall. A load cell was used to monitor the constancy of the vertical load throughout the testing. The spreader beam was simply resting on the top of the wall allowing it to rotate as a true cantilever. A 500 kN servo-controlled tension-compression hydraulic actuator was used

to apply the horizontal displacement on the vertical face of the bond beam. The load, the displacement and the surface strain data were collected using the LABVIEW data acquisition program on a PC.

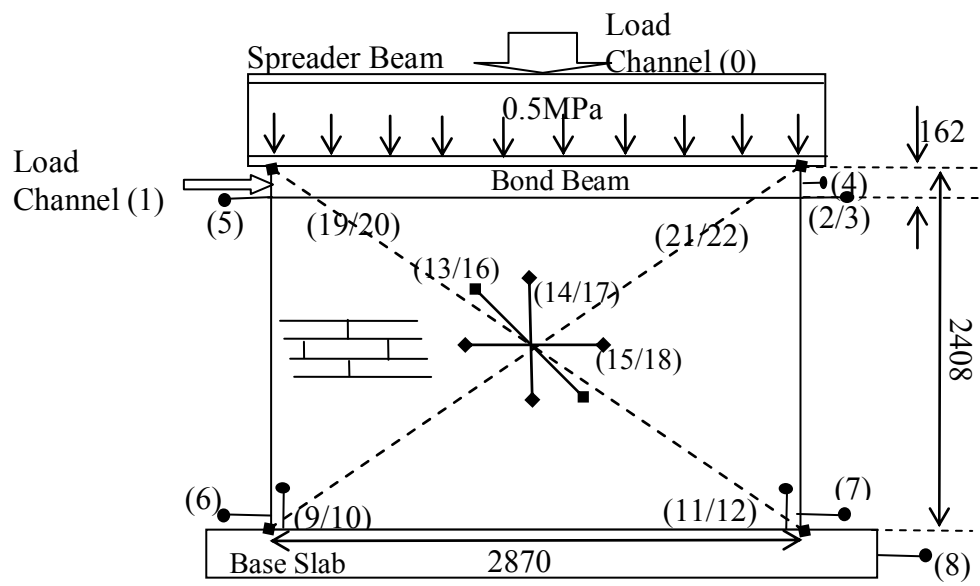
Figure 4 - Instrumentation and test setup

A total of 23 channels of loads, displacements and surface strains were measured using load cells, LVDTs and potentiometers as shown in Figure 4. Channels 0 and 1 were used for vertical and horizontal loads respectively. Channels 2 and 3 recorded the horizontal displacement of the bottom of the bond beam on either side of the thickness of the wall at the right end; channel 4 recorded the horizontal displacement of the centerline of the bond beam. Channel 5 recorded the bottom displacement bond beam at the left end of the wall (just below the horizontal actuator). Channels 6 and 7 monitored horizontal displacement of the toe and the heel of wall respectively. Channel 8 recorded the relative movement of the slab to the floor, channels 9, 10, 11 and 12 recorded the vertical displacement of the heel and toe of the wall on either side of the wall; channels 13-18 monitored surface strains at the center of the wall. The final four channels (19 – 22) measured the global diagonal deformation of the wall on both sides. Channel numbers shown in Figure 4 and separated by slash (/) refer to the instrument on the opposite sides of the wall.

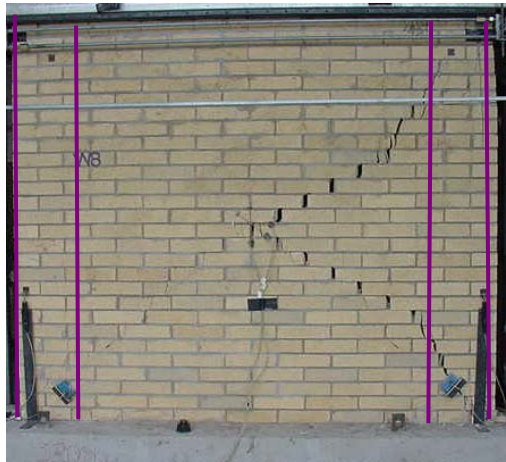
**(a) Wall 1A**

**(b) Wall 2A**

(c) – Wall 3A

(d) – Wall 4A

**Figure 6 – Final crack patterns of PGRM shear walls tested under cyclic loading**

Ultimate crack patterns of the four PGRM shear walls (1A, 2A, 3A & 4A) tested under cyclic lateral loading are presented in Figures 6a – 6d respectively. For convenience, the location of the reinforcing bars is also shown. The effect of the spacing of the vertical reinforcement is clearly evident in these four walls. Walls 1A, 2A & 3A whose spacing of mid reinforcing

bars was less than 2000mm ( $S_l < 2000\text{mm}$ ) exhibited a combination of “>” and “<” shaped diagonal cracks in the end panels with the central panel not showing significant damage. Wall 4A with  $S_l = 1000\text{mm}$  exhibited “X” shaped cracking in the central panel typical of unreinforced walls and little to no observed damage in the edge panels typical of fully reinforced walls.

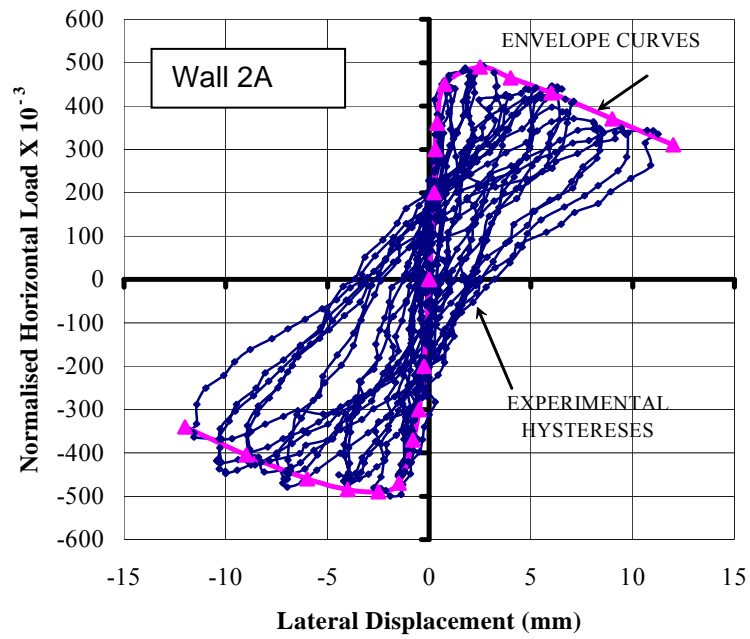
Figure 11 - Typical normalised load-displacement curves of PGRM walls under cyclic loading

Typical normalised test data on horizontal load - displacement of the PGRM shear walls subjected to cyclic and monotonic loading are presented in Figures 11 and 12 respectively. The normalised cyclic load – displacement data (Figure 11) also contains an envelope curve. The normalised monotonic load – displacement data (Figure 12) also contains smoothed idealised curve.

The hysteretic load-displacement curves are generally fat indicating good cyclic load performance without severe localisation; this is consistent with the failure modes observed from these cyclically loaded walls.

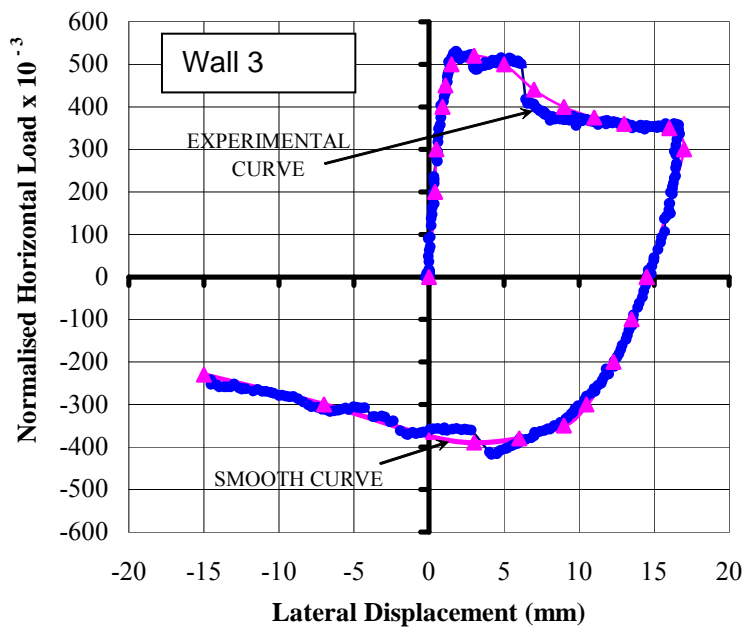
Fig. 12 - Smoothed load –displacement curve of a PGRM wall under monotonic loading

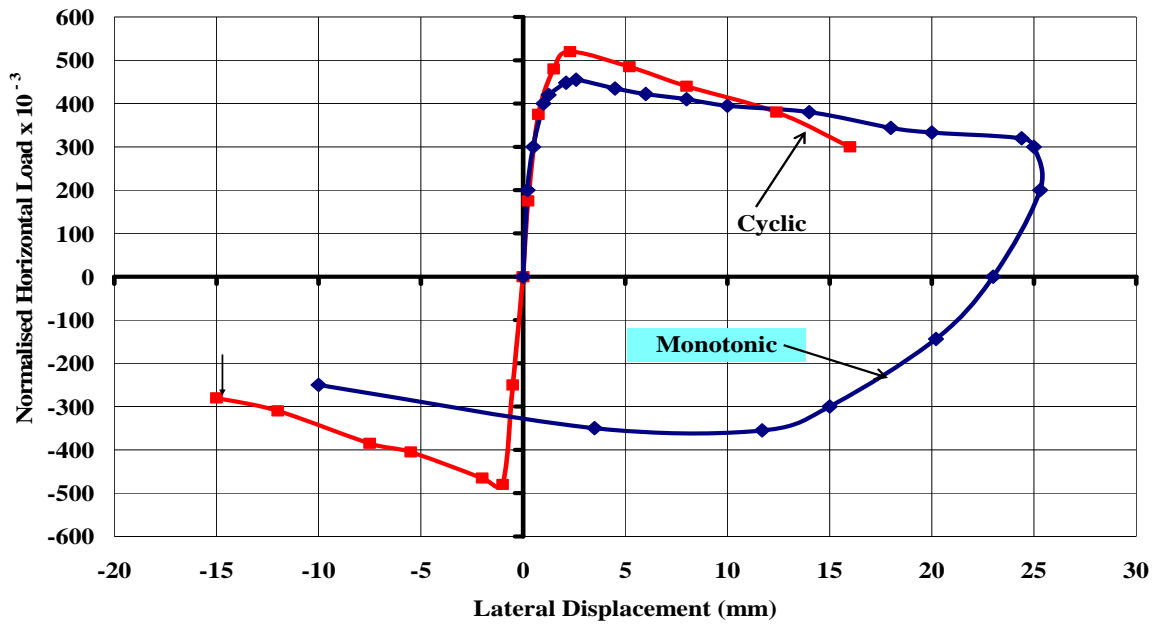
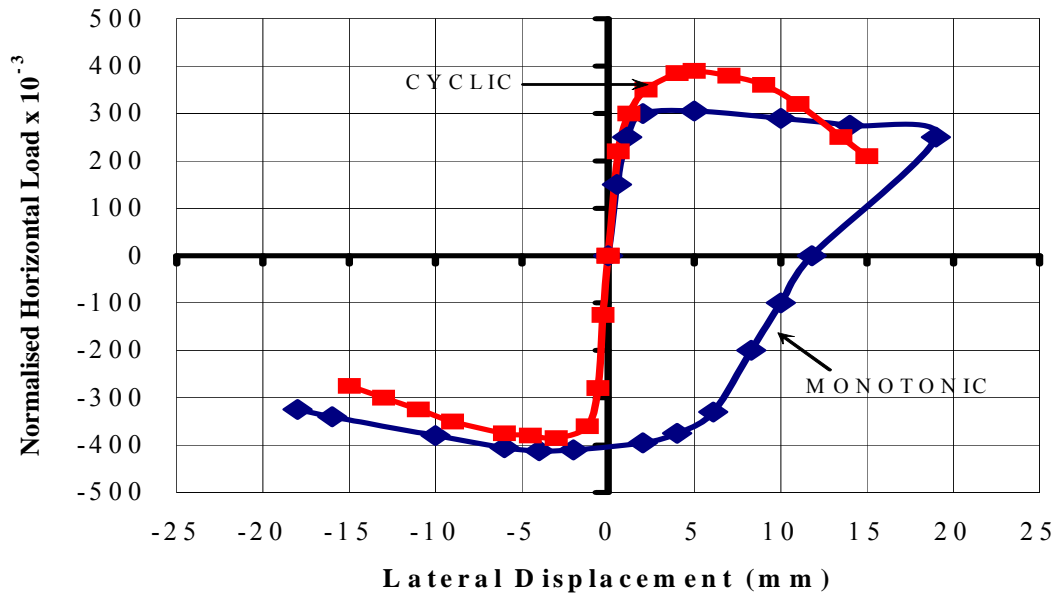
(a) Walls 1 & 1A

(b) Walls 2 & 2A

(c) Walls 3 & 3A

(d) Walls 4 & 4A

Figure 13 – Monotonic and cyclic envelope curves

Smoothed, idealised and envelope load – displacement curves for walls 1 & 1A, 2 & 2A, 3 & 3A and 4 & 4A under monotonic and cyclic loading respectively are shown in Figures 13a – 13d. The envelope curves of cyclically loaded hysteretic curves exhibit faster degradation rates when compared with the smoothed, idealised monotonic load-displacement curves of PGRM walls.

The monotonically tested walls (1, 2, 3 and 4) exhibited more apparent ductile behaviour as seen in Figures 13a – 13d; their displacement ductility values were worked out to be 7.5, 8.3,

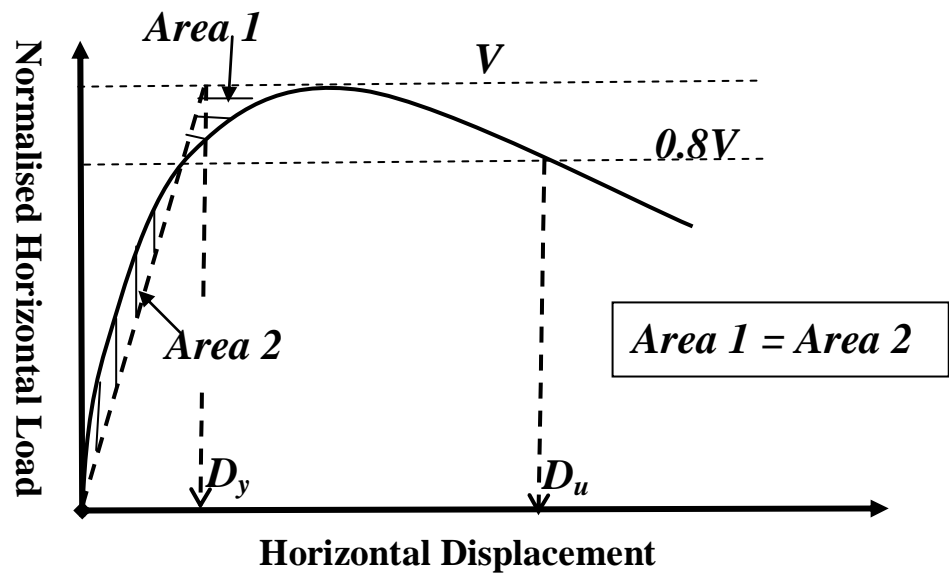
Figure 14 –Definition of yield and ultimate displacements

the normalised, smoothed load – displacement response curves, a method used for the determination of the displacement ductility of reinforced concrete columns (Saatcioglu, 1991) was used to identify the yield and ultimate displacements. This method idealises the curve such that the yield point is set to divide the pre yield and post yield – pre peak energy equally as shown in Figure 14. The ultimate displacement was taken corresponding to 20% reduction in the peak load.

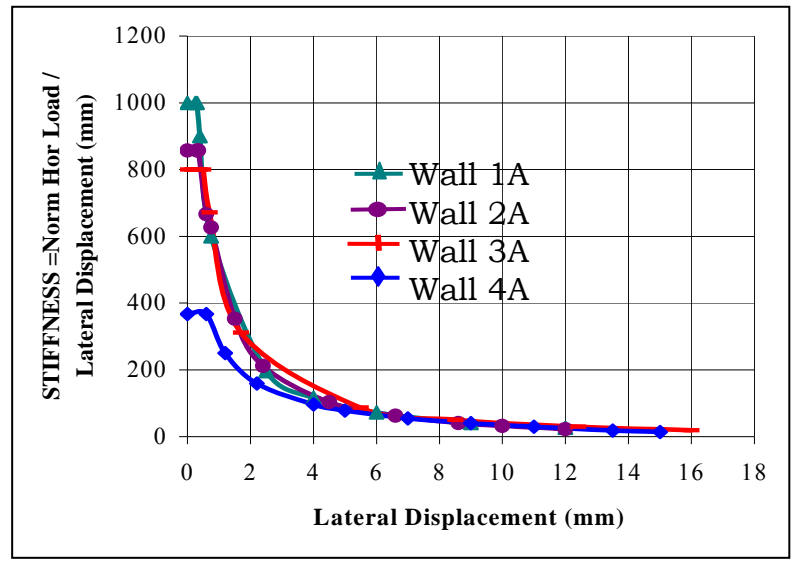
Fig. 15 – Stiffness Degradation of PGRM walls tested under cyclic loading

' $K_0$ ' is the slope of a line passing through the origin to the yield point and 'K' is the slope of a line passing through origin to any other point on the load - displacement curve where the stiffness degradation value is determined. Normalised load – displacement curves were used for the determination of the stiffness degradation. Values of stiffness degradation were evaluated from envelope curves of the cyclically loaded walls at different values of lateral displacement and are plotted in Figure 15. Walls 1A and 2A exhibit high initial stiffnesses compared to that of wall 3A. Wall 4A exhibited only 50% of the initial stiffness of the wall 1A. In spite of the differences in the initial stiffness, the stiffness of all cyclically loaded walls degraded at a similar rate.
