Institut of
Composite Structures
and Adaptive Systems

TESTING AND ANALYSIS OF OMEGA STRINGER DE-BONDING

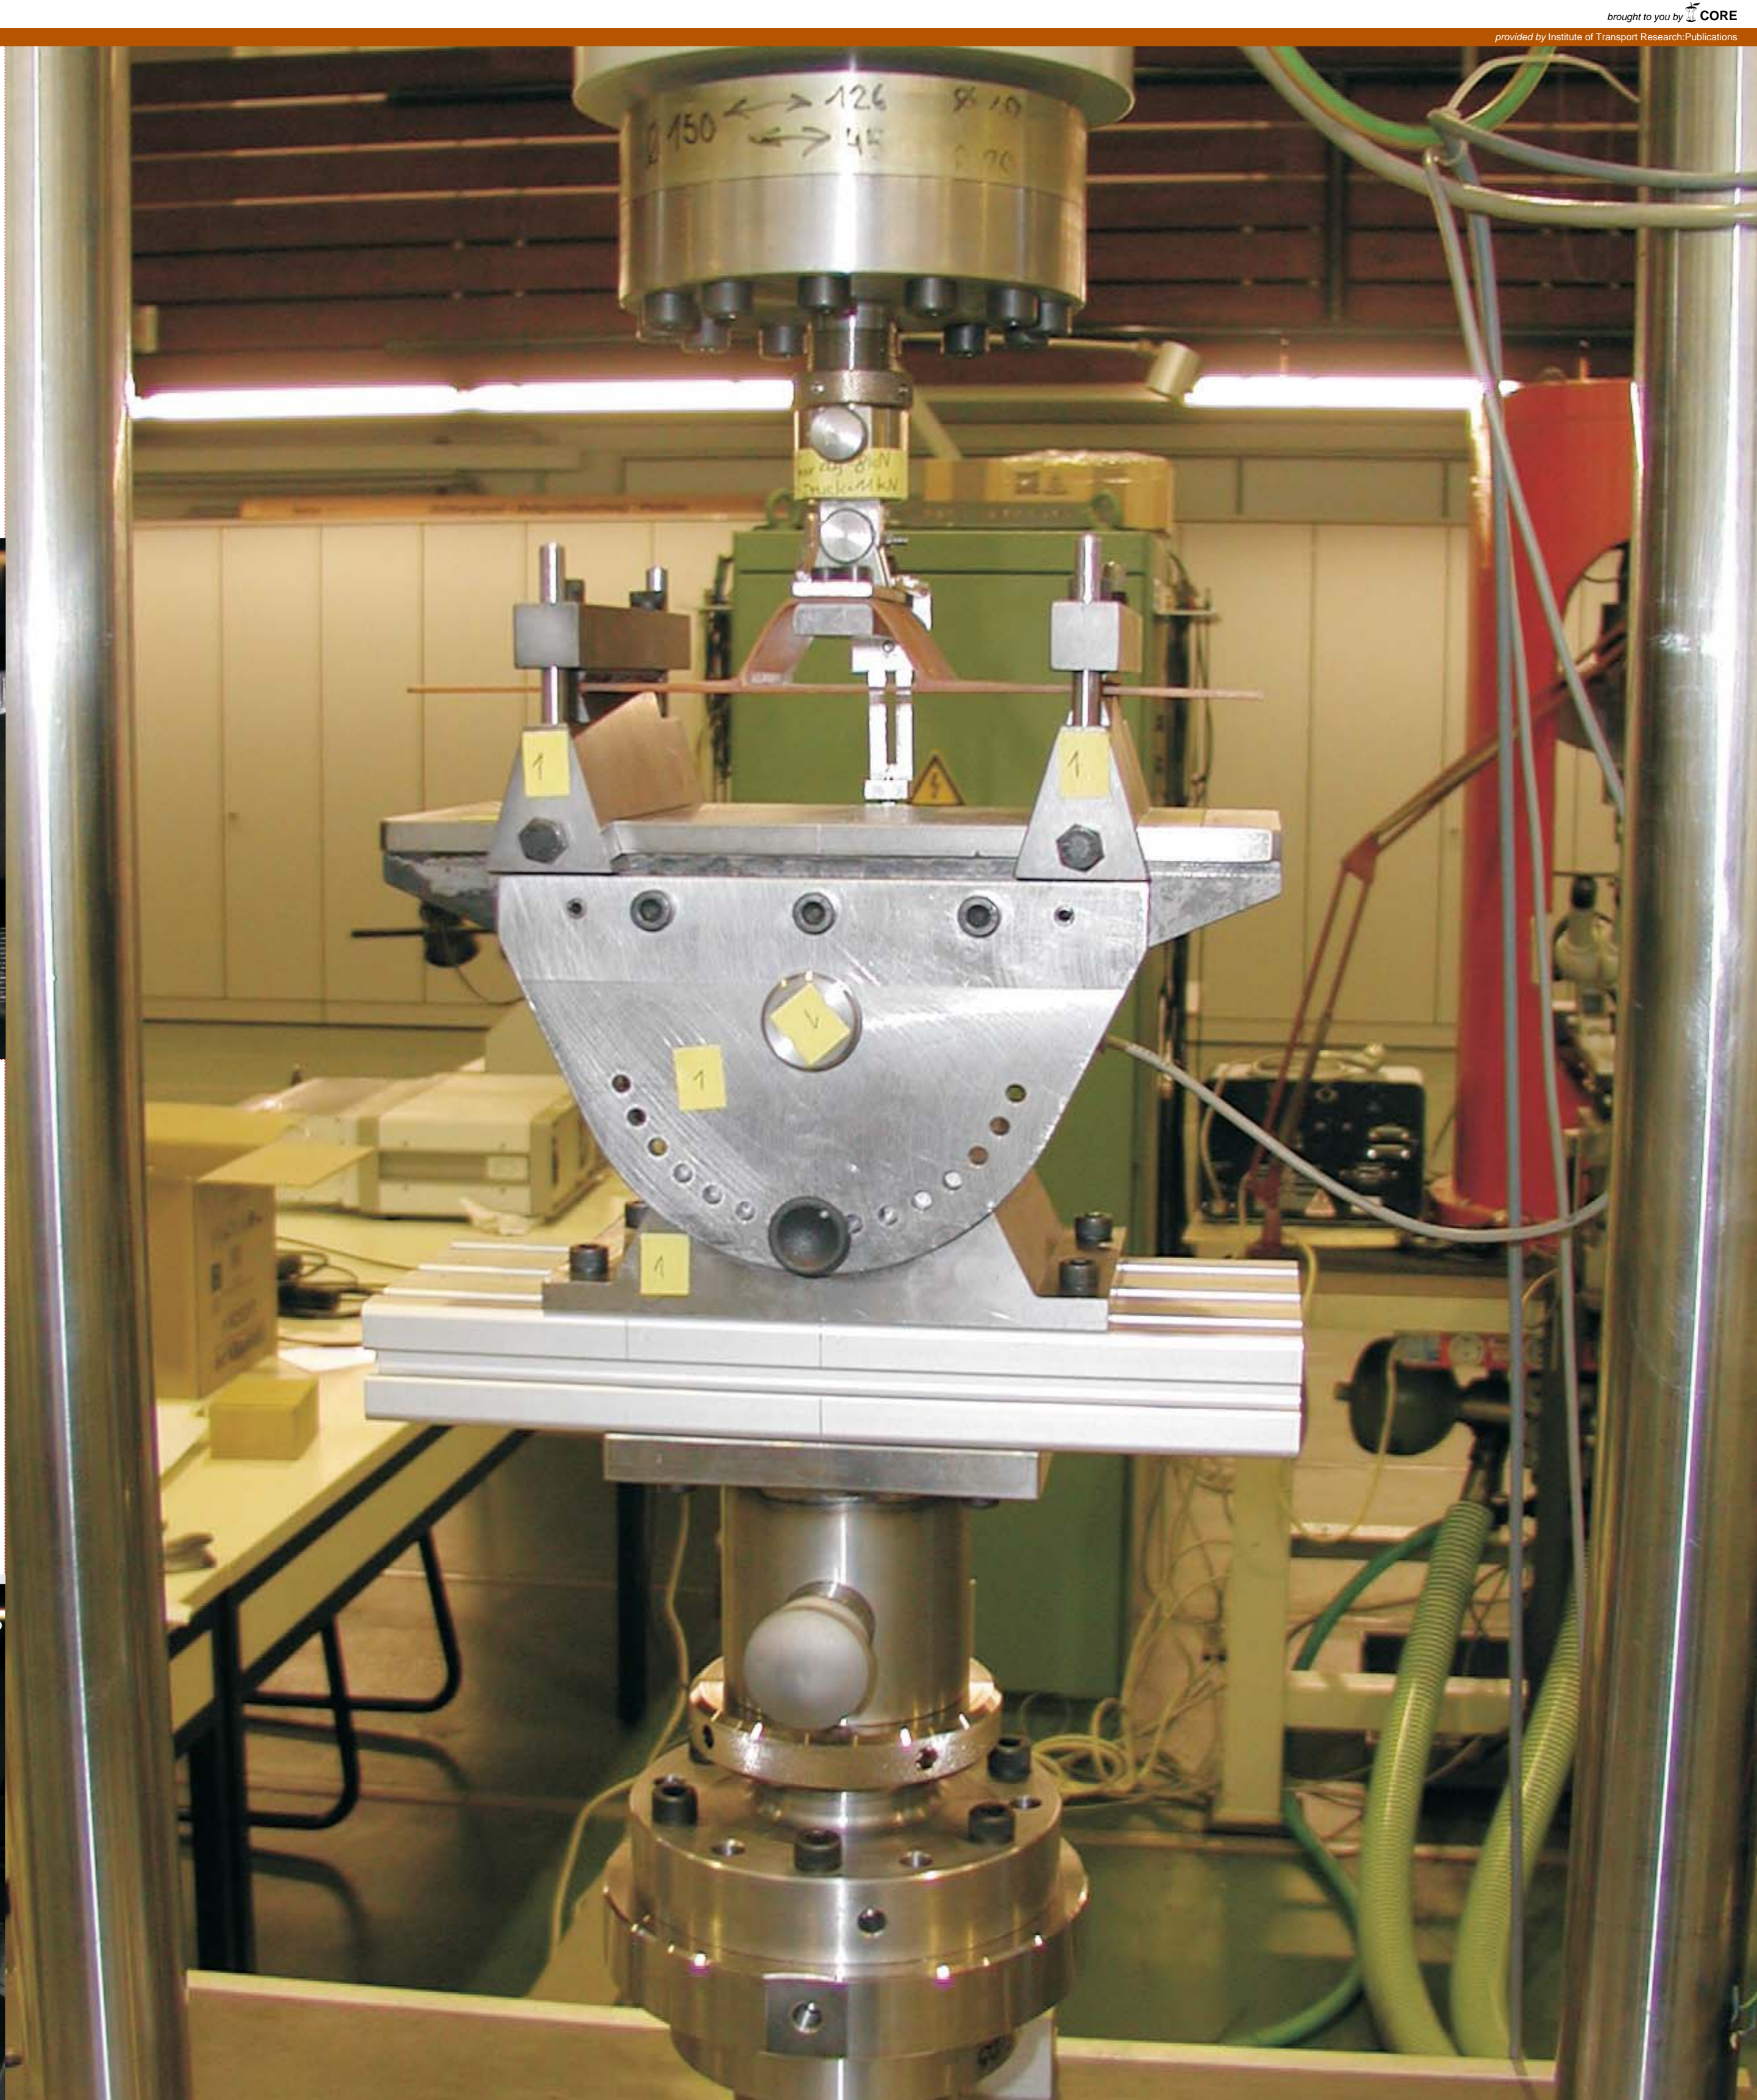
The interface strength between omega stringers and the skin was tested at DLR Braunschweig. Therefore the stringer is teared-off with a new test device using a standard test machine. Pull angle can be varied from 0° to 45°. With the help of this device omega stringers can be tested according to stresses dominated by fracture Mode I and stresses from combined fracture Mode I and Mode II. This allows to compare different omega stringer geometries and bonding technics. In parallel a de-bonding analyses was made using different numerical approaches (e.g. 3D continuum damage model).

Picture:
Omega Stringer Tear-off Test Device with Specimen
