TRANSIENT SEEPAGE AND SLOPE STABILITY ANALYSIS FOR RAINFALL-INDUCED LANDSLIDE: A CASE STUDY

Nurly Gofar^{1,*}, Lee Min Lee¹, Marwan Asof²

Abstract: A transient seepage and slope stability analyses were carried out for a case of rainfall-induced landslide in Air Laya Indonesia. The landslide occurred in December 2002 on a dumping area of an open coal mining site. This study examined the mechanism causing the slope failure based on transient analysis between April 21, 2001 and December 1, 2002. The slope profile was simulated using a seepage analyzing tool, VADOSE/W and the soil properties were determined based on field and laboratory data. The saturation profile resulted from seepage analysis was exported to SLOPE/W for the slope stability evaluation. The results show that the main factor contributing to the landslide is the reduction of shear strength due to increase in soil moisture content impelled by the formation of tension cracks on the ground surface of the slope.

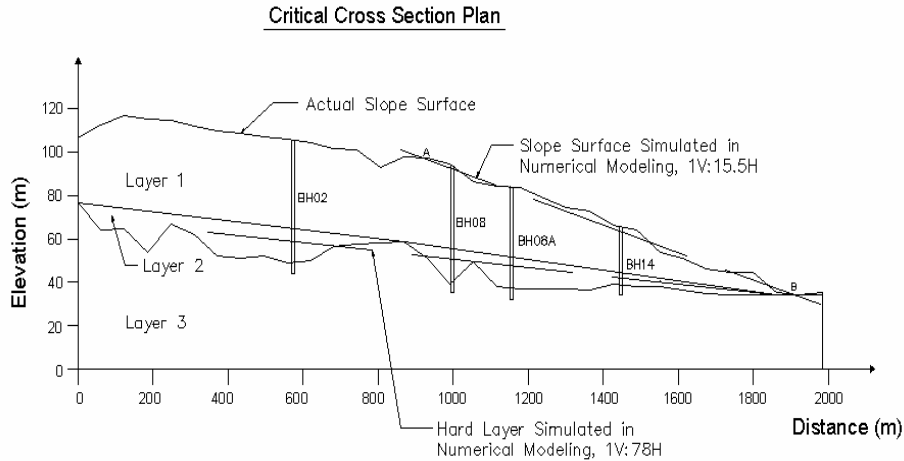
Figure 1: Critical cross section plan and soils stratification

Figure 1 shows the geometry of the critical section of the slope concerned. Site investigation indicated that the general stratification of the dumping area consisted of three layers, namely Layer 1, 2, and 3. Layer 1 is the dumped material consists of overburden soil from the mining activity. Due to its mineral content (montmorillonite and kaolinite), soil in Layer 1 exhibits a high potential for swelling and shrinkage under wet-dry conditions. The soil absorbs water quickly, but the low permeability inhibits the water to flow within the soil. Layer 2 is the interface between the natural ground and fill material. Due to inadequate clearance before dumping, Layer 2 existed in loose

condition and it contains a lot of organic materials. Layer 3 is the natural ground consists mainly of unconsolidated clay-stone. The shear strength properties of the soil before and after failure, based on laboratory test, indicated that layer 2 is relatively weaker than layers 1 and 3 (Nurly Gofar, 2003).

The initial condition of the numerical model of the case study was simulated based on the critical section shown in Figure 1. The model has been simplified in terms of surface and bedrock inclination beyond point A because at this point the mass movement has already started. The initial condition was established prior to transient analysis. The suction values near the surface were extrapolated based on the data obtained by tensiometer at depth of 1.5 m, which gives a value of 20 kN/m².

Seepage forces contributed to the landslide through an increase in the driving force along the failure plane. For this case study, the hydraulic gradient, i of 0.106 obtained from numerical modeling at a particular point, A (refer Figure 1) is enough to produce additional driving force towards the toe of the slope.

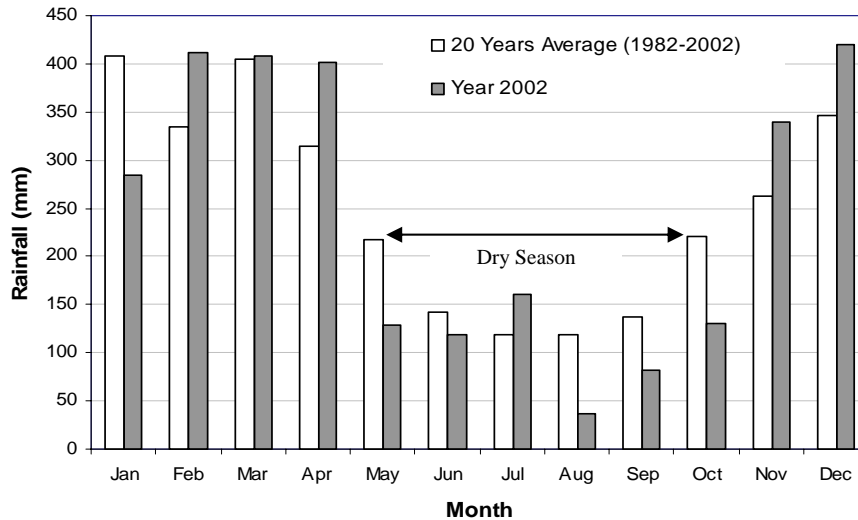
Figure 2: Monthly rainfall in year 2002 and 20 years average

The year 2002 experienced a longer and much dryer period than the 20 years rainfall average (Figure 2). On the other hand, November and December 2002 received excessive rainfall. This distinctive climate changes is expected to be one of the factors that lead to the landslide.

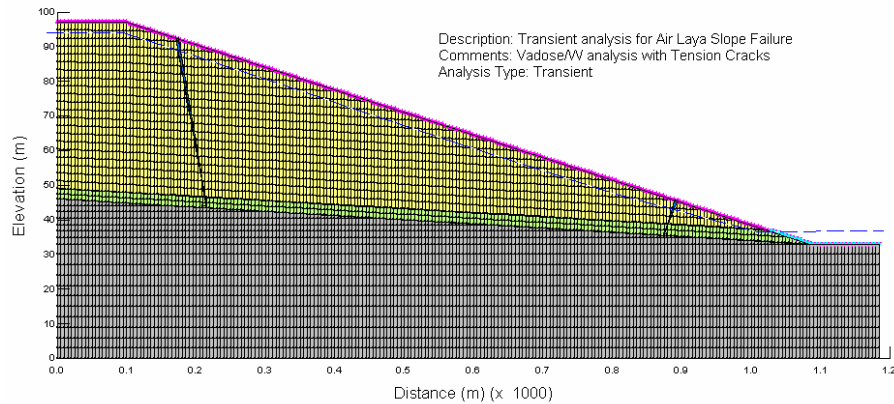
Figure 3: Numerical model simulated using VADOSE/W

The transient analyses were performed with daily time increment over 589 days, i.e. from April 21, 2001 to December 1, 2002. The time range was selected because the tensiometer was installed on April 21, 2001 and the landslide movement ceased on December 1, 2002. As many as 6887 element meshes were designed to represent the 97 m deep and 1185 m long slope profile (Figure 3). Climatic data was applied as boundary condition at the surface. Head boundary equal to the water level of the pond measured from datum is applied at the toe of the slope where the mud collecting pond is located. The bottom and side boundaries were assigned as a drained boundary.

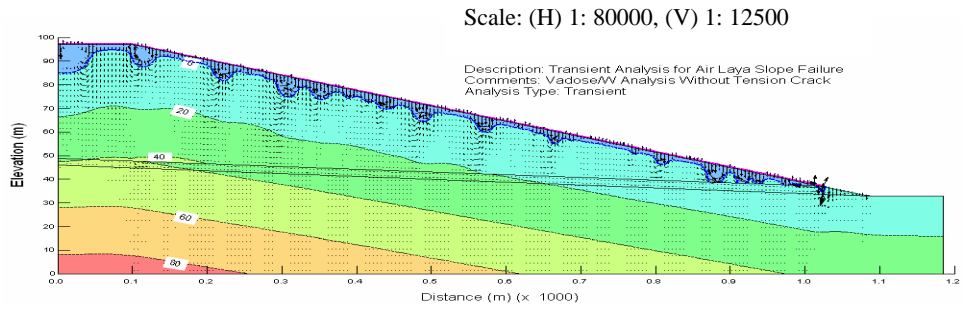
(a) Case 1: without the presence of tension crack

Figure 4 shows the difference in seepage pattern and water table condition resulted from the transient analysis for the initial condition (April 21, 2001) and during the actual failure (November 27, 2002). For Case 1 where no tension crack was assigned, the water level does not change significantly (Figure 4a). For case 2, only little amount of water infiltrated into the slope through the 10 m deep tension crack at crest (Figure 4b). However, for case 3 where 40 m deep tension crack was simulated, large amount of water have infiltrated into the soils and significantly increased the water table (Figure 4c).

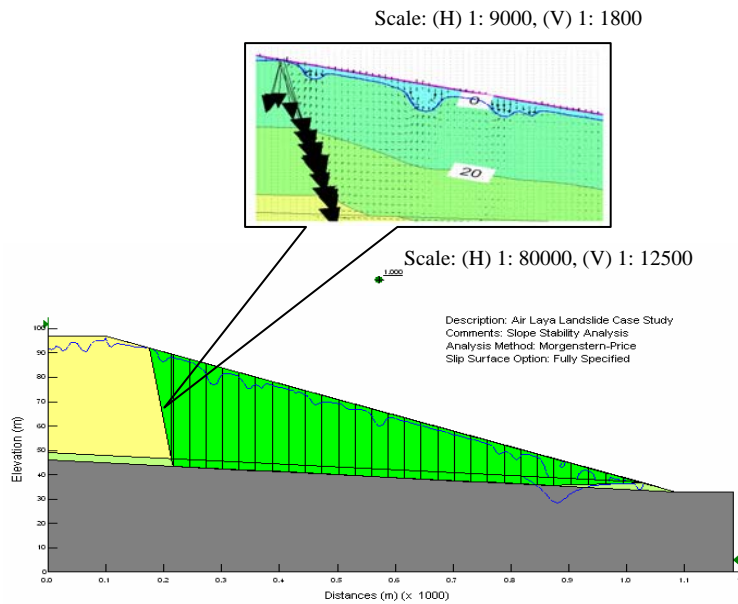
Figure 5: Slope stability analysis computed from SLOPE/W

The slope stability analysis was carried out with one month interval based on the seepage pattern and pore-water profile obtained from transient seepage analysis for the case where tension cracks have propagated to Layer 2. The result of stability analysis using SLOPE/W for the most critical condition is shown in Figure 5 with the seepage pattern near the tension crack shown in the zoom-in diagram.

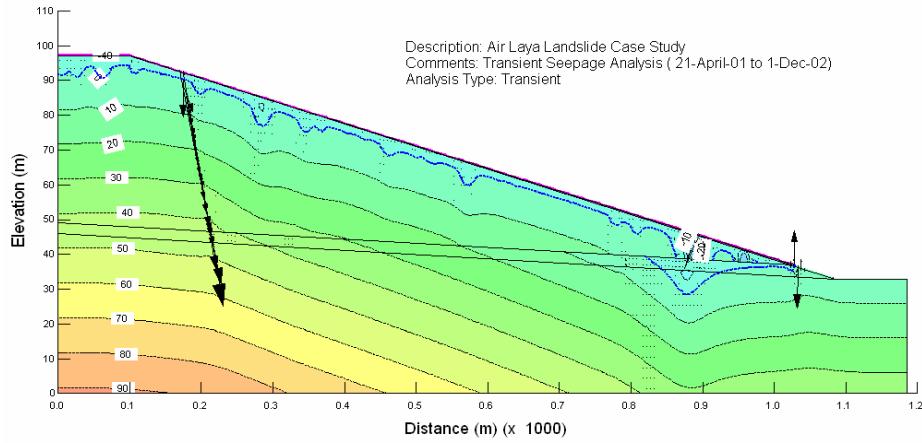
(a) Seepage pattern and pore-water pressure head profile on October 14, 2002.

Figures 6a and 6b show the seepage pattern and pore-water pressure profile of the slope at two calculation steps before the actual failure on October 14 and November 13, 2002, respectively. The results showed that large amount of water infiltrated into the slope on October 14, 2002, but only little infiltration was observed on November 13 despite the large amount of rainfall. This is because the infiltration potential on October 14, 2002 is higher than that of November 13, 2002. The site experienced few months of dry seasons prior to October 14, 2002. Thus, large amount of water was allowed to infiltrate into the dry slope. As the rainfall amount increase dramatically in November 2002, the slope must be in saturated condition and only limited rainwater can infiltrate.

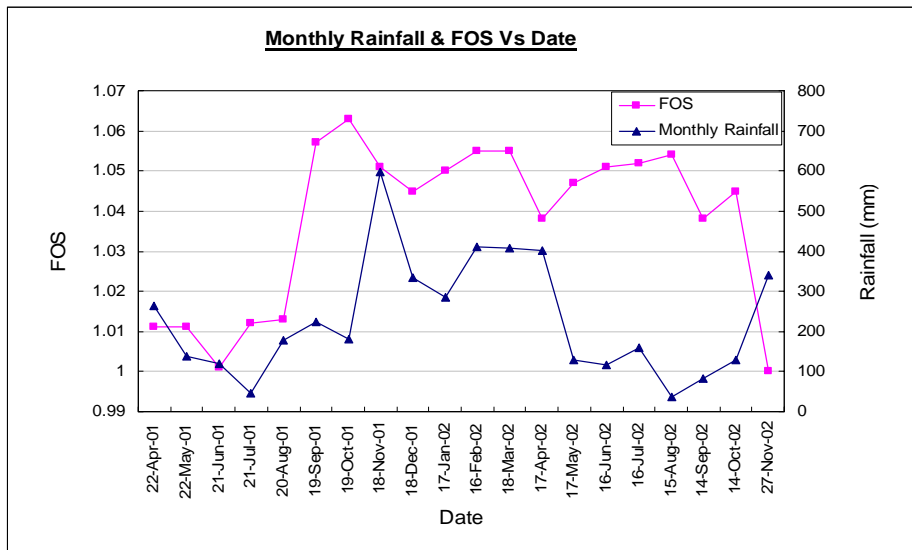
Figure 7: Monthly rainfall and FOS during the period concerned

Figure 7 shows the factor of safety and the corresponding monthly rainfall. The minimum factors of safety were obtained on day 61 and day 585. Failure did not occur on day 61 (June 21, 2001) but occurred on day 585 (November 27, 2002). This information suggests that the main cause of the failure was not the rainfall itself but other factor that was not present on June 21, 2001, which is a dramatic change in the climate and rainfall pattern. Detailed analysis was conducted on a daily basis over 19 days which included few days before and after the landslide occurrence (November 13, 2002 to December 1, 2002). The changes in the factor of safety and rainfall intensity during these periods are shown in Figure 8.
