# ENGINEERING AND CLINICAL EVALUATION OF THE VA-PAMAID ROBOTIC WALKER

The Veterans Affairs Personal Adaptive Mobility Aid (VA-PAMAID) is a robotic walker that is designed to provide physical support, obstacle avoidance, and navigational assistance to frail visually impaired individuals. The goal of this study was to develop and implement testing protocols to determine the performance and safety capabilities of the device and use the results to redesign the walker to make it more reliable and effective.

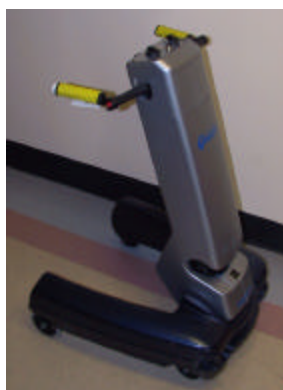
The most current design of the VA-PAMAID is shown below in figure 2. This version of the walker was used for the obstacle detection and avoidance capability tests, as well as the clinical trials in Atlanta, GA, Salisbury, NC, and Tucson, AZ.

**Figure 2 The most current version of the VA-PAMAID.**

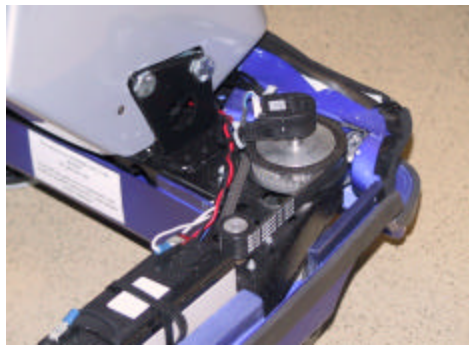
**Figure 3 Motors connected to the front casters allow the device to control the direction of the walker.**

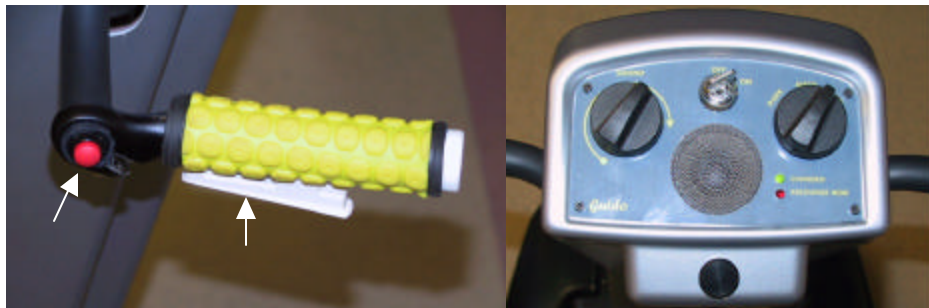
The user can direct the walker with the spring-loaded handlebars that are equipped with sensors to determine the intended direction of travel. Turn buttons are located on the end of each handlebar (Figure 4). Depressing these buttons causes the front wheels to turn parallel to each other and thus allows the walker to rotate in a circle about its rear wheels. This feature was incorporated into the design because the obstacle avoidance algorithm does not account for reversing. The sensors are only actively scanning the environment in front of the device, not behind it. If the system detects a reversing motion, it can apply the brakes proportionally to reduce the speed [13]. Brake levers are also positioned on the handle grips (Figure 4). If the user

**Figure 4** The picture on the left shows the walker handgrip. The arrows are pointing to the red turn buttons and the white brake lever. The photo on the right shows the control console of the device.

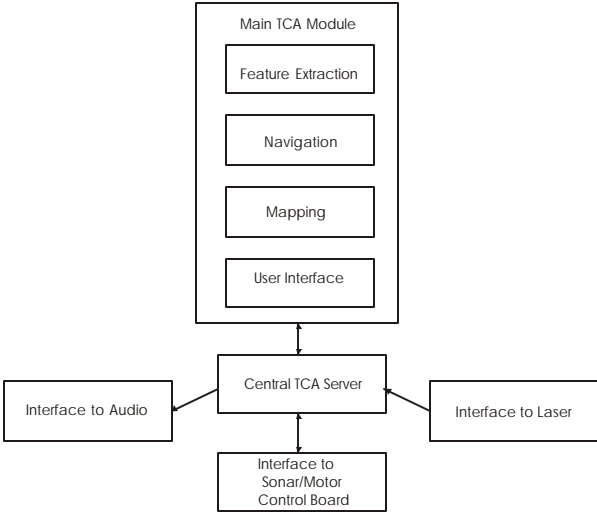
**Figure 6 Software architecture for the VA-PAMAID [13].**

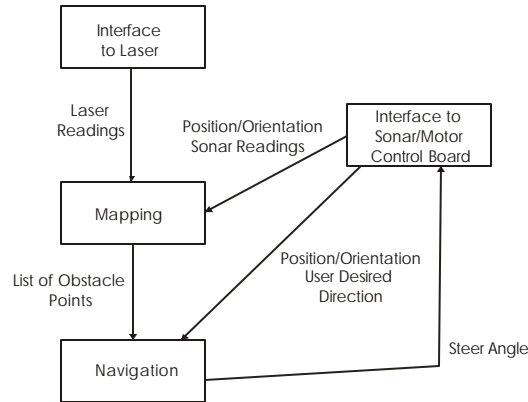
**Figure 7 Mapping and navigation data flow for the VA-PAMAID [13].**

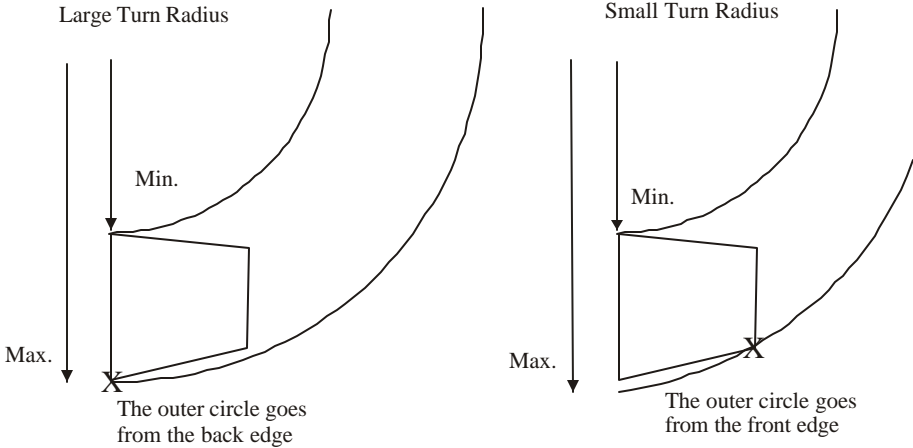
for a specific turn radius. Figure 9 demonstrates how the device calculates the inner and outer paths for both a large and small turn radius. This method insures that the outermost edge of the device will not contact obstacles during turning.

**Figure 9 The walker calculates the inner and outer circle paths depending on the given turn radius.**

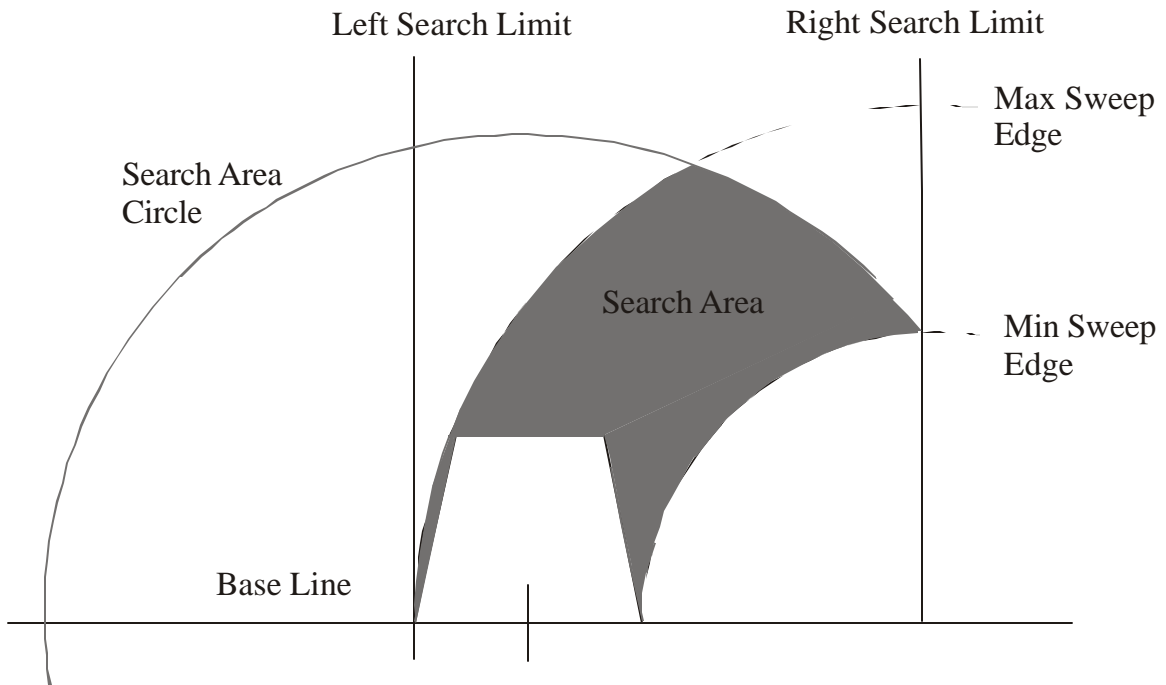
The parameters for the area checked for a clear path are shown in Figure 10. They include: the search area circle, the left and right search limits, the baseline, and the maximum and minimum sweep edges.

**Figure 10 The walker performs a number of checks to insure that the given turn radius is free of obstacles.**

The system first checks between the minimum and maximum sweep edges. The second check detects points in front of the baseline. The next check tests inside of the search area circle. The last check uses the left and right side limits.

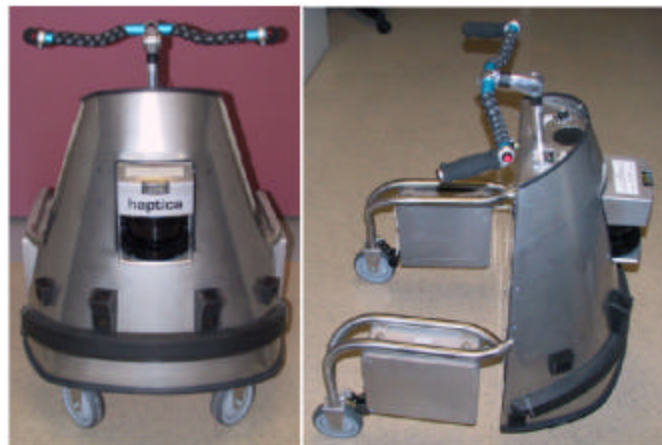
**Figure 11 The front and side views of the VA-PAMAID walker.**

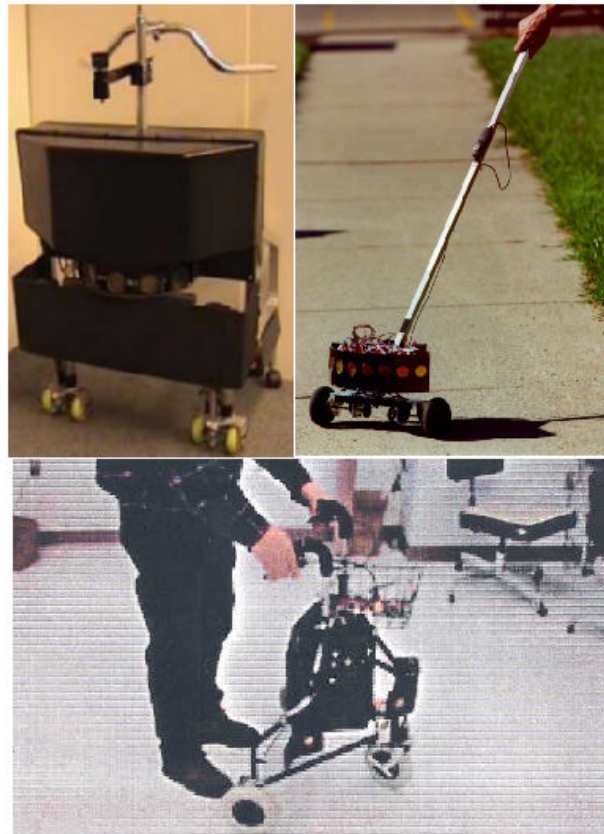
**Figure 12 Clockwise from the top left: The PAMM smart-walker developed at MIT; The GuideCane invented at the University of Michigan; The assistive robotic walker designed at the University of Virginia Medical Center.**

The GuideCane has been designed to help blind and visually impaired users navigate among obstacles and hazards [25]. The device is equipped with ten ultrasonic sensors and is controlled by a central computer and servomotors on both wheels (Figure 12). The GuideCane scans the environment and then determines the momentary optimal direction of travel. The computer first builds a local map of the surroundings. This is accomplished through a two-dimensional array based on certainty grids. The size of the map is 18m x 18m, with cell sizes of 10cm x 10cm. The local obstacle avoidance algorithm then determines the most appropriate instantaneous directional motion. The GuideCane is semi-autonomous device. It provides full autonomy for obstacle avoidance, but requires user input for path planning and localization. This device is intended solely for navigation and does not provide mobility support like the other walkers.

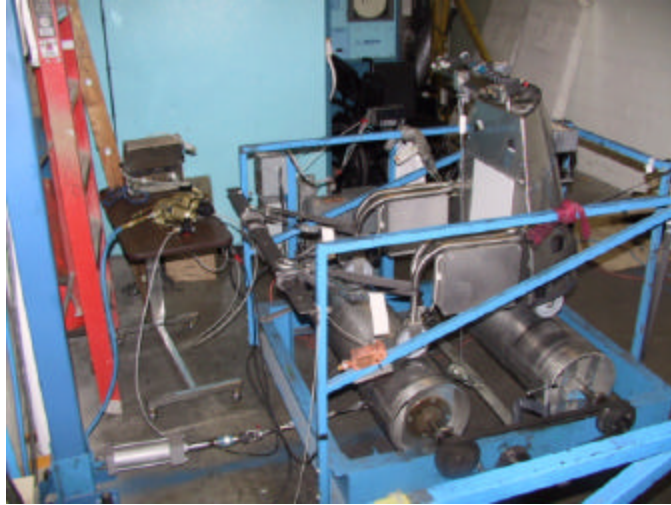
The walker was then run on a two-drum test machine with 27.3 cm diameter drums and no slats for 200,000 cycles at a speed of 1m/s. An 800 N cyclic load was applied to the midpoint of the handlebars at a rate of 0.15 Hz [18]. The walker was then run through the functionality test and visually inspected for cracks or damage. Figure 13 shows the VA-PAMAID during fatigue strength testing.

**Figure 13 The VA-PAMAID on the two -drum tester. A cyclic load was applied to the handlebars and the walker completed 200,000 cycles at 1 m/s.**

The VA-PAMAID passed all of the static and impact strength tests. The walker also completed 200,000 cycles on the two-drum machine without any failures or problems. The device functioned properly after all testing was completed.

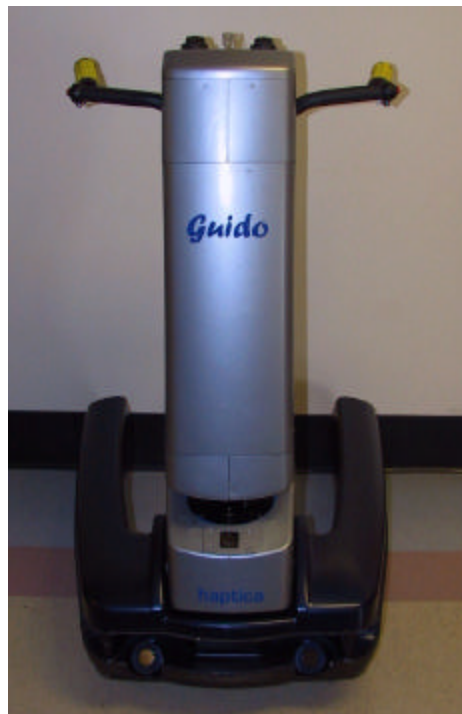
The VA-PAMAID is equipped with a laser and sonic sensors that can map the environment and identify obstacles and landmarks (Figure 14). Feedback is provided to the user in the form of audio warnings. The front two wheels of the walker are coupled to motors that allow the device to control the direction of travel and avoid collisions. The VA-PAMAID has 3 different modes. In manual mode, the user has complete control of the walker. Information detected by the sensors is issued as voice messages describing landmarks and obstacles. In automatic mode, the user and the computer share control of the walker. The computer uses motors connected to the front wheels to steer the device away from obstacles. The controller will override user input when attempting to negotiate obstacles. Voice messages are still given as well. In park mode, the front wheels are oriented to prevent movement of the device (Figure 15).

**Figure 14 Front view of the VA-PAMAID robotic walker.**

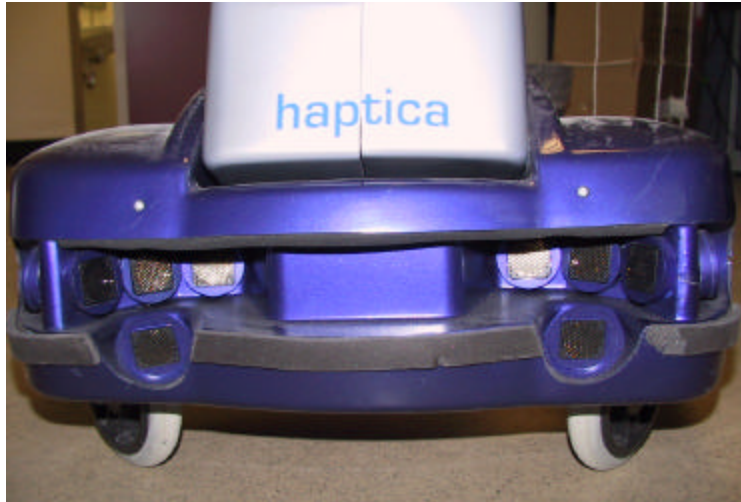
**Figure 15 View of the front wheels in park mode.**

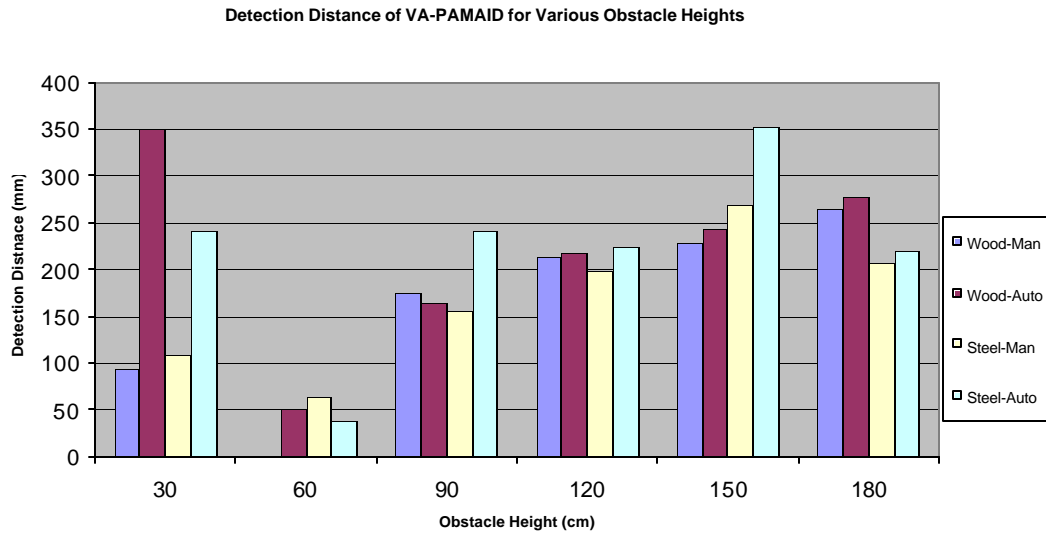
The VA-PAMAID detected the obstacle at every height except for 60cm for the wood obstacle. The device also had difficulty detecting the sheet metal obstacle at this height. The detection distance was considerably shorter than at the other heights. This height appears to be a blind spot for the walker. As the height of the obstacle increased, the detection distance of the walker generally increased, as well (see Figure 25).

**Figure 25 Graph showing the relationship between detection distance and obstacle height.**

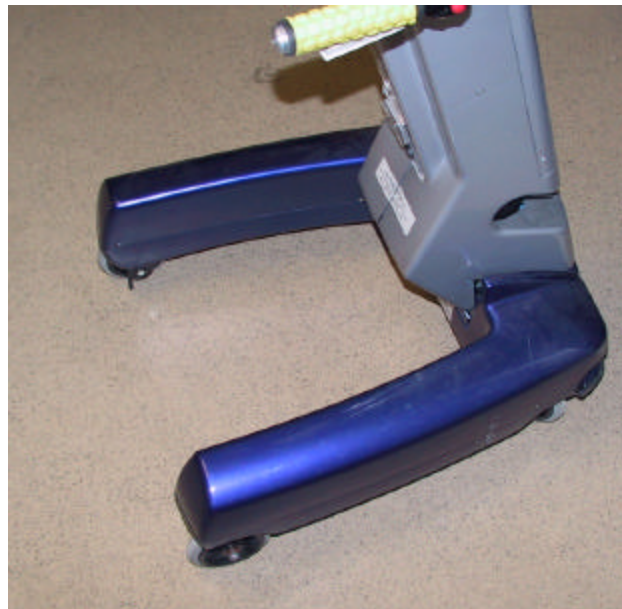
Overall dimensions: Some of the subjects felt that the walker was too big and bulky. People are most likely more used to traditional type walkers that are smaller and lighter because they contain no electronics or motors. Certain steps could be taken to reduce the overall size of the device, though. Reducing the length of the struts that connect the rear wheels to the walker would decrease the footprint of the walker (Figure 31). This would allow for tighter maneuvering and make the device look less bulky. Additional testing would have to be performed to insure that stability is not grossly affected. However, few supervised care facilities have steep indoor inclines.

**Figure 31 The length of the walker legs could be shortened in order to reduce the overall dimensions of the device.**
