Procedia Engineering 145 (2016) 1004 – 1012

International Conference on Sustainable Design, Engineering and Construction

## Waste Water Force Main Pipe Construction Alternatives to Protect Existing Foundations in the City of Chandler: Case Study

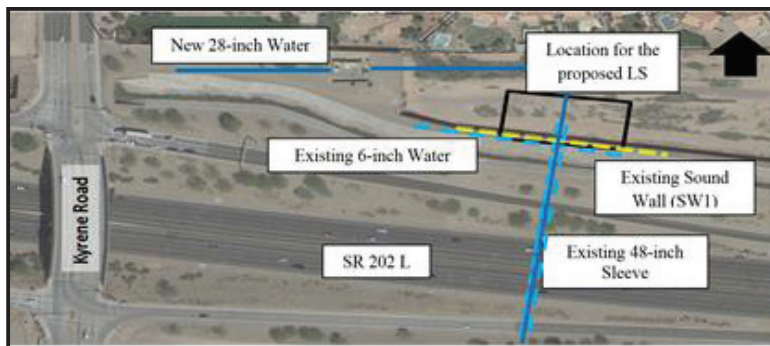
**Fig. 2.** Schematic drawing of 28-inch Force main project

A mandate of the project was to protect or replace the existing sound wall prior to the start of force main construction. Three alternatives were proposed to expose the existing 48-inch sleeve and evaluated based on the construction costs and soil material properties. Alternative 1 made use of temporary shoring around the north end of the casing to eliminate impacts to existing facilities and minimizes excavation width to access the deep casing. Alternative 2 used sheet piles just north of the wall with excavation extending north at a standard 1:1 slope. This protected existing facilities and involved excavating soils north of Wall SW1 while preserving the soil supporting the wall and drilled shafts. This also enabled for additional excavation north should the casing not be in the correct location per the as-built drawings. Alternative 3 requires removal and replacement of Wall SW1, the 24-inch waterline and the Santan Channel, and maximizes excavation. **Fig. 2** illustrates the 28-inch force main project and three construction alternatives to find the existing casing are shown in **Fig. 3**.
