## Analysis of Framing Failures in Wood-Frame Residential Roofs Under Wind Load

Sarah A. Stevenson  
*The University of Western Ontario*

Graduate Program in Civil and Environmental Engineering  
A thesis submitted in partial fulfillment of the requirements for the degree in Master of Engineering Science  
© Sarah A. Stevenson 2017

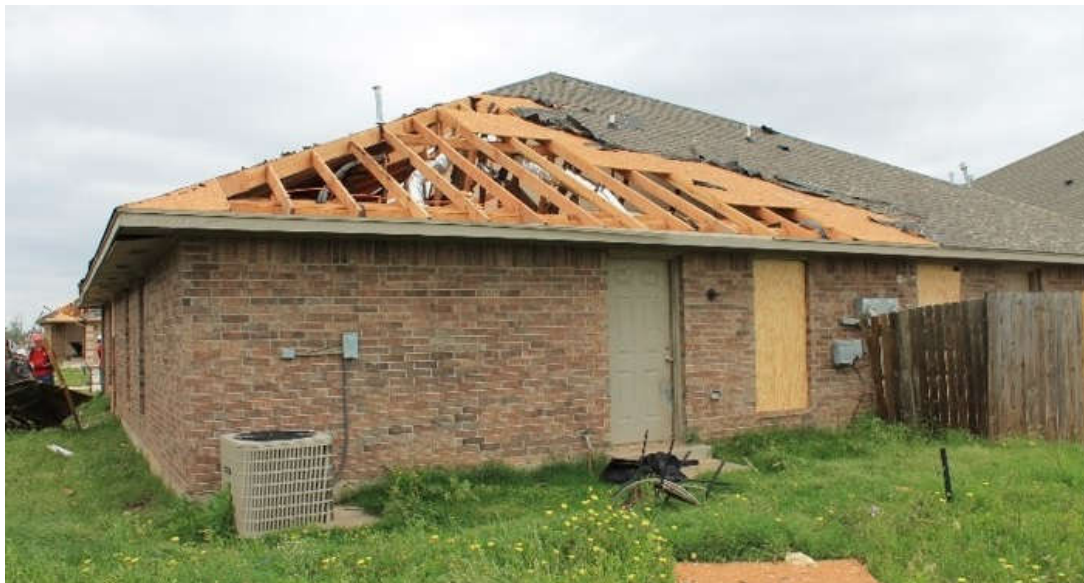
**Figure 1-1: Example of roof sheathing failure, corresponding to DOD-4 (Image provided by Dr. David Prevatt of University of Florida)**

failure modes. Figure 1-1 shows an example of typical sheathing failure, and Figure 1-2 shows failure of the RTWC. The current understanding of DOD-6 is limited to research focused on RTWC failures.

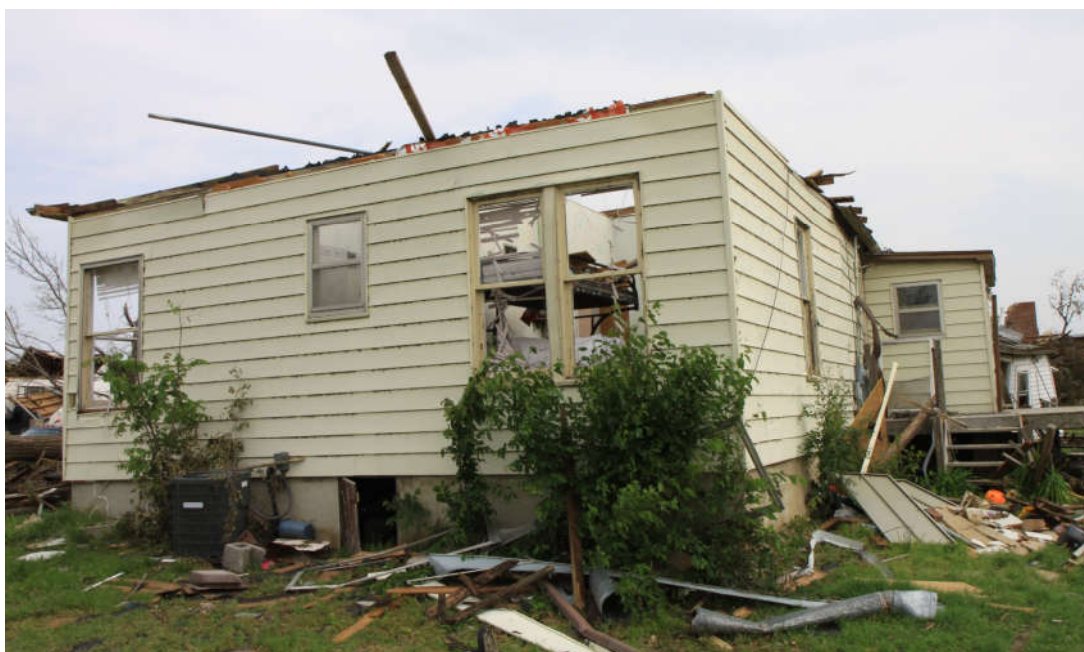
**Figure 1-2: Example of roof-to-wall connection failure, corresponding to DOD-6 (Image provided by Dr. David Prevatt)**

As seen in the shaded row of Table 1-1, DOD-6 describes failure of the RTWC and subsequent loss of large roof sections, which can occur at an expected wind speed of 195 km/h. This wind speed corresponds to relatively weak EF2 tornadoes (Environment Canada, 2013). DOD-4 occurs at lower wind speeds; however, loss of a single sheathing panel can allow for water ingress, which often results in loss of the entire house and its contents (Sparks, et al., 1994). As discussed in the following sections, gable roofs have been observed to perform poorly under these modes, especially DOD-6, relative to neighboring hip roofs of similar construction. In fact, the FR12 listing from the Canadian EF-Scale notes that for hip-roof homes, the upper-bound wind speeds for DODs 4 and 6 can be assumed. This is counter to the original EF-Scale documentation (Wind Science and Engineering Centre, 2006) which specifies that the lower bound of DOD-6 is due to inadequate construction or large overhangs while the upper bound is due to enhanced, construction such as the use of hurricane straps. The difference between the two versions of the EF-Scale is a significant point, which warrants further investigation.

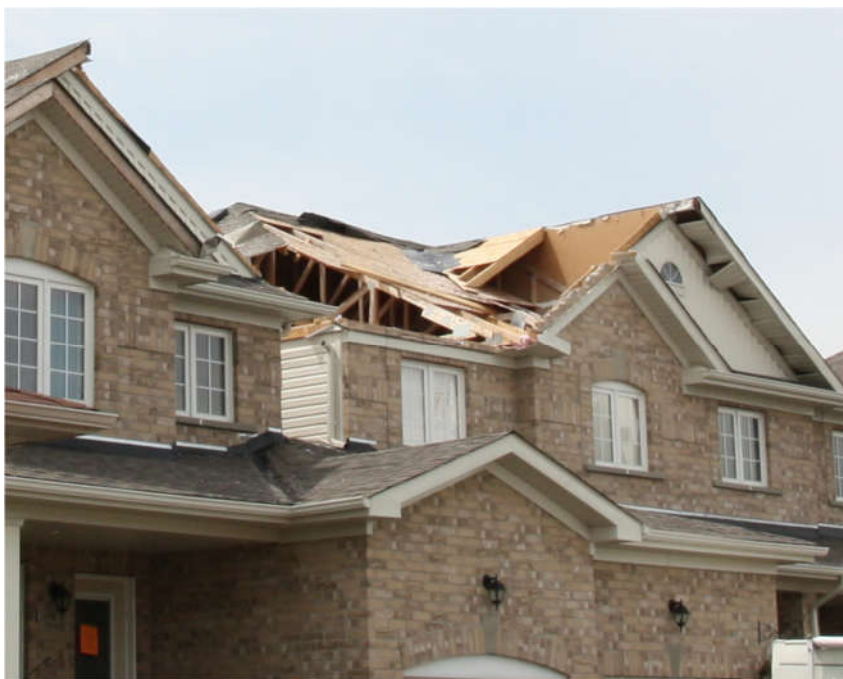
**Figure 1-3: Partial hip roof failure observed following EF2 tornado in Angus, Ontario, June 2014. (Image provided by Dr. Greg Kopp)**

An example of a partial hip roof failure from the Angus tornado is shown in Figure 1-3. This failure does not appear to have occurred simply as sheathing failure or failure of the RTWC. At the left corner of the damaged house there is an opening where it appears that a portion of the roof has been removed. Inside of the opening intact trusses are still visible. This suggests either that hip trusses near the edge of the roof have failed, or that smaller framing members making up the corner of the roof have been removed. In either scenario, partial failure of the roof frame has occurred, though it may have been initiated by failure of the RTWC at the corner. Several other observed failures which do not clearly fall into the sheathing or RTWC failure categories will be introduced in the following section, providing further background and justification for the current research.

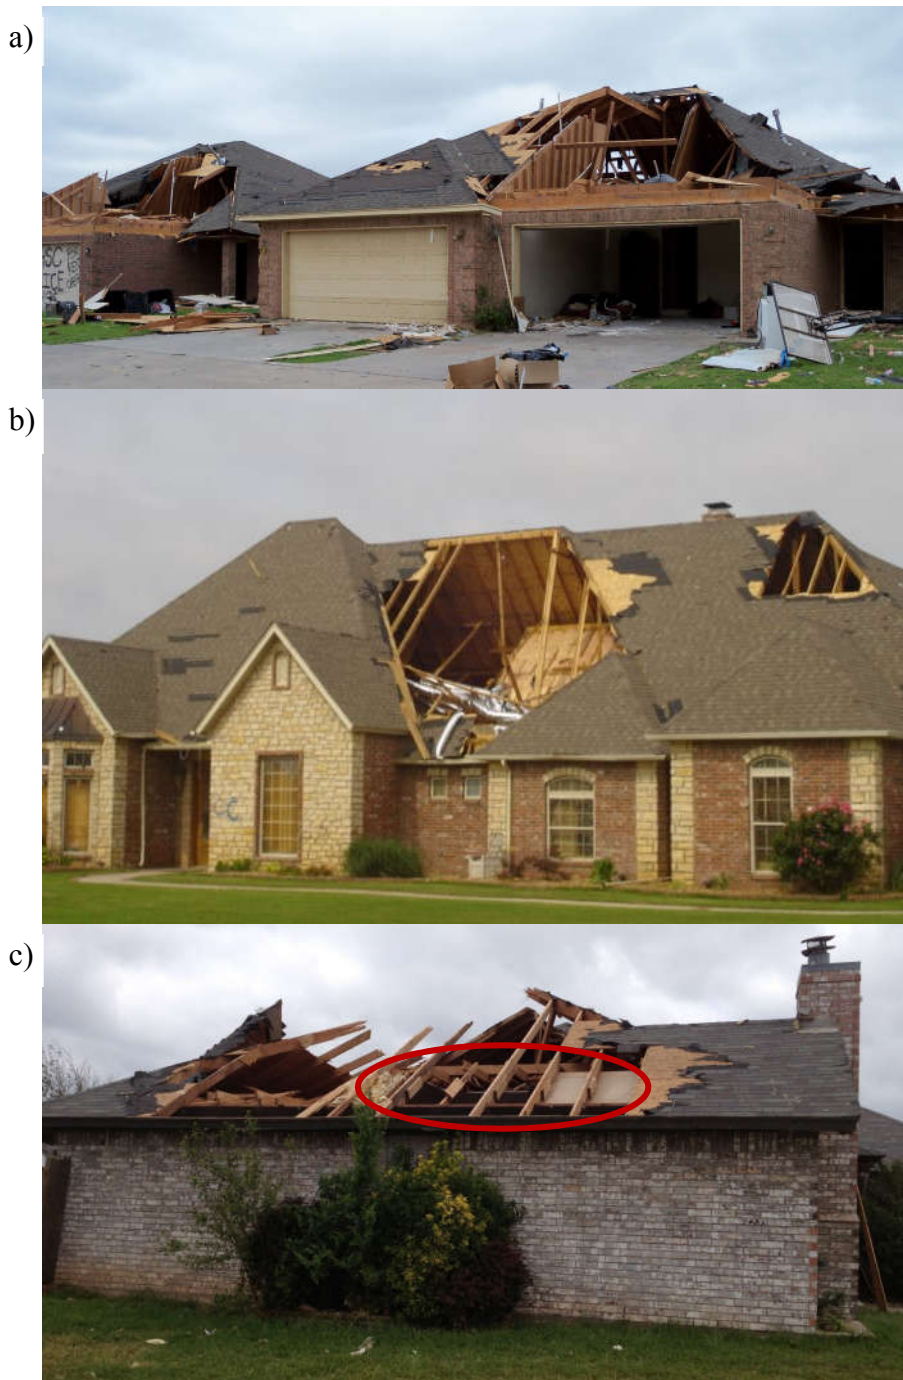
**Figure 1-4: Hip roof failures in Moore, OK following the EF5 Tornado of May 21, 2013. a) Framing failure of similar, neighboring hip roofs b) Framing failure of steep, stick-frame hip roof c) Hip roof displaying material failure of the wood framing members (Images provided by Dr. David Prevatt)**

Figure 1-4(a) shows neighbouring hip-roofed homes that exhibit similar failures of the front face of the roof. The RTWC appears to be intact around the remaining perimeter of the roof and it is apparent that several members of the roof frame have failed or been removed, in addition to the sheathing covering this portion. At the right side of the photo the remaining part of the roof is sagging, which further indicates that the underlying frame has failed. The houses shown in Figure 1-4 (a) were located along Kyle Drive at the western edge of Moore, OK. Several houses along this short stretch had similar failures of hip roof framing. The houses in this area had similar structural configurations and were built around 2006 (Graettinger, et al., 2014). Inspection of the damage photos from this neighborhood indicated that, of houses experiencing DOD-4 or DOD-6 roof damage, 40% appeared to

have failed through similar partial failures. In these cases, it appears that the frame failed at the nailed connections between the members, as no broken lumber is visible. The following section will present additional statistics and observations from two selected neighborhoods following the Joplin, MO tornado.

Figure 1-4(b) shows a similar failure to that in 4(a) but of a much steeper roof. The RTWC appears to be intact, and a large open cavity is visible where both framing members and sheathing have been removed. Similar to 4(a), it is apparent that this roof did not exclusively suffer sheathing loss, although the smaller area of sheathing loss at the right side of the photo should be noted. The lack of visible internal members in the cavity, especially those supporting the intact opposite face of the roof, strongly suggest that this roof was built as a stick-frame structure as opposed to one containing prefabricated trusses. Many of the failed hip roofs in the available data appear to have used stick-framing. The trussed and stick-frame construction methods will be described in Section 1.3.

Figure 1-4 (c) shows a partial failure of a combined hip/gable roof. This failure is unique from those shown in Figures 1-4(a) and 1-4(b) because material failure of the wood members is apparent. The RTWC appears to be intact, with the lower part of the roof having lost only sheathing on the right side, and framing members in addition to sheathing on the left. Near the peak of the roof, the frame has failed on both faces. This structure appears to contain either trusses or stick-framing with robust connections. As indicated on the figure just above the RTWC, the members were connected or otherwise reinforced using nailed wooden plates.

Upon inspection of the failures shown in Figure 1-4 and similar damage in the available photos, it becomes apparent that partial framing failures are another possible, repetitive mode of failure occurring in hip roofs. When comparing these hip roof failures to nearby structures from the data, it was determined that framing failures such as those shown in Figure 1-4 may govern in hip roofs at EF2 wind speeds, rather than RTWC failures or sheathing loss. It was also noted that the construction of the roof may be important. The observed stick-frame failures especially suggest that the performance of stick-frame roofs may need to be distinguished from that of trussed structures in analysis and design, as well as in the present research.

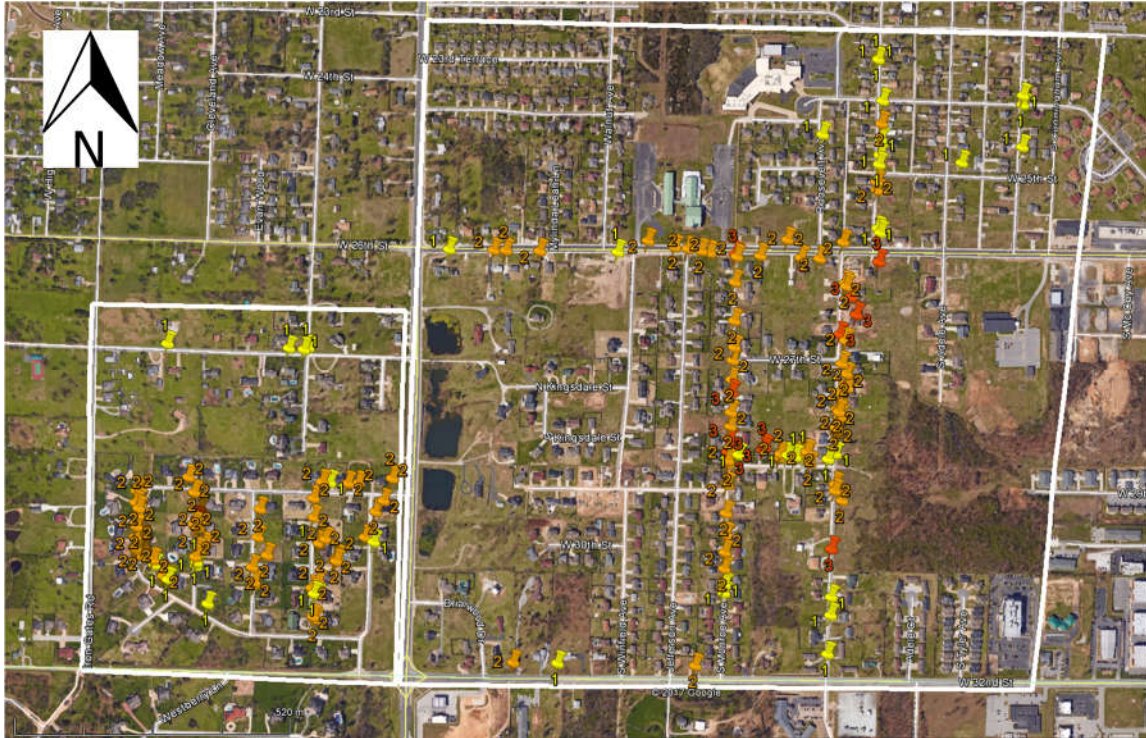
The damage survey data provided from the Joplin tornado includes an Excel spreadsheet which lists every photo that was used for assessing the event in accordance with the EF-Scale. The longitude, latitude, and EF-Scale rating at each location was listed, along with the file and path name for each image. The EF-ratings were assigned by the damage survey team at the time of the investigation. Using this data to manually create source code for the .kml file type used by Google Earth, it is possible to map the photos, including those with no GPS metadata, and label them using color-coded pins to represent the EF-Scale ranking. A sample from the resulting map is shown in Figure 1-5. This map shows the two areas analyzed to obtain the preliminary statistics presented herein. These neighbourhoods are located at the West end of the damage path. Only the data corresponding to EF1, EF2, and

EF3 damage was analyzed because these rankings correspond to the DOD-4 and DOD-6 wind speeds for residential roofs. In the figure, EF1, EF2, and EF3 rankings are represented by yellow, orange, and red pins, respectively.

**Figure 1-5: West end of tornado damage path following the May 22, 2011 tornado in Joplin, MO; two present study regions are shown by white outlines**

Two study areas, outlined in white on Figure 1-5, were analyzed and the occurrence of different failure modes can be compared across them. The damage photos at the marked locations in each region were inspected and the perceived mode of failure was noted. This pass through the data marked each separate residence based on whether the damage appeared to be wall, RTWC, sheathing, or framing failure. Wall failures corresponding to DOD-7 were included because the expected wind speeds causing this failure mode falls under the same EF category as DOD-6. The study areas were selected based on the characteristics of the houses in each. Region 1, on the left side of Figure 1-5, was found to contain houses that appeared to be newer, most with steep-sloping hip roofs and large building footprints. The homes in Region 2 mostly appeared to be older, masonry homes with shallow wood-framed roofs.

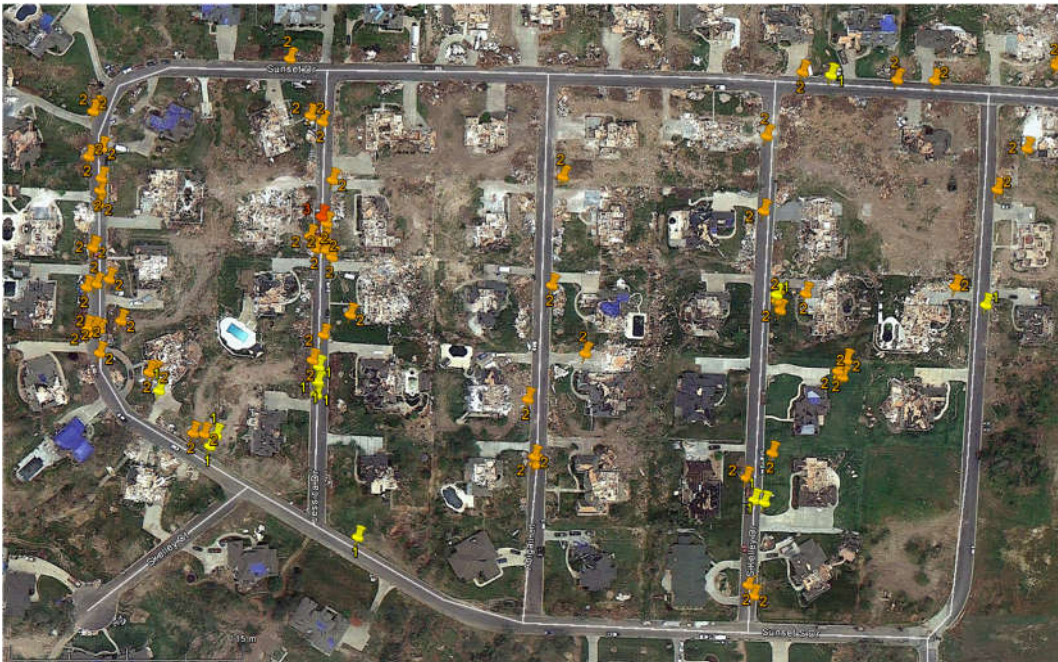
The results of the present analysis found that in Region 1, 42% of the houses with relevant damage failed through partial framing failure, while 40% showed signs of failure of the RTWC. Figure 1-6 shows Region 1 at a smaller scale, including aerial imagery depicting the aftermath of the tornado. As can be seen, most of the damage in this neighborhood was limited to the EF2 range, aside from one location on Jessica Drive. Figure 1-7 shows an example of the steep-sloping hip roofs visible throughout this neighbourhood, with an aerial image showing how the surface area of the roof was affected by the failure. In many instances, the largest surfaces of the roof were removed, while parts of the structure enclosing smaller spaces remained in place. Many of these structures also appeared to be of stick-frame construction.

**Figure 1-6: Map of Region 1 neighborhood (Sunset Drive) with aerial photography showing the aftermath of the tornado in Joplin, MO (Image provided by Dr. David Prevatt)**

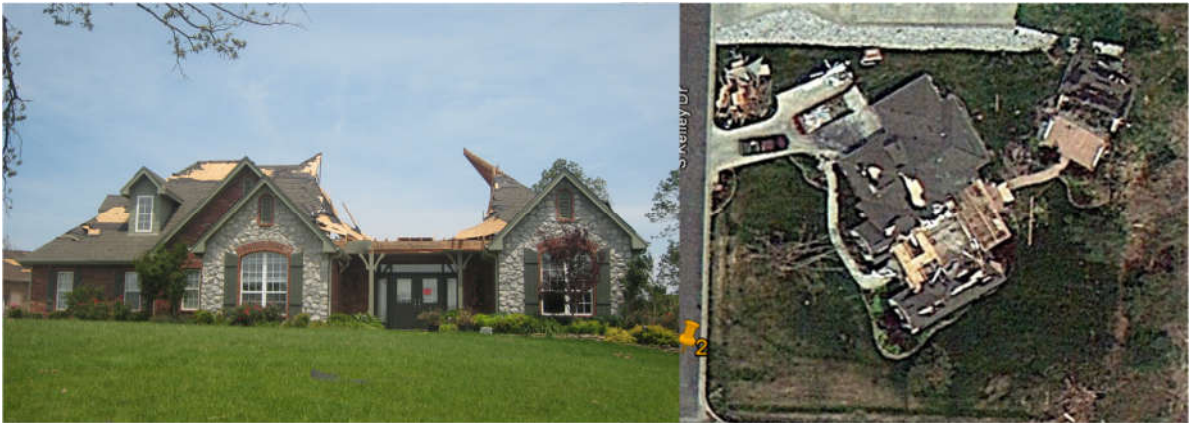
**Figure 1-7: Example of typical hip roof configuration in Region 1, with an aerial photo showing the footprint of the partial failure on the right-hand side of the figure (Image provided by Dr. David Prevatt, Google Earth)**

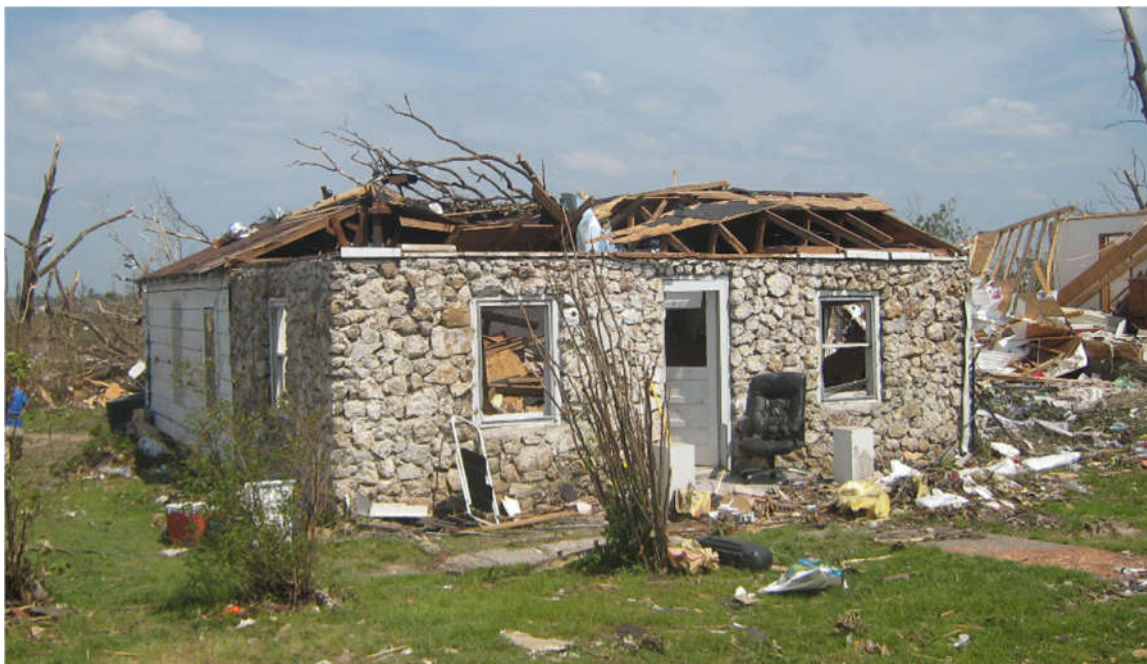
**Figure 1-8: Partial hip roof failure in Region 2 (Image provided by Dr. David Prevatt).**

The distribution of failure types in Region 2 is different from that of Region 1; 15% showed partial failures, while 2%, 22%, and 18% suffered RTWC failure, sheathing failure, and wall collapse, respectively. This shift could have occurred due to a number of factors; however, it was noted that many of the houses in Region 2 appeared to be of older construction than those in Region 1, and had lower-sloping roofs. While this observation may suggest that roof slope contributes to the occurrence of framing failures, it is not apparent what other factors may have had an additional impact. For example, the lack of lateral restraint in older houses may have led to increased numbers of wall collapses, and aging structures may also be less resistant to debris damage. In the example shown in Figure 1-8, partial roof failure occurred. However, this failure may have occurred due to the tree debris visible on top of the failed roof. Other instances of partial failure in Region 2 were similarly ambiguous, and because Region 2 was downwind of Region 1, debris likely played a larger role. In both regions, partial failures were found to occur at least as often as other modes of roof failure. More work is required to obtain a complete set of statistics on these failures and better define the regional conditions that may contribute to their occurrence.

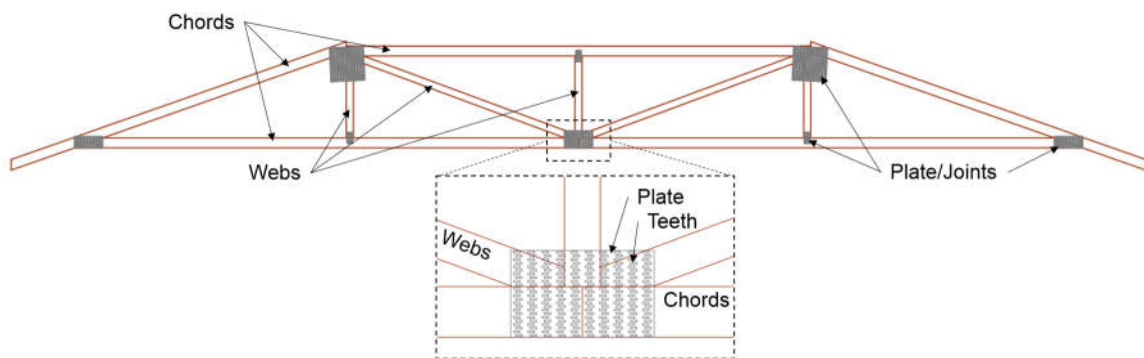
**Figure 1-9: Illustration of MPC Truss with Components Labelled**

Figure 1-9 illustrates the parts of a MPC truss and shows the nomenclature used in the present study. On site, trusses are placed on top of the wall top plate at equal spacing. Roof sheathing is fastened to the top of the top chords to enclose the roof, and ceiling drywall is typically fastened directly to the bottom faces of the bottom chord members. In gable roofs, all trusses in a roof may be identical in shape and configuration, while hip roofs require progressively taller trusses moving towards the centre of the roof, as well as short jack trusses placed perpendicular to the outermost full-length trusses to complete the roof slope at the eaves. For the reader's reference, Figure 2-4, later in this thesis shows a 3-dimensional model of an entire trussed hip roof, including full-length hip trusses and jack trusses.

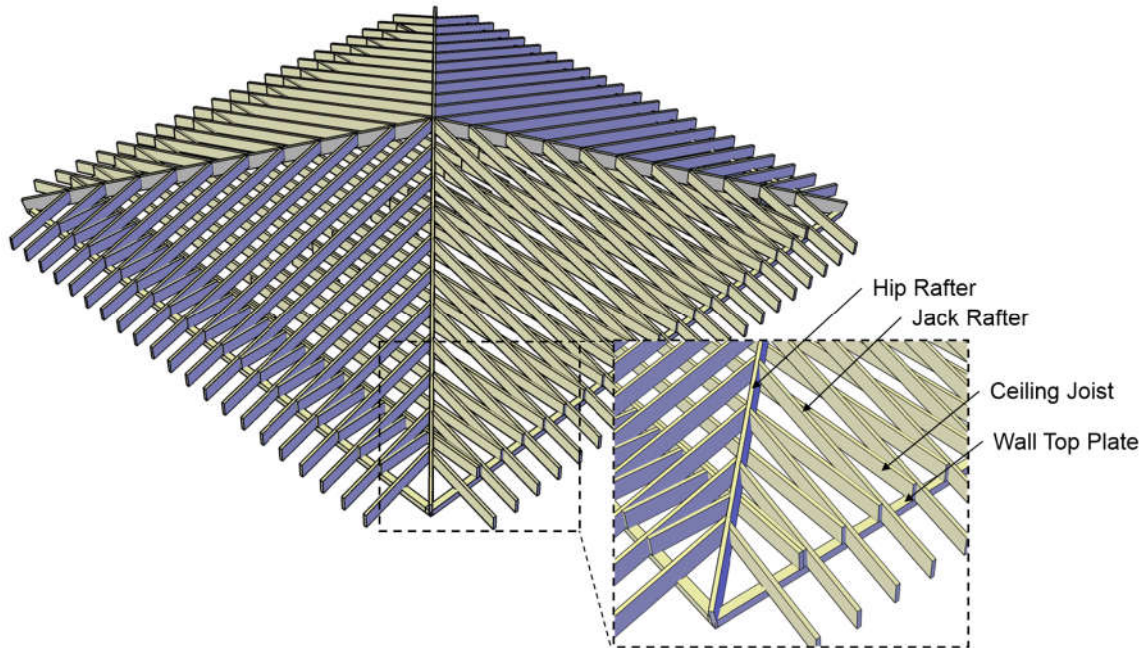
**Figure 1-10: Illustration of Stick-Frame Hip Roof with Components Labelled**

In stick-frame roofs such as that shown in Figure 1-10, the closely-spaced jack rafters are structural members, while the larger hip rafters simply provide a rigid, continuous member for the jack rafters to frame into. There is no requirement in the code to join the hip rafters together at the peak of the roof, and it is expected that the roof sheathing significantly contributes to load sharing throughout each face of the roof. The connections between the jack rafters and hip rafters along the ridge typically consist of nails going through the side of the hip rafter and into the end of the jack rafter, though they can alternatively be horizontal toe-nailed connections. It is well understood that both end-nailing and toe-nailing yield weak connections, and strength reduction factors must be applied to these values during capacity estimation (Canadian Wood Council/Canadian Standards Association, 2015). At the RTWC, the jack rafter is nailed to the ceiling joist using several nails perpendicular to the length of each member, and both the jack rafter and the ceiling joist are toe-nailed into the top plate.

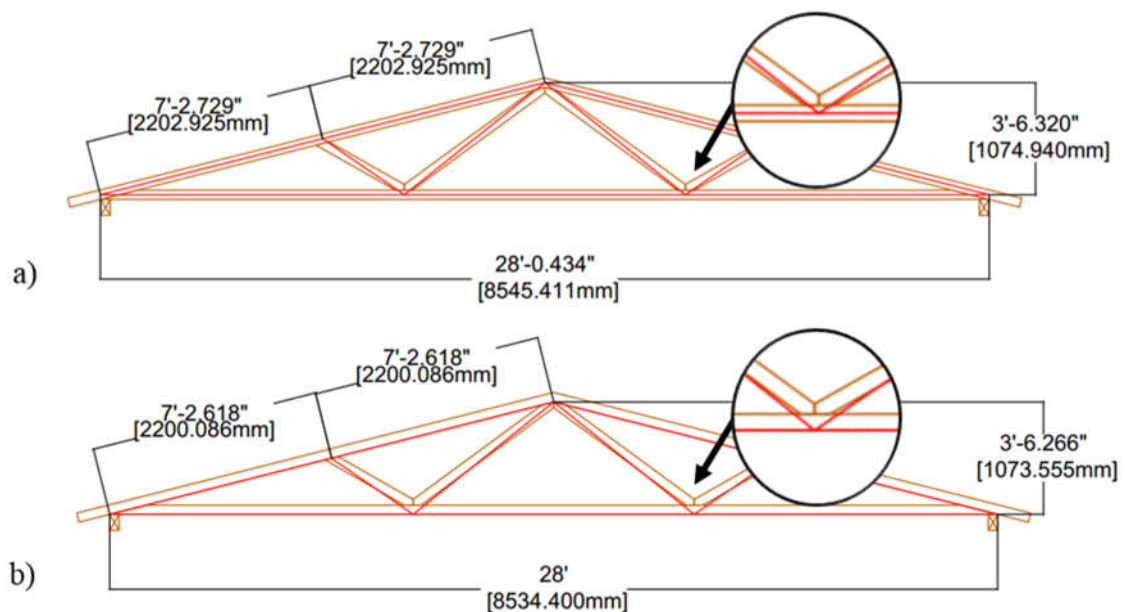
**Figure 1-11: Geometric analogs applied to a 3:12 slope Fink truss, using different chord member insertion points: a) Chord Centerline, b) Chord Bottom-Line**

Commonly, truss members are modeled along the centroid of their cross-section, as shown in Figure 1-11 (a). This assumption was used and validated with deflection data in many past studies (Li, 1996; Pfretzschner, 2012; Jacklin, 2013), and is the method most often used in conventional design and analysis. The Chord Centerline (CL) analog, as it will be referred to herein, assumes that the MPC truss behaves as an ideal truss, with member actions acting through concentric points at each connection. In reality, eccentricity occurs at most MPC joints due to member geometry and joint cut tolerances. Previous standards have recommended accounting for these eccentricities by using analog lines along the bottom edges of chord members (Limkatanyoo, 2003), as shown in Figure 1-11 (b).

Martin (2010) validated similar Fink trusses using the Chord Bottom-Line (BL) convention. In this analog, the top and bottom chords of the trusses are modelled along the center of the bottom face of the actual members. This results in an offset between the joint nodes and the neutral axes of the chord members equal to half of the height of a member.

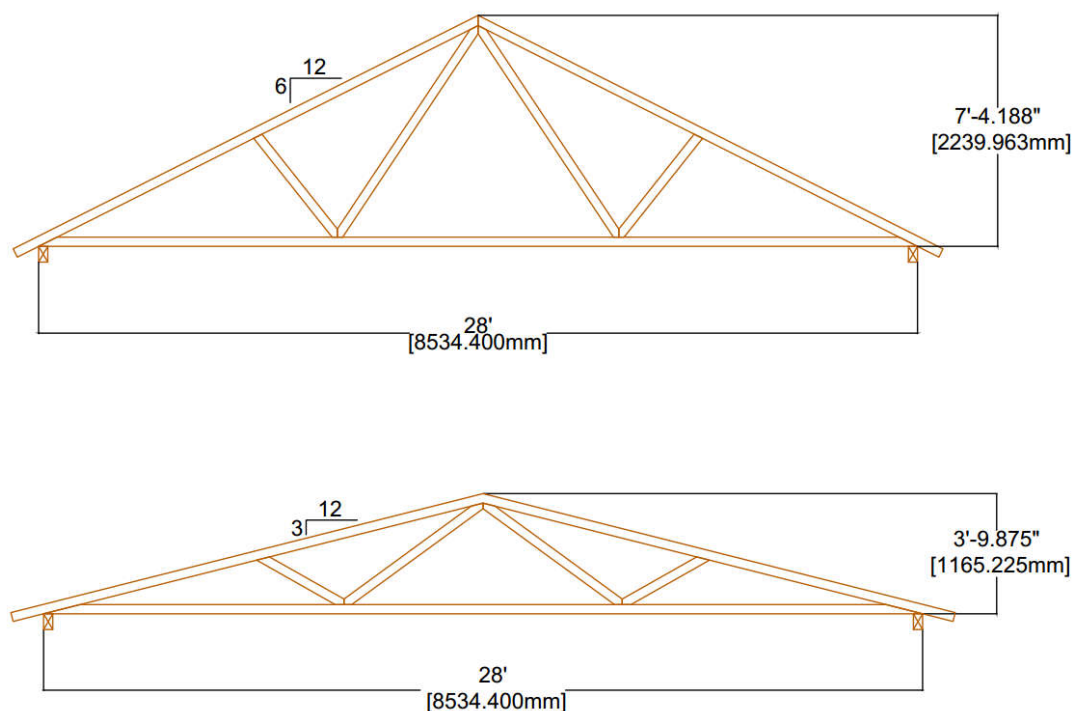
**Figure 1-12: Illustration of Fink trusses used in 2-D model validation, based on the 6:12 slope and 3:12 slope truss configurations tested in FPL (1986, 1989, 1991, 1996)**

The FPL studies included tests performed on geometrically-similar trusses with slight differences in the truss design or test setup, depending on the scope of each study. In all reports, 28-foot-long, 3:12 slope and 6:12 slope Fink trusses were initially designed according to conventional design procedures. All trusses consisted of No. 2 Southern Pine sawn lumber with nominal cross-sectional dimensions of 38 by 89 mm (Standard 2x4 lumber). Figure 1-12 provides an illustration of the Fink trusses tested in the FPL studies.

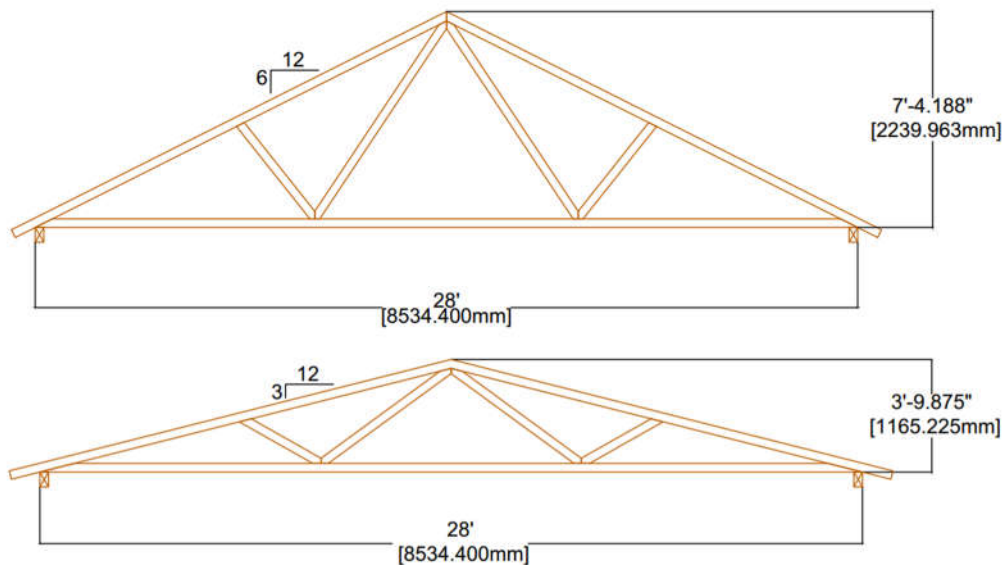
**Figure 2-1: Overview of Fink Trusses used in 2-D Model Validation, based on the 6:12 (upper) and 3:12 (lower) Truss Configurations Tested in FPL-1986 and FPL-1991**

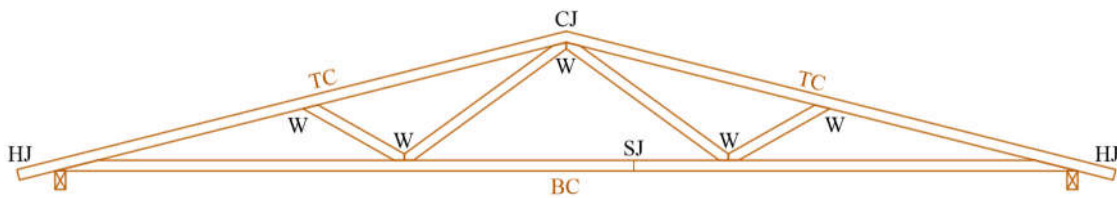
**Figure 2-2: Truss 3H joint and member naming convention**

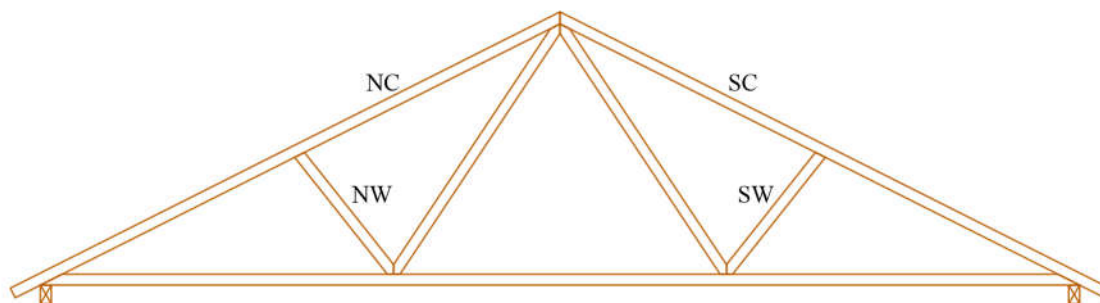
**Figure 2-3: 6:12 slope trusses tested in FPL-1996, with members labeled and approximate locations of force data readings shown by location of member labels**

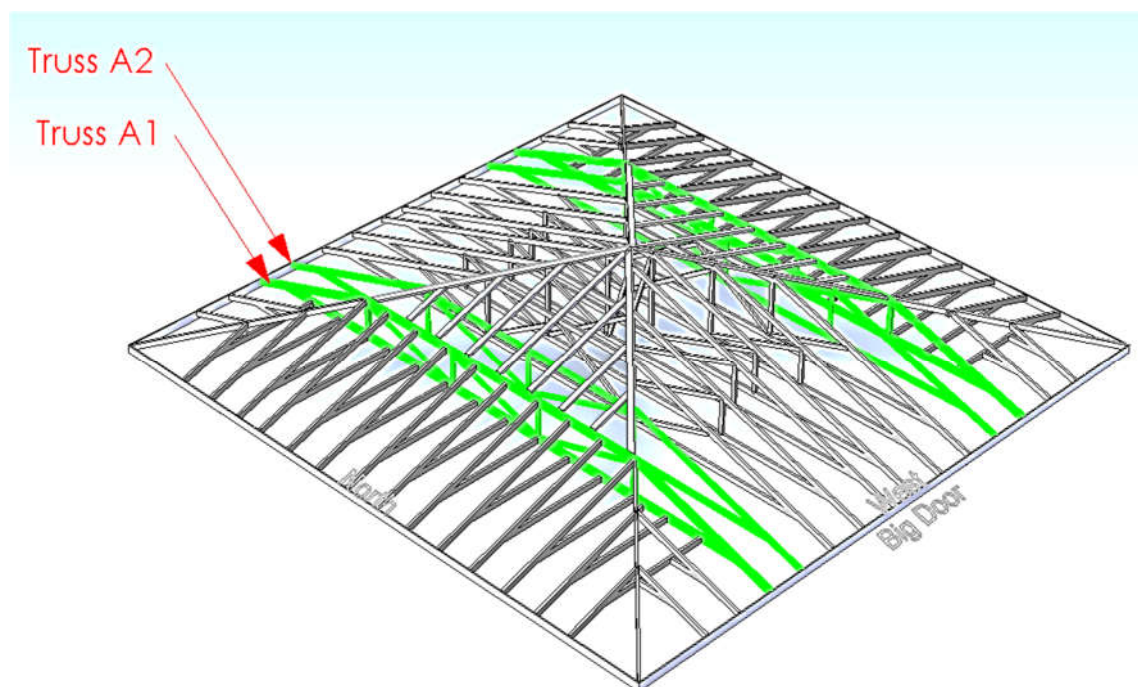
**Figure 2-4: Model rendering of full-scale hip roof tested by Henderson et al. (2013)**

One of the truss configurations constructed as part of the hip roof tested in Henderson et al. (2013) is selected from the truss drawing package and is used for the first D/C analysis. The envelope modeling method and force results for the selected truss are summarized using the figures in the present section. The second full-length truss in the roof is used for the present modeling. Figure 2-4 shows the configuration of the roof tested in Henderson et al. (2013), and the location of the selected truss, labeled “A2”. This truss is selected for the present analysis because it is the first full-length truss from the outer edge of the roof, aside from the two-ply “A1” truss, and its symmetry simplifies the determination of joint capacities.

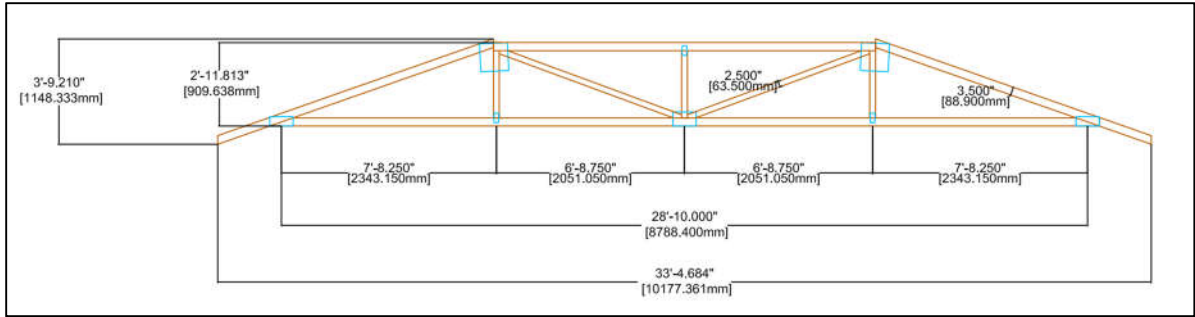
**Figure 2-5: Dimensioned drawing of hip roof Truss A2 from the full-scale house tested at the Insurance Research Lab for Better Homes**

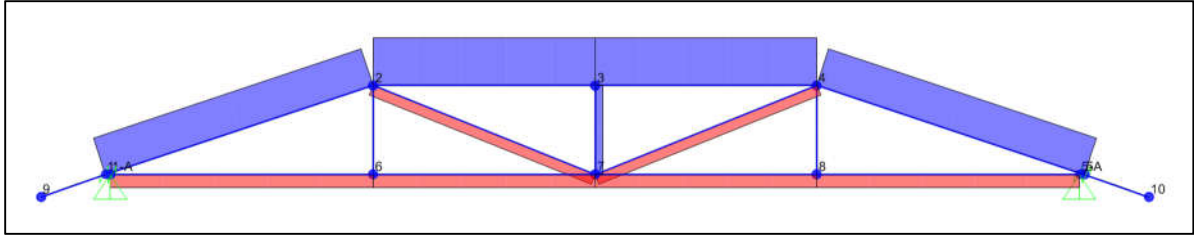
**Figure 2-7: Sample of relative axial force results from the rigid SAP2000 model of Truss A2, under 1.22 N/mm uniform uplift. The blue positive results indicate tension and the red results indicate compression**

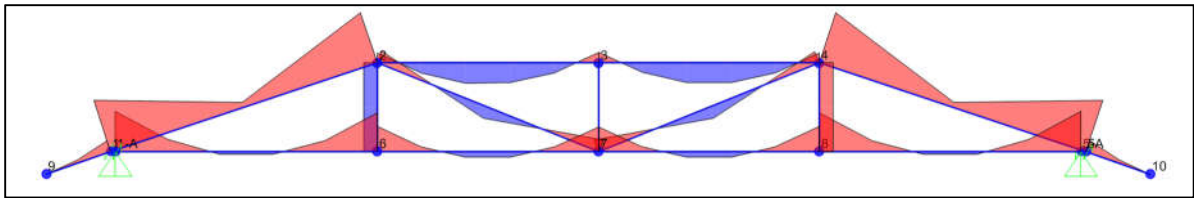
**Figure 2-8: Sample of relative member moments from the rigid SAP2000 model of Truss A2, under 1.22 N/mm uniform uplift**

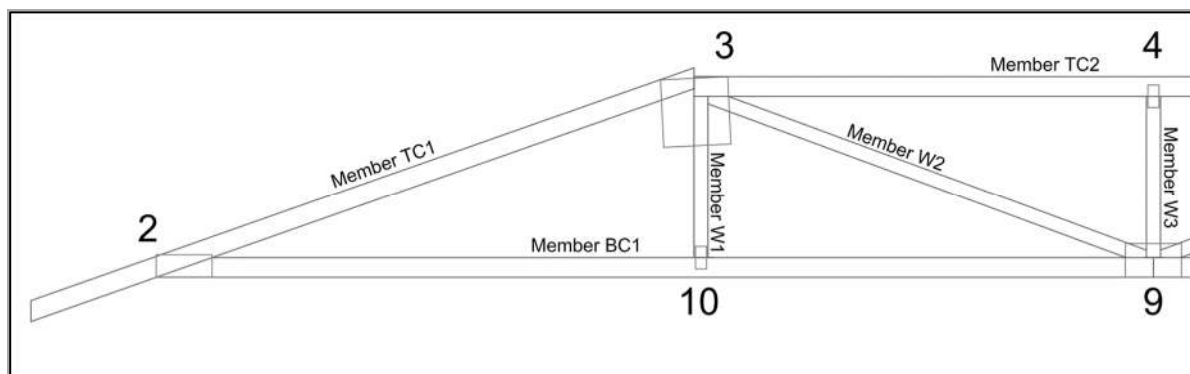
**Figure 3-1: Half of modeled hip roof truss with MPC joints and members labeled according to truss manufacturer's drawing package**

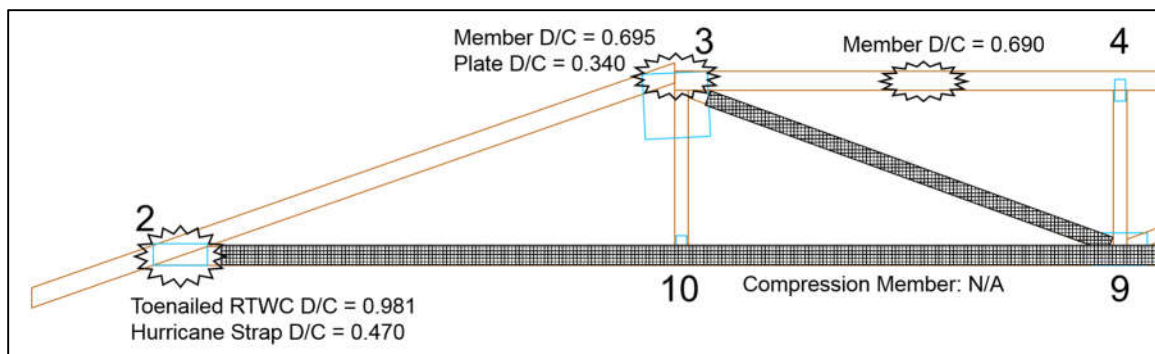
**Figure 3-2: Schematic of failure locations in Truss A2 based on estimated D/C ratios from Table 3-2**

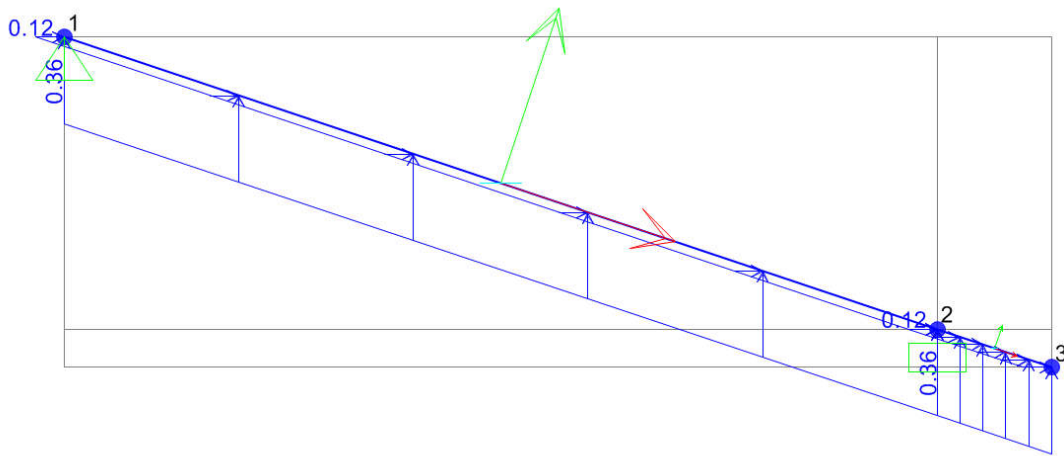
**Figure 4-2: SAP2000 model of jack rafter under 0.38 N/mm uniform uplift**

Analysis of a single rafter can easily be accomplished through hand calculations. For this study, however, SAP2000 is used so that the rafter can be modelled with Pinned and Rigid joint behaviour at the supports, and the maximum force results from both cases can be obtained. Figure 4-2 shows the modeled rafter with applied uplift loads. Like in the truss models, loads are applied as outward pressures, perpendicular to the member, rather than vertically upwards. The magnitude of the applied load is calculated using the same adjusted wind speed as presented in Section 3.2. The pressure corresponding to 115 km/h is multiplied by the tributary area supported by the rafter, resulting in a uniformly distributed load of 0.38 N/mm. From this model, maximum member forces and support reactions are obtained and shown in Table 4-1.

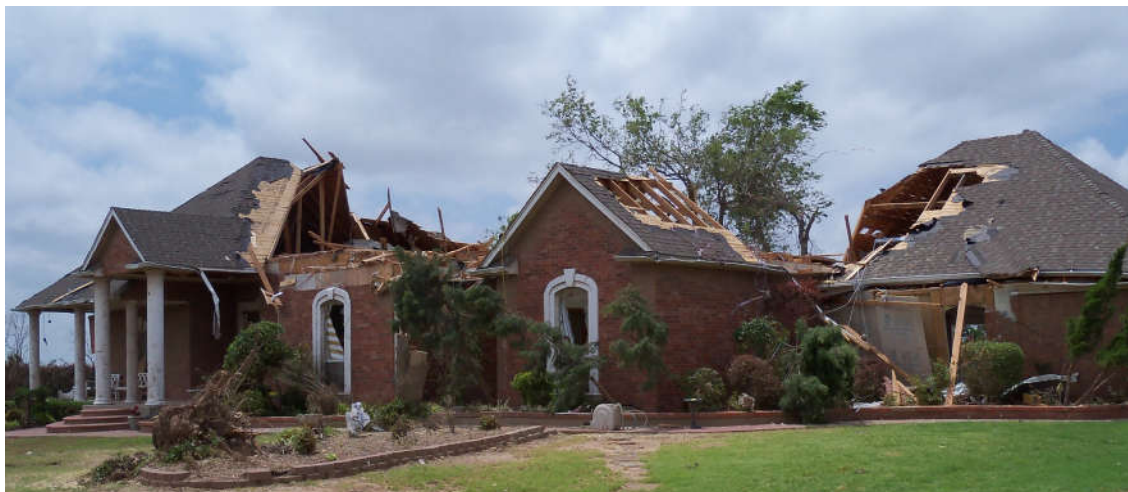
**Figure 4-3: Failure of stick-frame roof with irregular roof shapes (Image provided by Dr. David Prevatt)**

4-3 below. The results from the D/C analysis verify that loss of members or faces of a stick-frame hip roof may be likely under relatively low wind speeds, however the progression of failure of large sections of the roof is not well-defined. Other causes such as improper design or construction may have a significant impact as well.

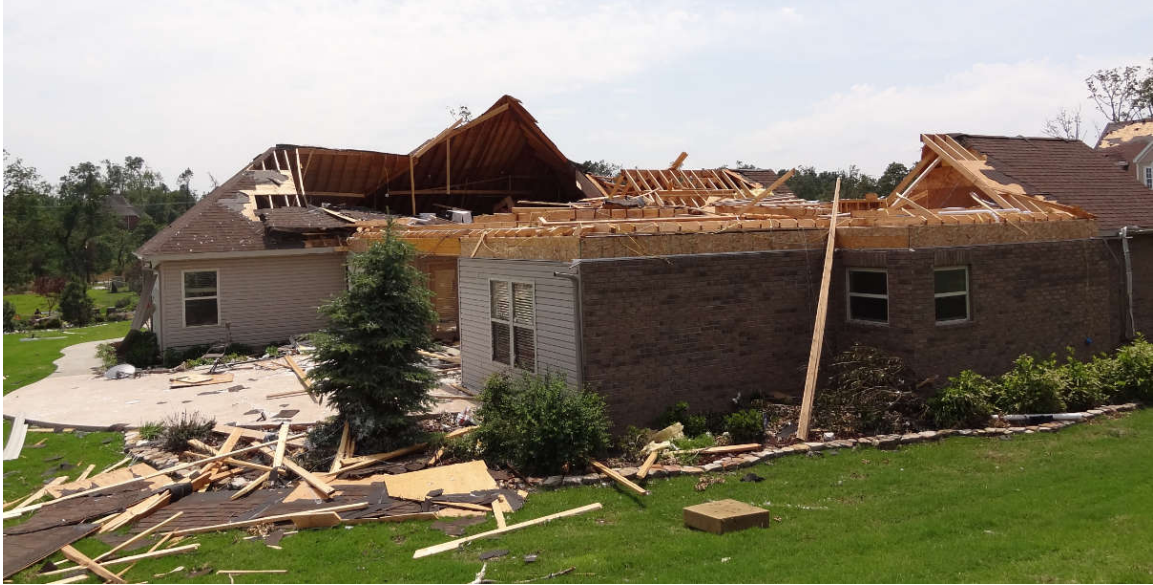
**Figure 4-4: Partial stick-frame, hip roof failure with ceiling joists intact (Image provided by Dr. David Prevatt)**

Upon revisiting the damage survey data and the report from the Moore, OK tornado (Graettinger, et al., 2014), an additional mode of failure related to the stick-frame case is noticed. This mode may point to improper construction of the outer roof frame, or to the potential impact of cascading failures caused by load sharing in stick-frame structures. In Figure 4-4, partial framing failure and removal of large sections of the roof appears to have occurred. Upon closer inspection, however, it becomes apparent that the ceiling joists, and the ceiling beneath them, are intact. Only the jack and hip rafters have been removed or damaged. Based on the results of the D/C analysis for the stick-frame case, this type of failure is unlikely, due to the relatively robust connection between the rafter and the ceiling joist. The RTWC and the connection along the ridge of the roof appears to be much more vulnerable. The pictured failure may have occurred due to improper or missing fasteners between the rafter and the joist at the wall top plate or initiated as failure of the upper rafter joint. Additionally, system effects may have led to progressive, cascading failure of adjacent joints, resulting in removal of entire faces of the roof following initiation at a single point.

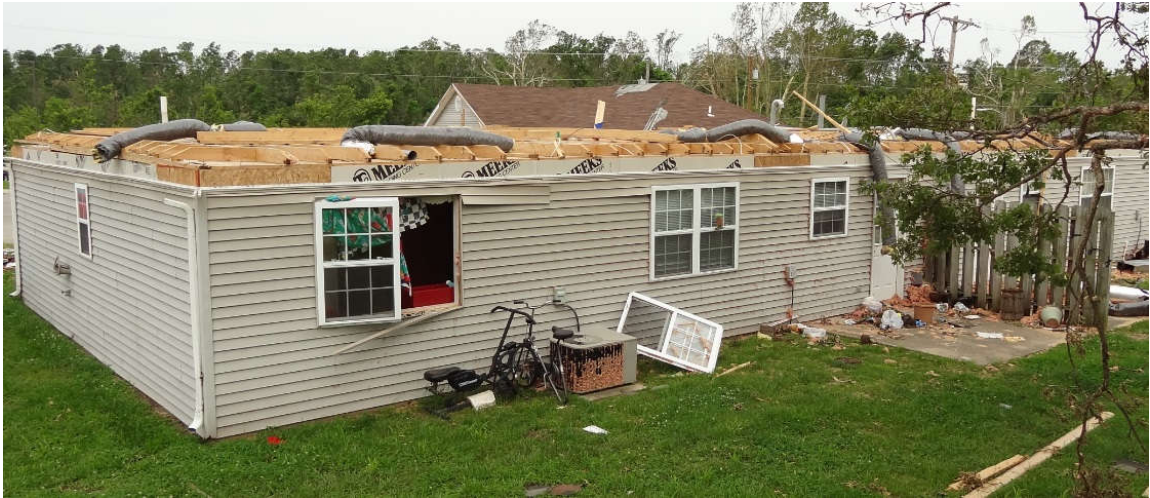
**Figure 4-5: Loss of the entire surface of a stick-frame hip roof with intact ceiling joists (Image provided by Dr. David Prevatt)**

Figure 4-5 shows another example of a major roof failure which has left the ceiling framing and drywall intact. This failure, and many others like it, would be objectively classified within DOD-6 for residential roofs, however this may be an inaccurate assumption. As mentioned in the previous example, the D/C analysis for the stick frame case did not predict that the rafter-to-wall connection would be vulnerable due to its relatively robust connection to the ceiling joist. Closer inspection of Figure 4-5 suggests that there were some connections at the ends of the intact joists, however from the faces of the members it does not appear that there were more than a few nails. Keeping in mind that these houses were not designed in Canada, exploration of the prescriptive design requirements in the US is required to determine whether these connections are meant to include more nails.

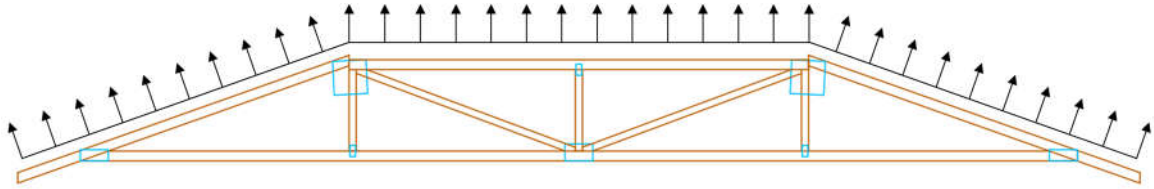
**Figure A-1: Diagram of Truss A2 under uplift pressure**

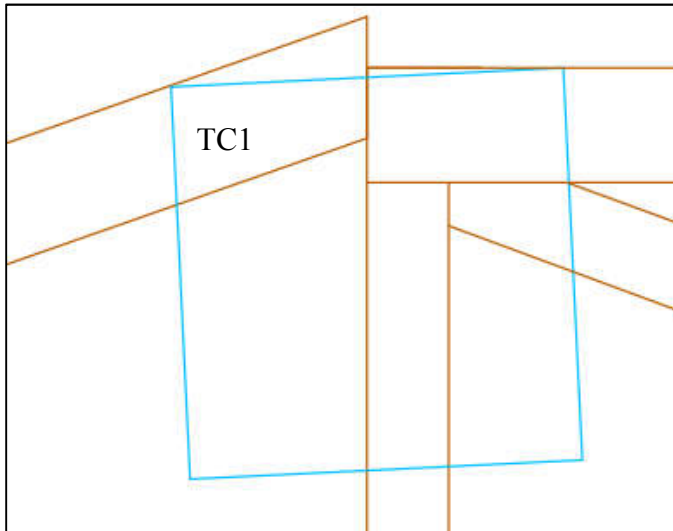
**Figure A-2: Truss A2 Joint 3 diagram with member TC1 contact area shown**

The following sample calculations are based on the Member TC1 capacities from Joint 3. The TC1 contact area is shown in the following diagram.

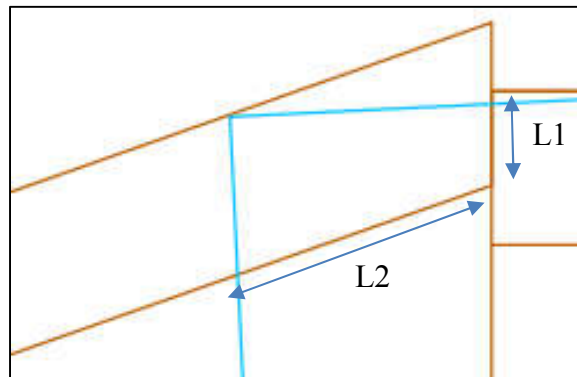
**Figure A-3: Joint 3 with shear and tension lengths labeled**
