**To cite this version** : Andrieu, Eric and Max, Bertrand and Viguiier, Bernard *Oxidation Assisted Intergranular Cracking in Alloy 718: Effects of Strain Rate and Temperature*. (2015) AerospaceLab-journal, vol. 9. ISSN 2107-6596

## Oxidation Assisted Intergranular Cracking in Alloy 718: Effects of Strain Rate and Temperature

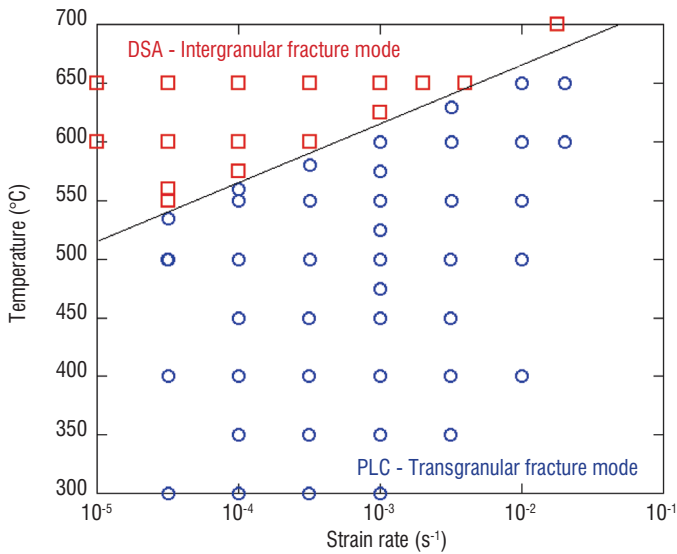
Figure 2 - Representation of the plastic instability occurrence or absence domains (PLC: denotes the domain where serrations were observed; DSA: denotes the domain where no serration was observed, often called the dragging domain) and of the associated rupture modes on the temperature – strain rate plane

In order to achieve a better understanding of this type of coupling between the mechanical behavior, oxidation and metallurgical state, further studies were performed. A transition between intergranular crack initiation and growth to transgranular ductile fracture is evidenced over the entire temperature range 300°C -700°C under air testing conditions when Portevin-Le Chatelier (PLC) type flow instabilities appear. Given that this boundary between the Dynamic Strain Ageing (DSA) without serrations and the PLC sub-domain is related to microscopic and macroscopic mechanical aspects and mechanisms, studies were continued and the results have been the subject of an earlier publication [10]. A great number of tensile tests have been carried out in an air atmosphere, in order to characterize the plastic instabilities (PLC effect) resulting from a DSA phenomenon in this alloy. The results of these tests are plotted in figure 2, showing the

absence or occurrence of plastic instabilities and the rupture mode exhibited by the fracture surface.

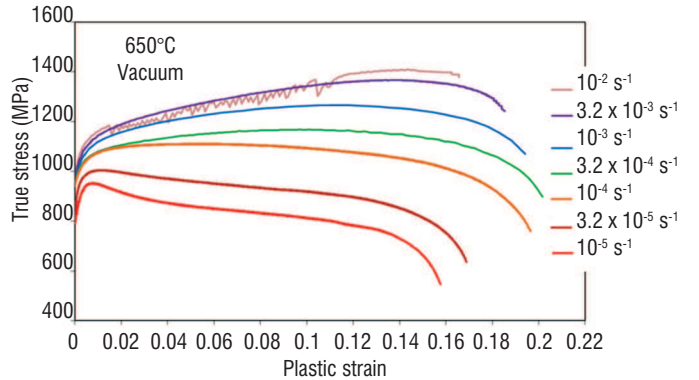
Figure 6 - Evolution of the flow stress for 650°C tensile tests in a vacuum ( $10^{-5}$  mbar), as a function of the strain rate

In order to assess the effect of the strain rate on the mechanical behavior, tensile tests were carried out in an inert environment. In this case, a dynamic vacuum equal to  $10^{-5}$  mbar was used. The results of these tests at 650°C are presented in figure 6. As expected, a positive effect of the strain rate on the flow stress is found. Flow instabilities appeared for an applied strain rate of  $10^{-2} \text{ s}^{-1}$ , as well as low noise emissions. This phenomenon is clearly related to the triggering of PLC instabilities. The fracture surface was observed for each test. All of the specimens exhibited a typical ductile fracture with dimples, mostly initiated on primary carbides, whatever the strain rate, independently from the occurrence or not of plastic instabilities. That is to say that flow instabilities in an inert atmosphere do not generate a change in the fracture mode.

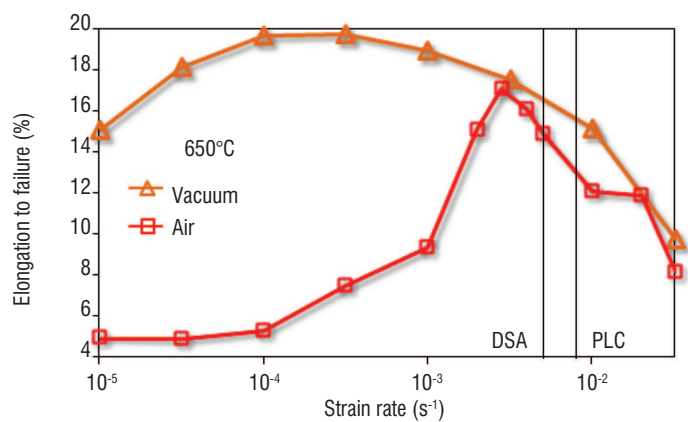
Figure 8 - Elongation to failure for tensile tests at T=650°C for different types of atmosphere: dynamic vacuum ( $10^{-5}$  mbar), or air

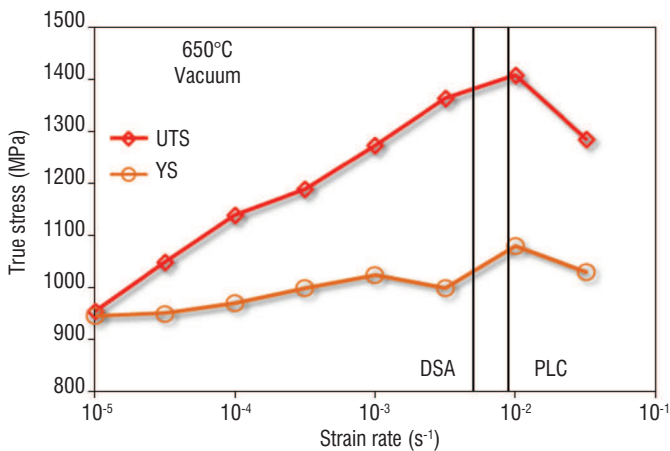
Figure 9 - Evolution of the yield stress and ultimate tensile stress for tensile tests at T=650°C in a dynamic vacuum ( $10^{-5}$  mbar)

It is worth noting that tensile properties, such as Yield Stress (YS) and Ultimate Tensile Stress (UTS), are strongly dependent on strain rate. A representation of their evolution as a function of strain rate is plotted in figure 9. The stress experienced by the sample can reach various levels as a function of the strain rate.

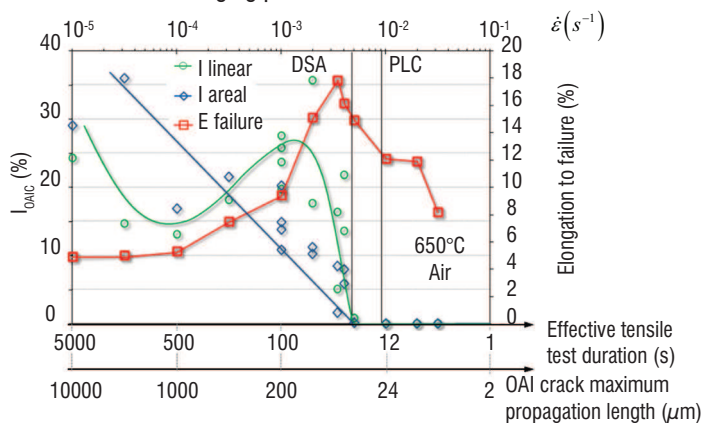
Figure 10 - Evolution of the elongation to failure and OAIC sensitivity indexes as a function of the strain rate for tensile tests at 650°C in an air environment

In order to better understand the OAIC mechanism, we compare macroscopic mechanical behavior with microstructural features. This is done through the graphical representation in figure 10, which shows the evolution of rupture elongation and both (linear and areal) indexes for OAIC sensitivity, as defined in a previous section of this paper, versus the strain rate. The plot also contains two complementary scales. The first corresponds to the duration of a tensile test, which varies both with the strain rate and the elongation to failure. The second one corresponds to the maximum crack length, determined using the maximum intergranular propagation rate in alloy 718 CT samples during creep-fatigue tests. This fastest crack propagation rate of a crack in alloy 718 has been evidenced in [12], it corresponds to the propagation of an initiated crack on a CT sample, during creep-fatigue tests (10s-300s-10s) in a high oxygen partial pressure environment ( $PO_2=0.2$  bar) and a high stress intensity factor ( $\Delta K = 40 MPa\sqrt{m}$ ). More precisely, these loading conditions have proven to lead to an average crack propagation rate of the order of  $2 \mu m.s^{-1}$ .

Something that must be pointed out is first of all that when tensile test parameters, namely the temperature and strain rate, trigger plastic instabilities, i.e., in the PLC domain, the fracture surface is entirely ductile. This experimental fact is due to the strong localization of plastic deformation within macroscopic bands resulting from the PLC effect. Hence, in this case, the fracture cannot be intergranular for two main reasons: the first is that the tensile tests do not last enough for the deleterious process of intergranular oxidation to occur; the second is the localization of the deformation into bands, which tends to enhance the mechanical damaging process.

When entering the DSA domain from the fastest strain rate side, the damage characteristics are as follows: the indexes are rather scattered; crack initiations are numerous, but propagation is inoperative; the bearing section of the sample is, in this case, nearly unaffected by the cracking phenomenon. This strain rate domain enables the crack initiation behavior of the alloy to be characterized. This is the domain of

When reaching the lowest strain rates in the DSA domain, the damage characteristics are the following: the indexes are weakly scattered; intergranular crack initiation sites are few, but cracks propagate widely. In this case, the bearing section of the sample is strongly affected by the cracking phenomenon and the elongation to failure is significantly reduced and nearly constant in this domain. Thus, this strain rate domain tends to be crack propagation controlled.
