THE NEED FOR DEFENCE IN THE ALICANTE COAST IN THE 16TH CENTURY: THE REJAS TOWER

M^a ASUNCIÓN LÓPEZ-PERAL, ENCARNACIÓN GARCÍA-GONZÁLEZ & M^a DOLORES ANDÚJAR-MONTOYA
University of Alicante, Spain.

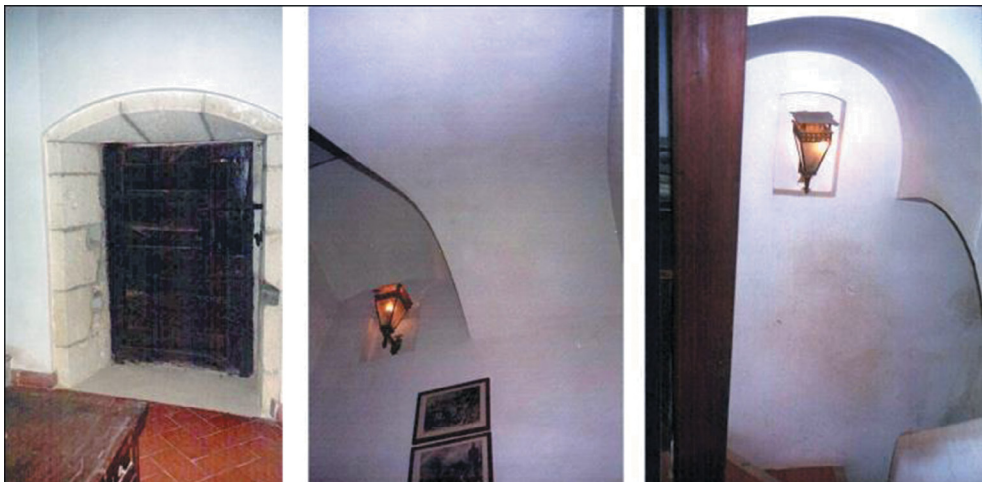
Figure 4: Left – communication door of the house and tower located on the first floor. Center and right – slab staircase.

On the first floor appears the door that connects the house and the tower. Originally this was the only entry door to the tower. The door measures 1×0.7 metres. The door lintel has an arch shape by the side looking at the house but it is straight in the other side, overlooking the tower. The materials it is made of include thick wood crossbars and a heavy iron latch inserted in the wall (Fig. 4 (Left)). Then the staircase, which is very narrow, has a width of 70 centimetres, enlarging 10 centimetres in the compensated part. The stairway slab is built with a vaulted ceiling, with several sheets of bricks, mainly for the purpose of compression (Fig. 4 (Center and Right)).

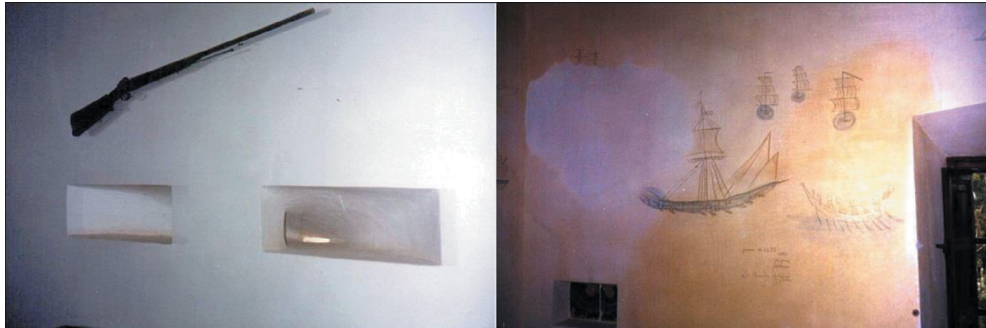
Figure 5: Left – the loopholes of the wall. Right – the paintings of the tower.

In this floor there are two loophole windows; these elements will appear again in the last floor (Fig. 5 (Left)). On the second floor, there appears the first of the three windows placed

at the south-east facade. They measure 0.9×1.20 metres; they have no trellis and are framed by ashlar to the outside. The tower slabs have wooden beams arranged parallel to the smaller side of the tower, and they have square section. On the third floor of the tower are inscriptions and drawings of boats on all walls (Fig. 5 (Right)).

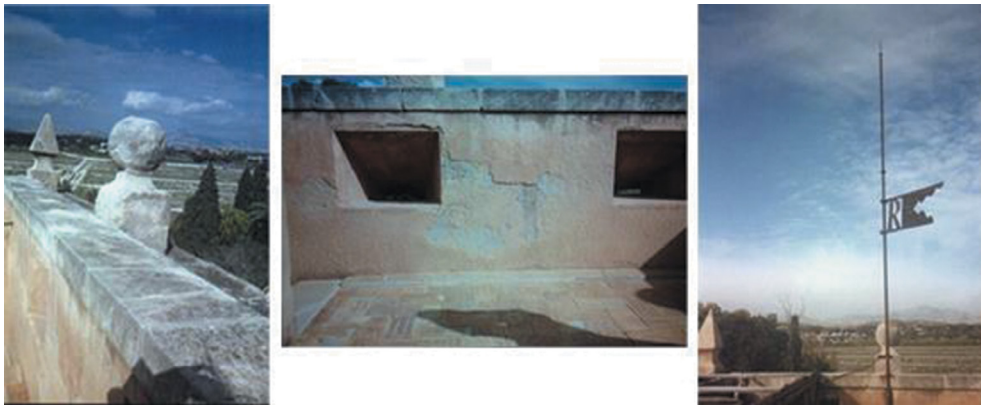
Figure 6: Left – the pinnacles of the tower. Center – the loopholes. Right – weathervane.

The roof parapet of the tower is one metre high, is plastered with lime mortar and has loopholes on three sides. The dimensions are 0.6×0.35 metres in the interior, decreasing in sections with inclined planes to the outside, until leaving a minimum opening (Fig. 6 (Center)). Eight pinnacles are arranged on the stone cornice. In the corners they are pyramid shaped and at the midpoints of the sides they are spherical in shape (Fig. 6 (Left)). At least, a weathervane appears with an 'R' design that refers to the name of the house (Fig. 6 (Right)).

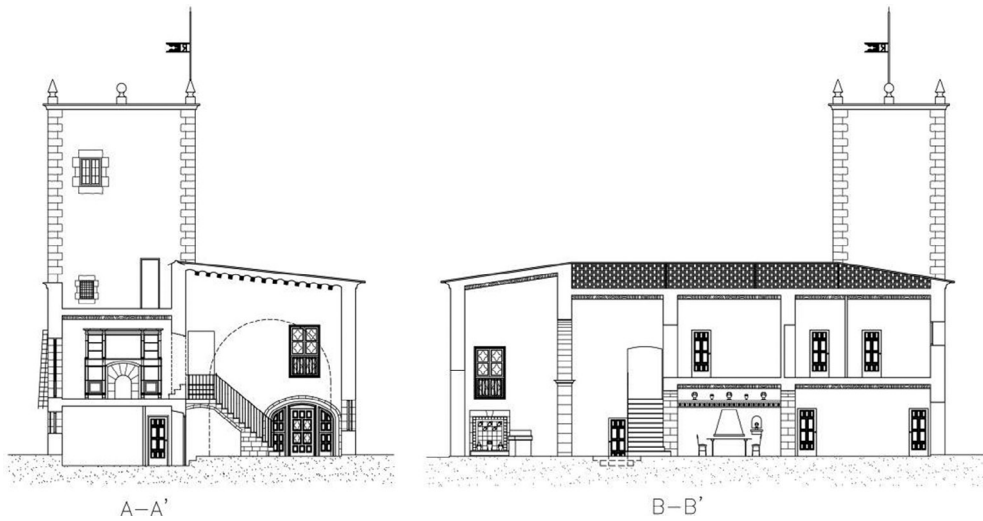
Figure 8: Left. A-A' cross section. We can see the entrance door to the tower at the first floor and the two levels hall with the big arch. Right. B-B' longitudinal section, a house global vision.

The access door is on the North East facade and its dimensions are 3.4×2.3 metres. This door leads to the lobby. The hall has two heights, so its ceiling is directly formed by the intrados of the roof. At the interior, the hall has a sloping plane, with wooden beams arranged orthogonally to the access facade (Fig. 8). The hall appears to be the large half-point arch parallel to the entrance door. This arch has a width of 5.1 metres. At 3.2 metres from the ground is placed the arch's start, and the top is located at about 5.8 metres. It consists of about 30 stone pieces joined with lime mortar. The arch joins the pilasters of the start with impostes

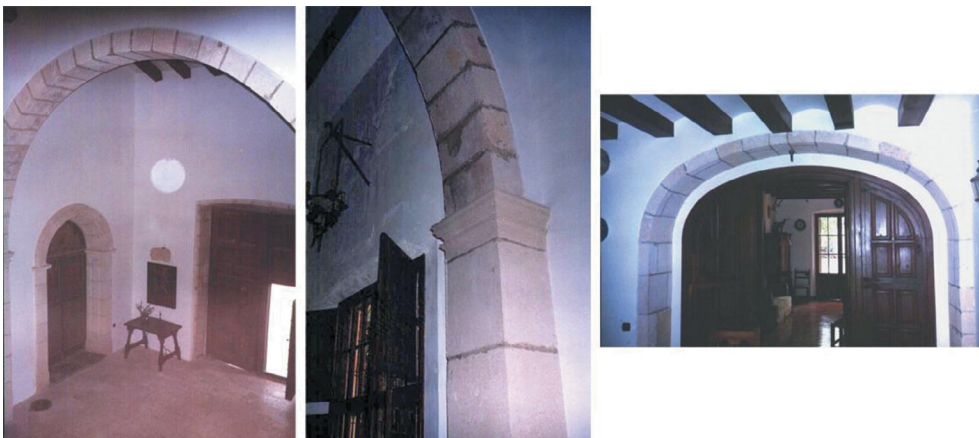
Figure 9: Left – interior view of the lobby. Center – the main arch of the hall. Right – arch of communication between lobby and dining room.

with mouldings (Fig. 9 (Left and Center)). In addition, next to the ladder there is another smaller arch (Fig. 9 (Right)).

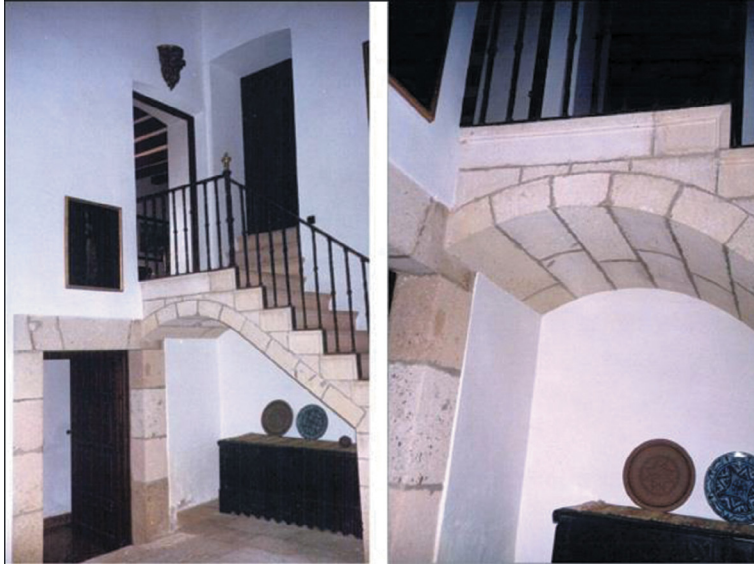
Figure 10: Staircase hall.

The main house staircase is made of stone. It has a total of 12 steps, all of them with the same length, except the first one that is longer. The handrail is simple without decoration and is formed by square bars made of wrought iron (Fig. 10).
