Summary report for PSO-F&U  
project (FU3101)

Fundamentals for remote condition  
monitoring of offshore wind turbines

Risø-R-1639(EN)

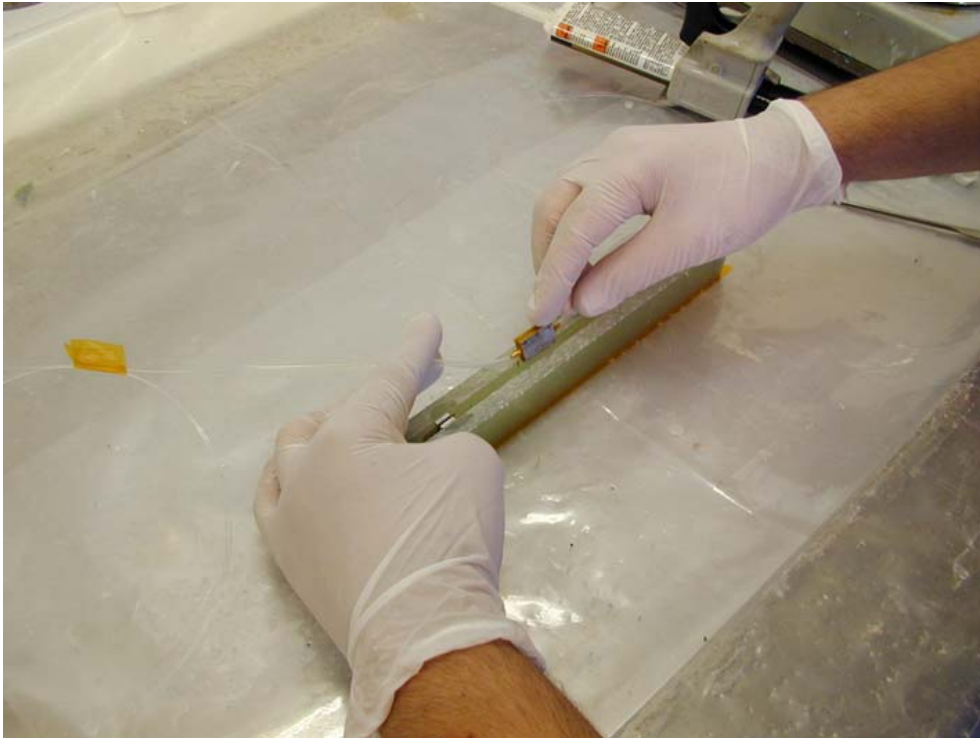
Figure 5. Showing the insertion of a fibre optic microbend transducer into the adhesive bondline during composite DCB specimen fabrication

The laboratory test specimen preparation involved gluing two composite pieces together with an adhesive thickness of 5mm, which was obtained using aluminium “spacers” between the two pieces. The microbend transducer was embedded within this glue-line with the fibre optic entering and leaving the adhesive protected by a silicon hose, see figure 5.
