Fukushima - Update November 2011

Fukushima Update 1/11-11

VBR seminar 15. november 2011, DTU Risø campus

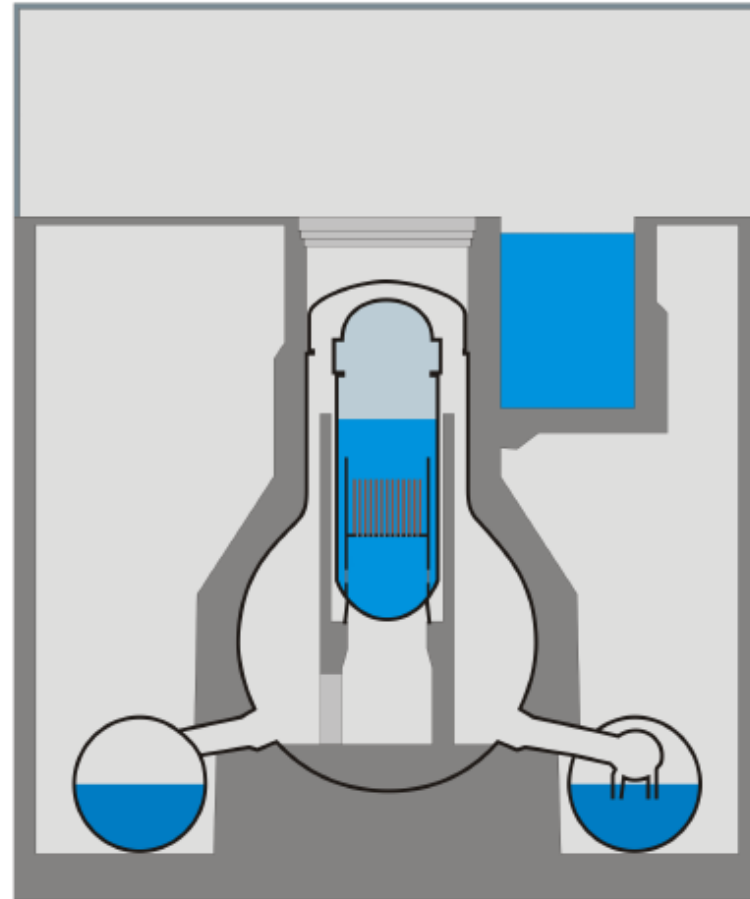
- ▶ 11.3. 15:41 Tsunami hits the plant
 - ◆ Plant Design for Tsunami height of up to 6.5m
 - ◆ Actual Tsunami height >7m
 - ◆ Flooding of
 - Diesel Generators and/or
 - Essential service water building cooling the generators

- ▶ Station Blackout
 - ◆ Common cause failure of the power supply
 - ◆ Only Batteries are still available
 - ◆ Failure of all but one Emergency core cooling systems

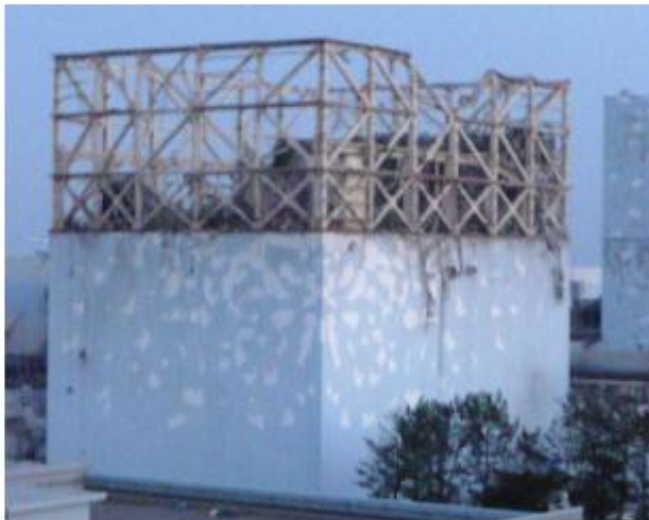
- ◆ Hydrogen burn inside the reactor service floor
- ◆ Destruction of the steel-frame roof
- ◆ Reinforced concrete reactor building seems undamaged
- ◆ Spectacular but minor safety relevant

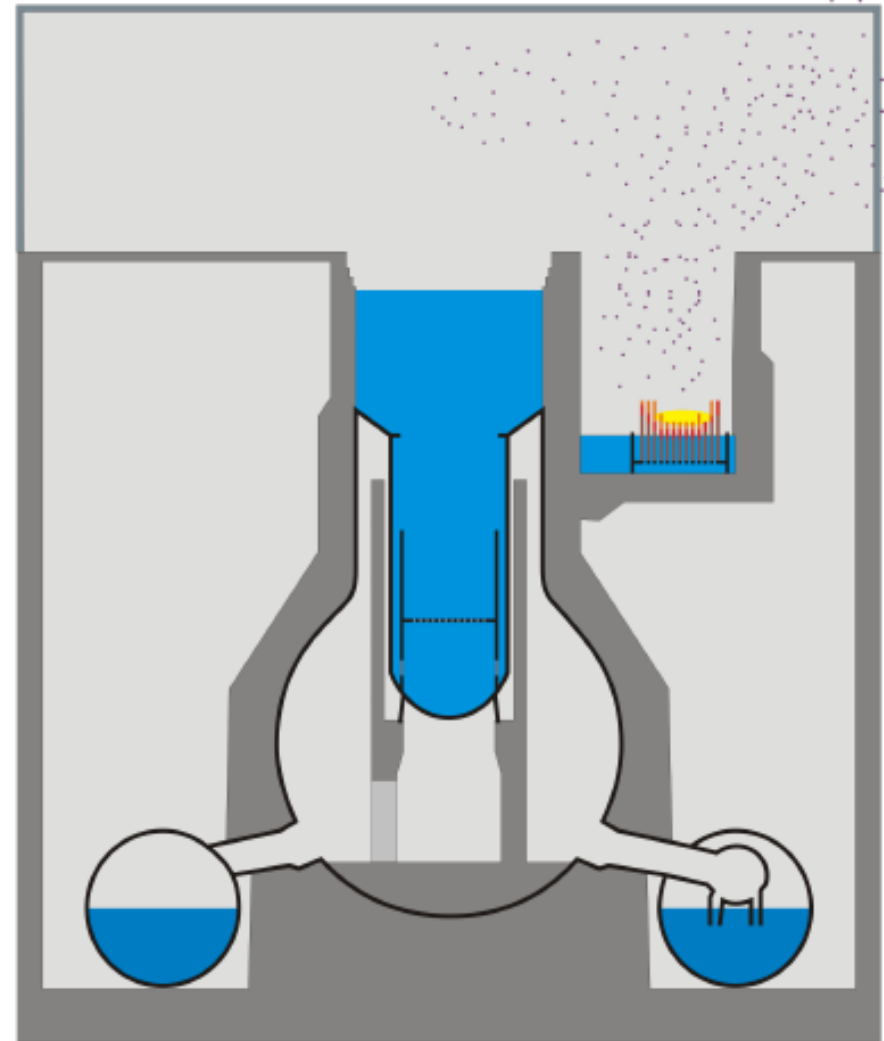
- ▶ Spent fuel stored in Pool on Reactor service floor
 - ◆ Due to maintenance in Unit 4 entire core stored in Fuel pool
 - ◆ Dry-out of the pools
 - Unit 4: in 10 days
 - Unit 1-3,5,6 in few weeks
 - ◆ **Leakage of the pools due to Earthquake?**
- ▶ Consequences
 - ◆ Core melt „on fresh air “
 - ◆ Nearly no retention of fission products
 - ◆ Large release
- ▶ **It is currently unclear if release from fuel pool already happened**

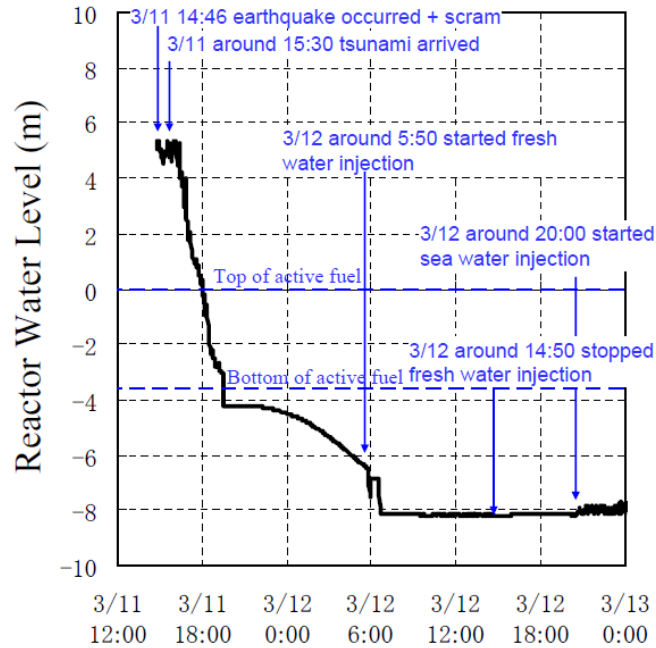
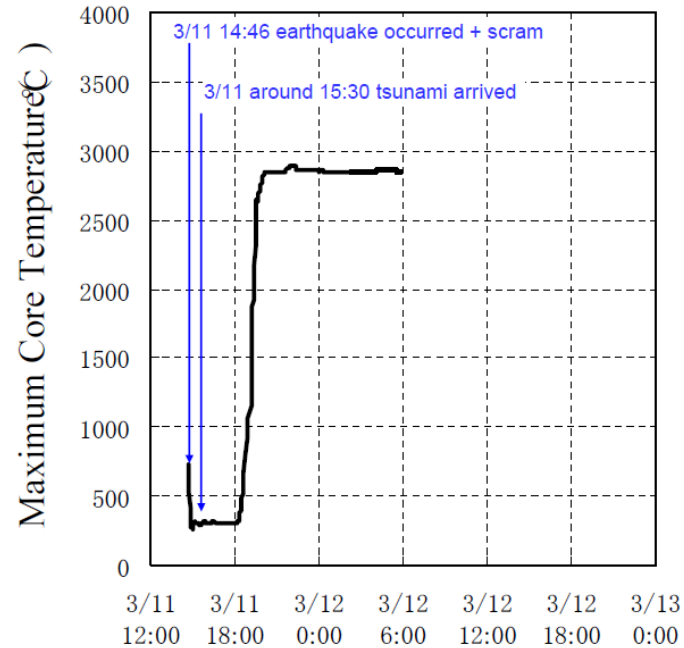
Unit 1: Reactor Water Level, Maximum Core Temperature (Analysis Result)

Key assumption: IC lost its function after the tsunami arrived at around 15:30

- reached top of active fuel in 3 hours (around 18:00) after the scram
- reached bottom of active fuel in 4 and a half hours (around 19:30) after the scram

The core temperature started increasing when the reactor water level became lower than top of active fuel, then reached the core melting temperature.

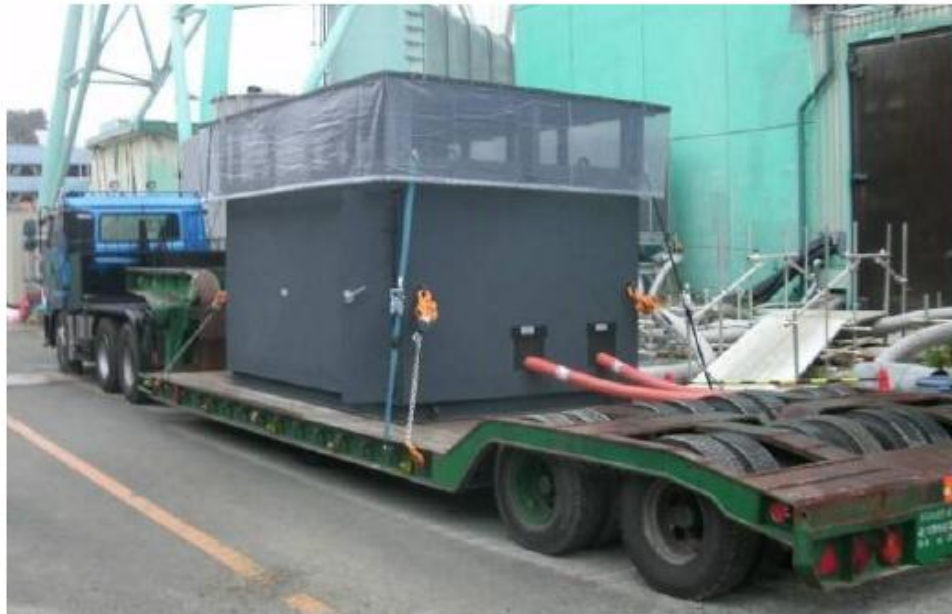
Figure 4: Caesium absorption apparatus inside shielding container

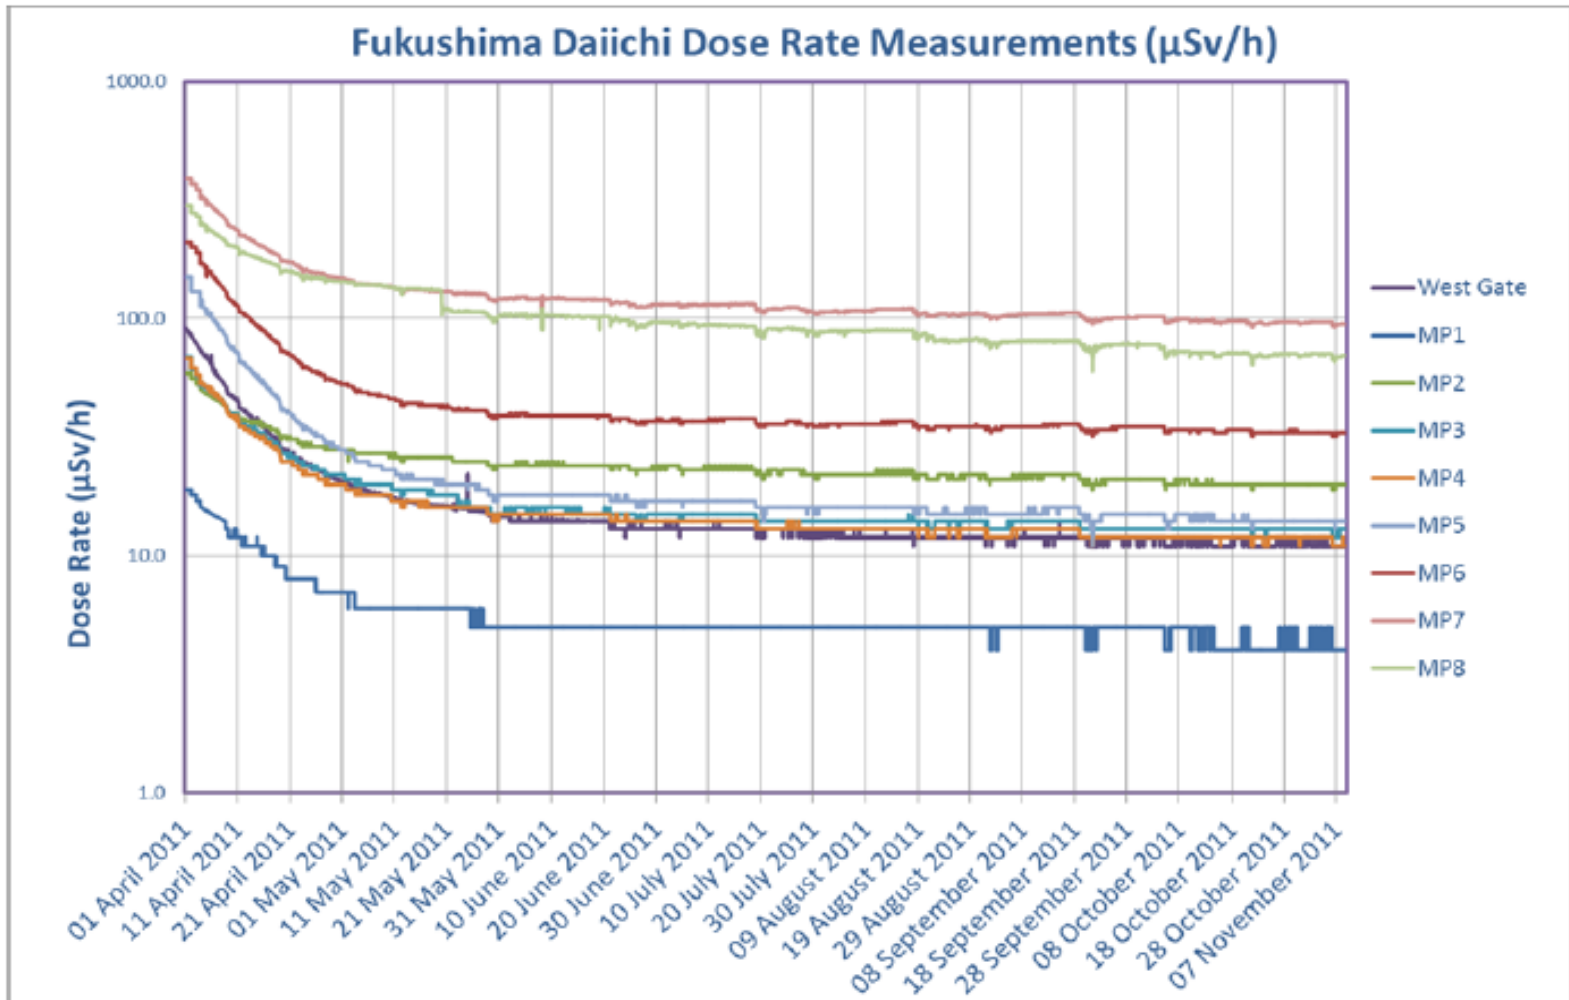
Figure 9: Onsite dose rate measurements ($\mu\text{Sv/h}$) at Fukushima Daiichi

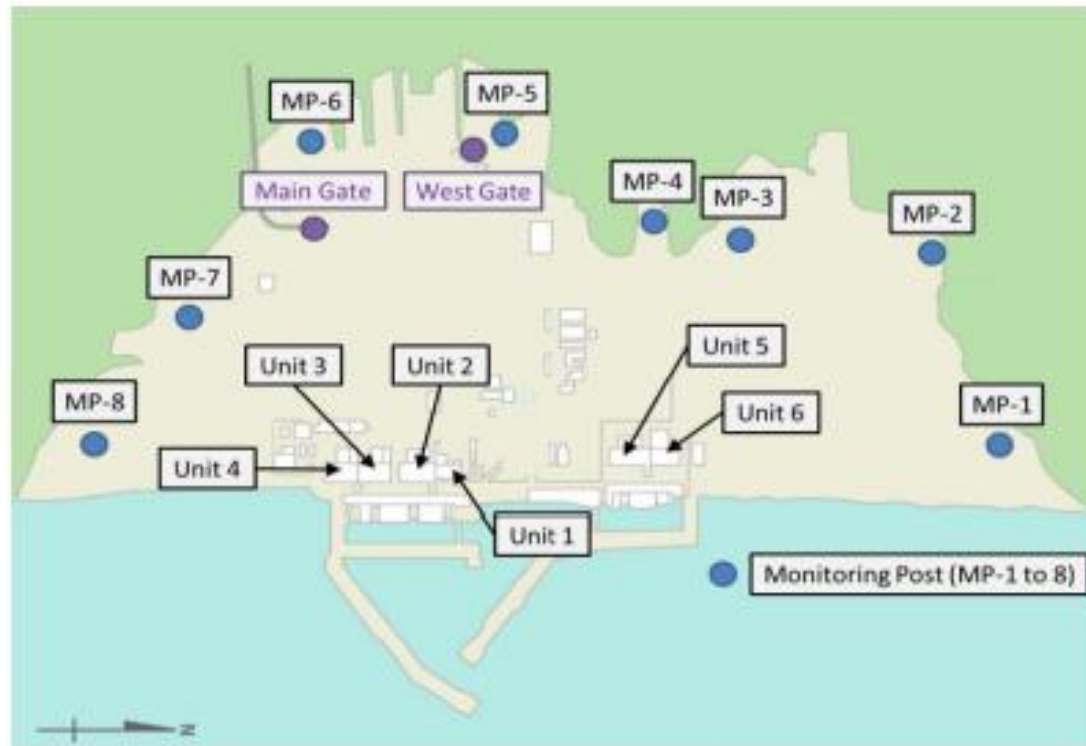
Figure 8: Onsite monitoring posts at Fukushima Daiichi

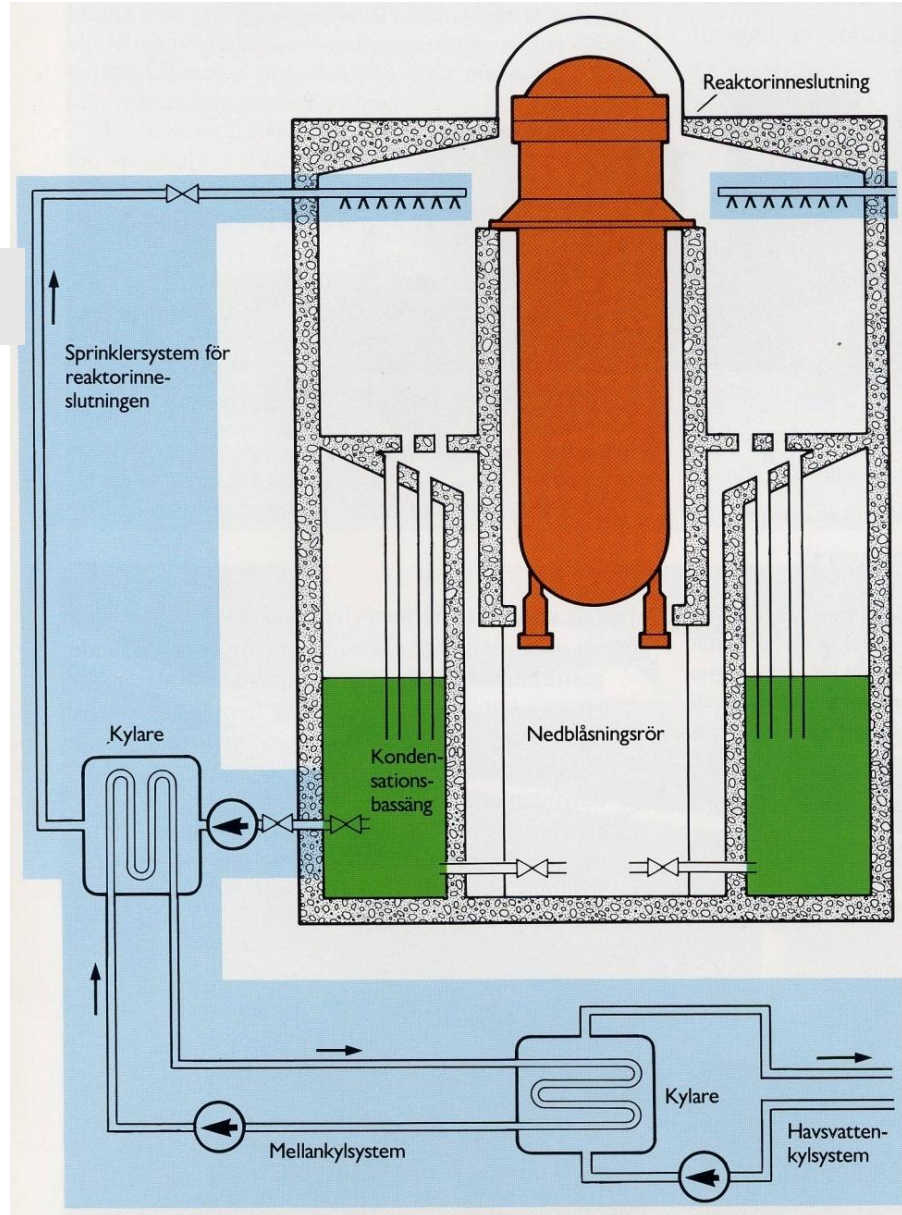
BWR – Containment emergency cooling system

Containment spray system
